# Transit Asset Management Plan

October 1, 2022 – September 30, 2026

**RHODE ISLAND PUBLIC TRANSIT AUTHORITY**

# RITPA Transit Asset Management Facility Condition Assessment

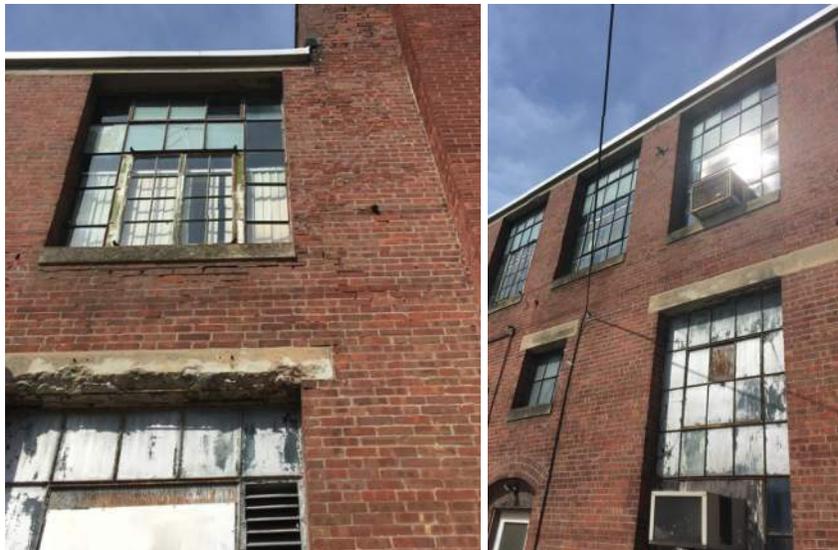
265 Melrose Street Maintenance Facility

Coding / Field Name	Asset Description
System Name	Exterior office windows
Condition	1
Quantity	~50
Unit Cost	Total: \$489,600
Year in Service	1975
Expected Useful Life	30 years
Remaining Useful Life	0 years, Estimated, Based on Date of Observation
Location	Building interior
Basis of Costing	Square Foot Costs with RSMeans Data 2022 – 43 <sup>rd</sup> Edition

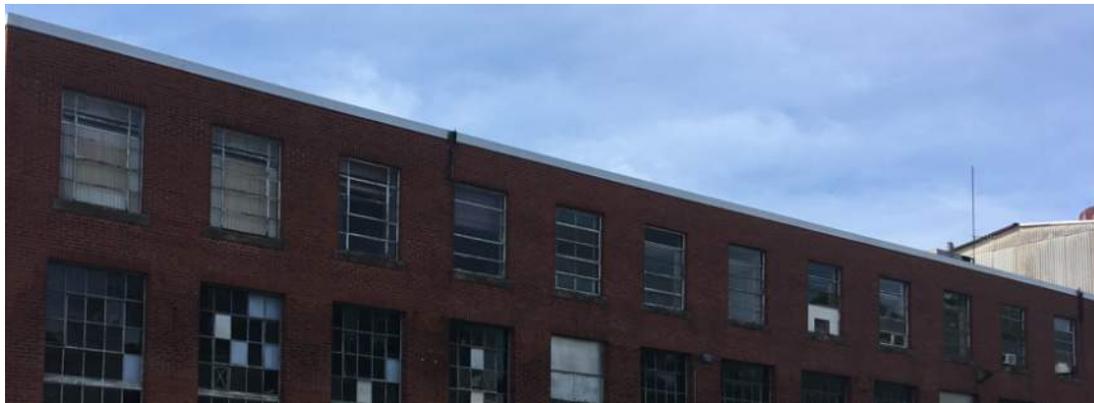
265 Melrose Street Maintenance Facility

Coding / Field Name	Asset Description
System Name	Exterior steel windows
Condition	1
Quantity	~29
Unit Cost	Total: \$350,096
Year in Service	1975
Expected Useful Life	30 years
Remaining Useful Life	0 years, Estimated, Based on Date of Observation
Location	Building exterior
Basis of Costing	Square Foot Costs with RSMeans Data 2022 – 43 <sup>rd</sup> Edition

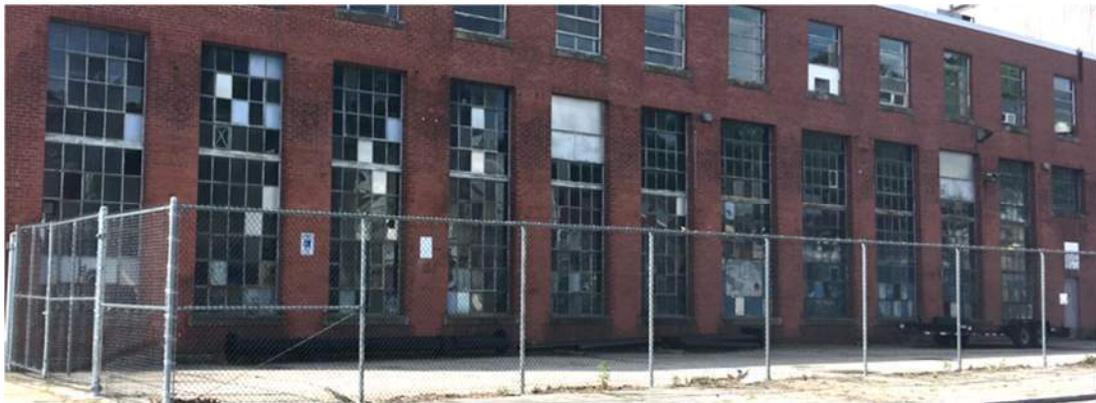
265 Melrose Street Maintenance Facility

Coding / Field Name	Asset Description
System Name	Storefront, Metal-framed with Glazing
Condition	1
Quantity	~500 sq. ft.
Unit Cost	Total: \$14,090
Year in Service	1985
Expected Useful Life	30 years
Remaining Useful Life	0 years, Estimated, Based on Date of Observation
Location	Building exterior
Basis of Costing	Square Foot Costs with RSMeans Data 2022 – 43 <sup>rd</sup> Edition

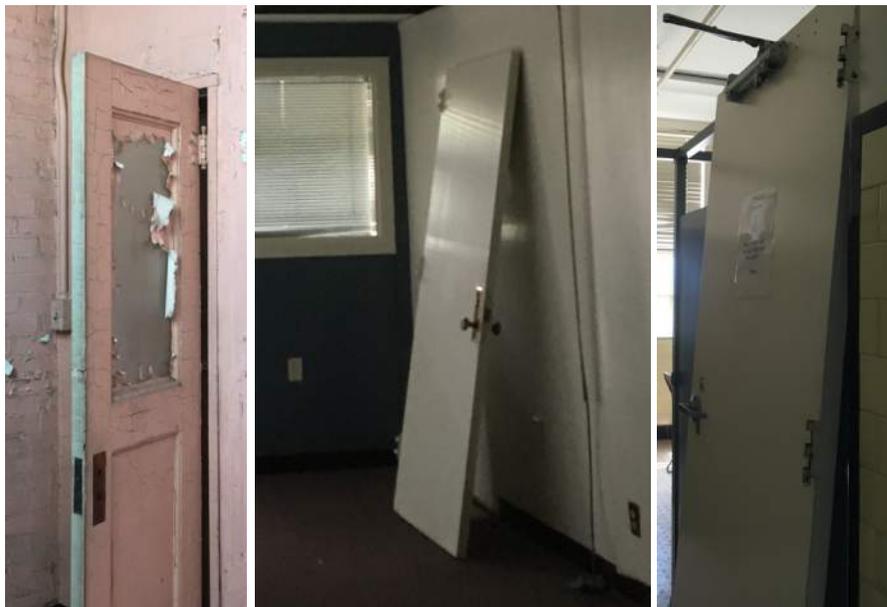
265 Melrose Street Maintenance Facility

Coding / Field Name	Asset Description
System Name	Interior fire rated doors
Condition	2
Quantity	6
Unit Cost	\$12,662.40
Year in Service	1985
Expected Useful Life	25 years
Remaining Useful Life	2 years, Estimated, Based on Date of Observation
Location	Building interior
Basis of Costing	Square Foot Costs with RSMeans Data 2022 – 43 <sup>rd</sup> Edition

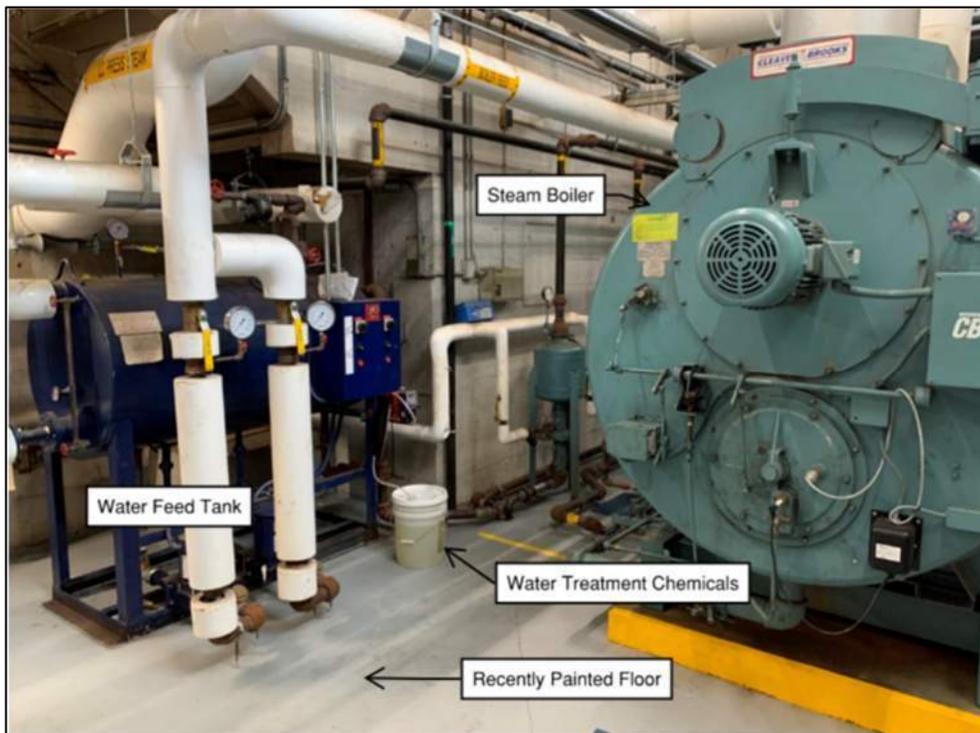
Figure 23: Boiler Room

The Cleaverbrooks boiler was manufactured in 2010. This system replaced the existing oil-fired steam boiler that was abandoned in place in the basement. The boiler room is clean and appears to be well maintained. The floor was recently painted. However, building maintenance mentioned that only recently has the boiler feed water been treated. There is a 5 gallon-bucket of treatment chemicals being dosed into the Shipco Water Feed Tank. There isn't a contract with a water treatment company. Building maintenance mentioned the steam system is very loud and condensate traps fail often. This is most likely due to the lack of water treatment. Air purge valves and condensate traps become stuck due to the corrosion effects of the inadequately treated water. Trapped air and cold condensate flash with the steam and knock pipes.

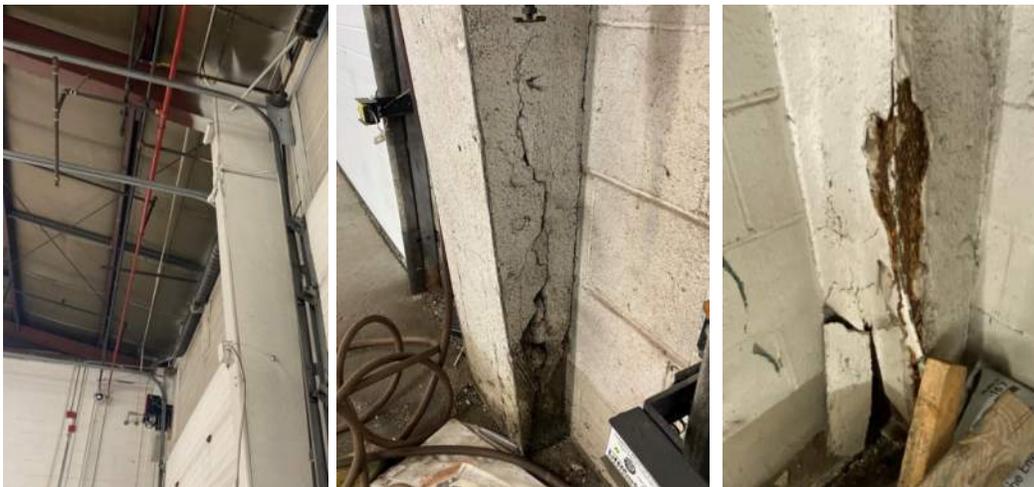
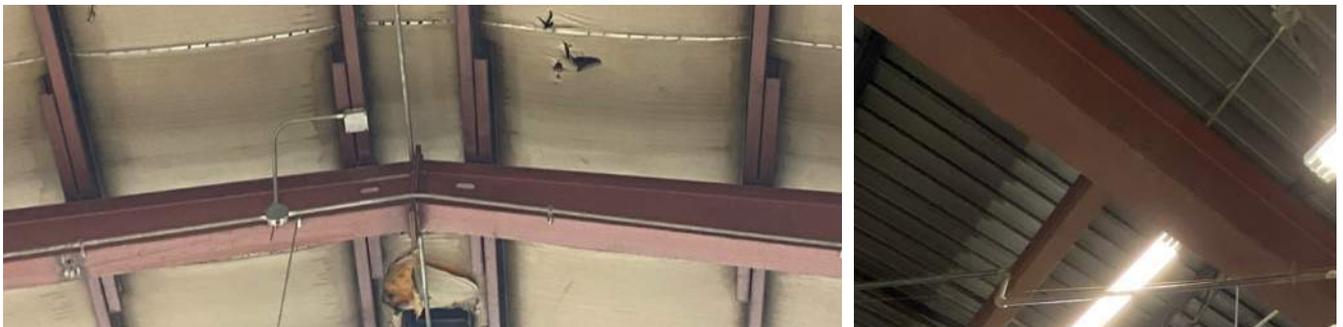
325 Melrose Street Maintenance Facility

Coding \$ Field Name	Asset Description
System Name	CMU walls
Condition	3
Quantity	~8,200 sq. ft.
Unit Cost	Total: \$200,694.42
Year in Service	~1960s with Sporadic Modifications
Expected Useful Life	100 years
Remaining Useful Life	35 years, Estimated, Based on Date of Observation
Location	Exterior and interior bearing walls.
Basis of Costing	Square Foot Costs with RSMeans Data 2022 – 43 <sup>rd</sup> Edition

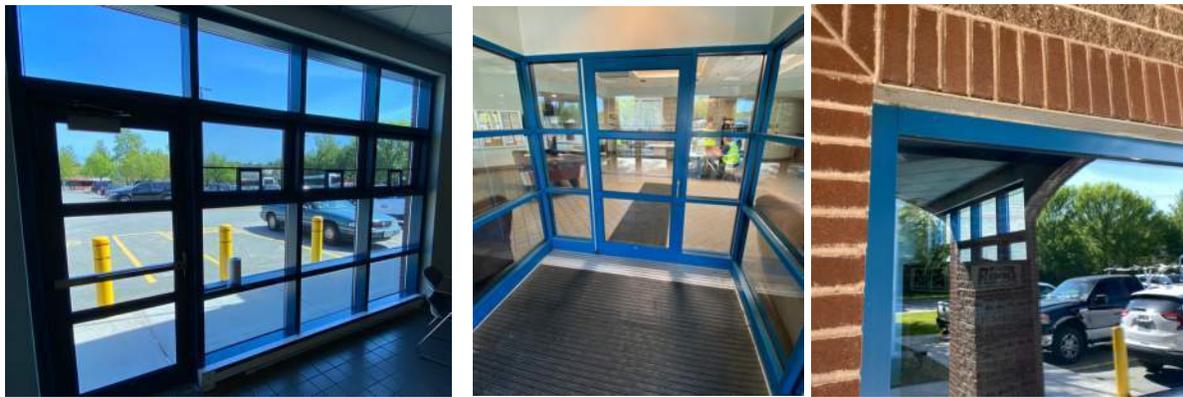
Coding / Field Name	Asset Description
System Name	Exterior linear metal ceilings
Condition	4
Quantity	~342 sq. ft.
Unit Cost	Total: \$4,258
Year in Service	1993
Expected Useful Life	50 years
Remaining Useful Life	35 years, Estimated, Based on Date of Observation
Location	Building exterior and vestibule
Basis of Costing	Square Foot Costs with RSMeans Data 2022 – 43 <sup>rd</sup> Edition

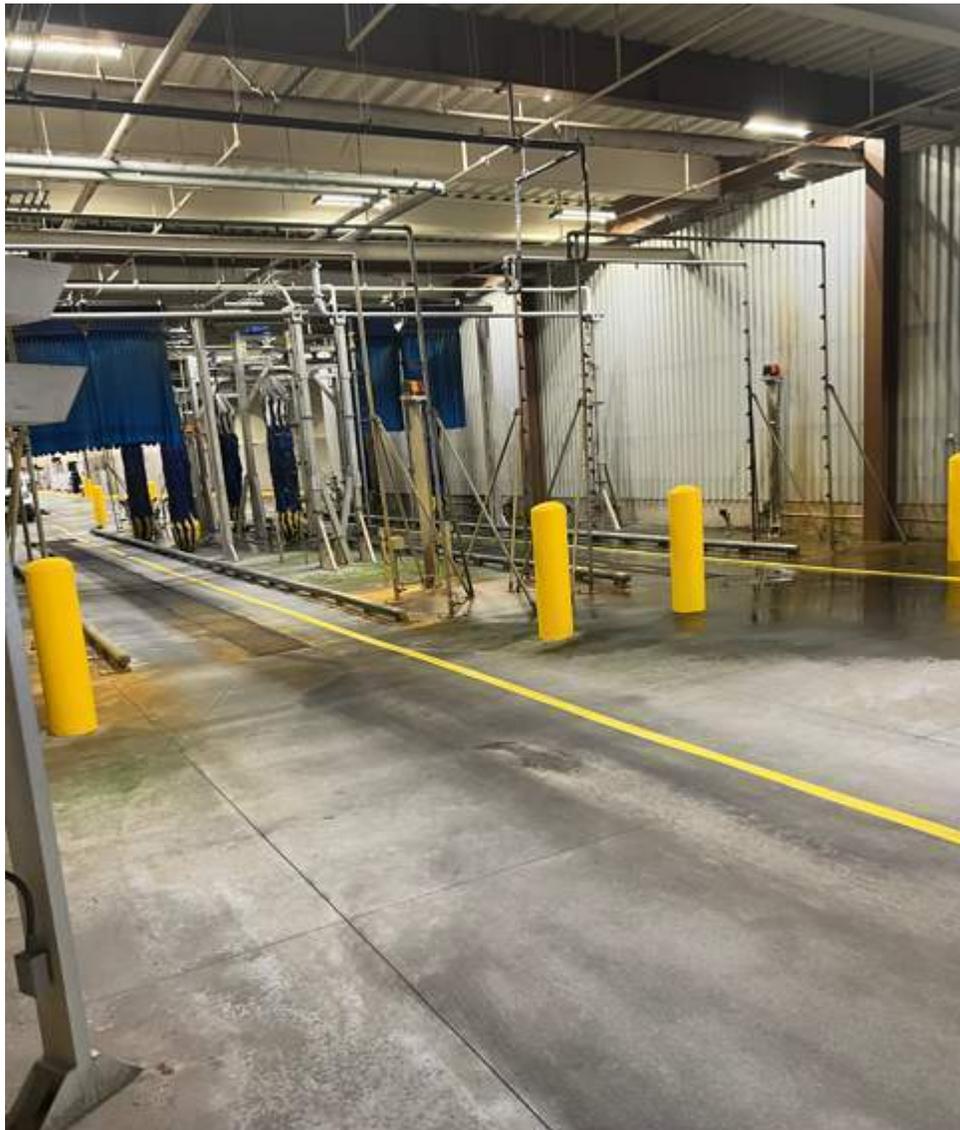
Coding / Field Name	Asset Description
System Name	Bus wash
Condition	3
Quantity	2
Unit Cost	\$99,172
Year in Service	2009
Expected Useful Life	25 years
Remaining Useful Life	15 years, Estimated, Based on Date of Observation
Location	Building interior
Basis of Costing	Square Foot Costs with RSMeans Data 2022 – 43 <sup>rd</sup> Edition
