# Transit Asset Management Plan

October 1, 2022 – September 30, 2026

**RHODE ISLAND PUBLIC TRANSIT AUTHORITY**

# RITPA Transit Asset Management Facility Condition Assessment

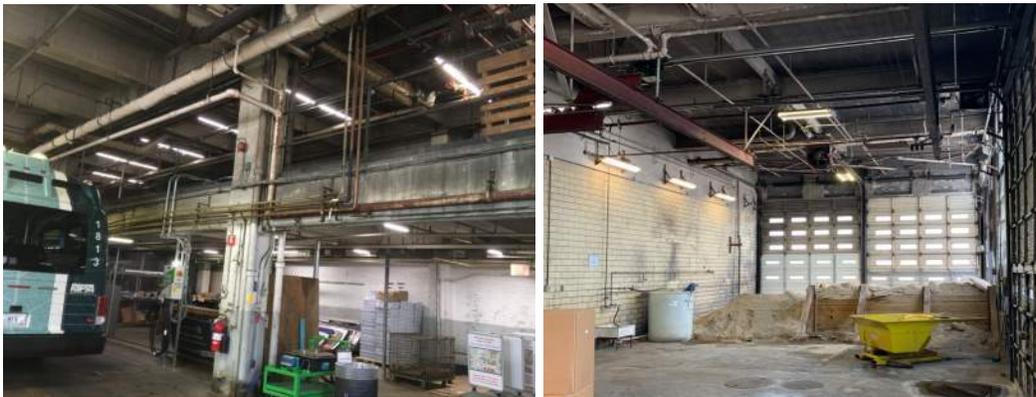
**265 Melrose Street Maintenance Facility**

Coding / Field Name	Asset Description
System Name	Superstructure, concrete/steel.
Condition	3
Quantity	72,000 sq. ft.
Unit Cost	Total: \$972,000
Year in Service	1922
Expected Useful Life	100 years
Remaining Useful Life	25 years, Estimated, Based on Date of Observation
Location	Structure
Basis of Costing	Square Foot Costs with RSMeans Data 2022 – 43 <sup>rd</sup> Edition

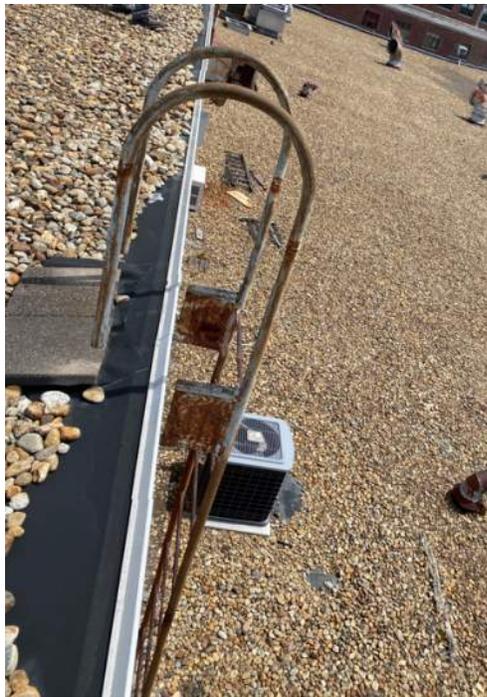
**265 Melrose Street Maintenance Facility**

Coding / Field Name	Asset Description
System Name	Roof access ladder, steel
Condition	1
Quantity	1
Unit Cost	\$2,296.85
Year in Service	N/A
Expected Useful Life	N/A
Remaining Useful Life	0 years, Estimated, Based on Date of Observation
Location	Roof
Basis of Costing	Square Foot Costs with RSMeans Data 2022 – 43 <sup>rd</sup> Edition

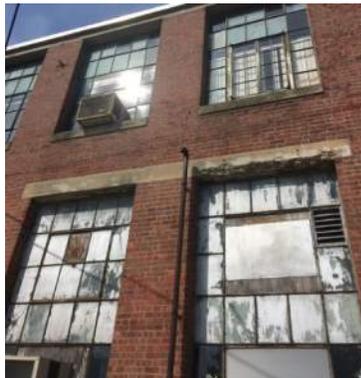
265 Melrose Street Maintenance Facility

Coding / Field Name	Asset Description
System Name	Exterior steel windows
Condition	1
Quantity	~29
Unit Cost	Total: \$350,096
Year in Service	1975
Expected Useful Life	30 years
Remaining Useful Life	0 years, Estimated, Based on Date of Observation
Location	Building exterior
Basis of Costing	Square Foot Costs with RSMeans Data 2022 – 43 <sup>rd</sup> Edition

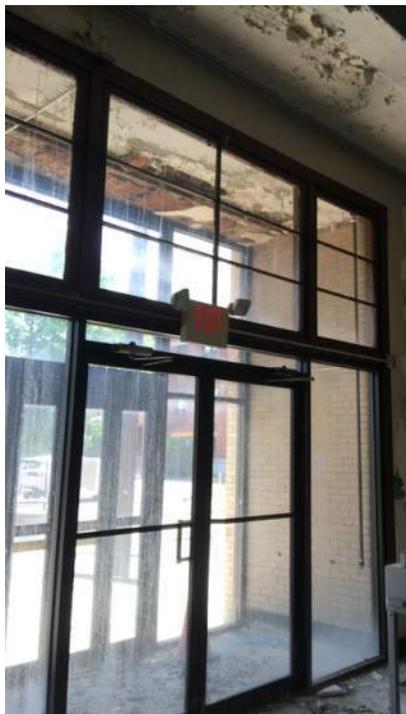
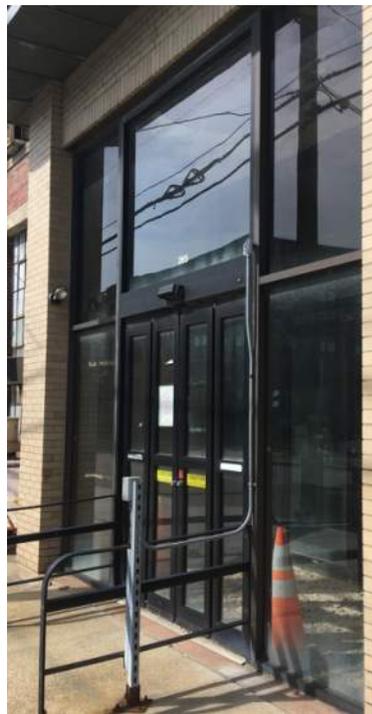
265 Melrose Street Maintenance Facility

Coding / Field Name	Asset Description
System Name	Storefront, Metal-framed with Glazing
Condition	1
Quantity	~500 sq. ft.
Unit Cost	Total: \$14,090
Year in Service	1985
Expected Useful Life	30 years
Remaining Useful Life	0 years, Estimated, Based on Date of Observation
Location	Building exterior
Basis of Costing	Square Foot Costs with RSMeans Data 2022 – 43 <sup>rd</sup> Edition

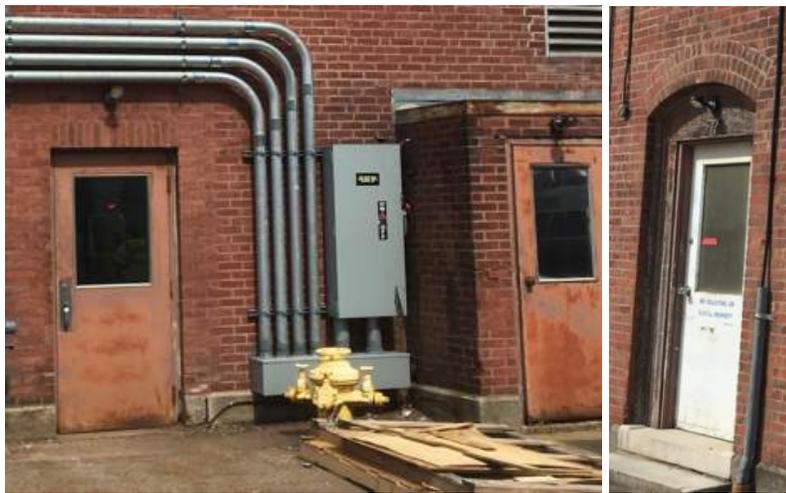
265 Melrose Street Maintenance Facility

Coding / Field Name	Asset Description
System Name	Steel exterior doors, frames, and hardware
Condition	1
Quantity	8
Unit Cost	Total: \$16,931
Year in Service	1997
Expected Useful Life	25 years
Remaining Useful Life	1 year, Estimated, Based on Date of Observation
Location	Building exterior
Basis of Costing	Square Foot Costs with RSMeans Data 2022 – 43 <sup>rd</sup> Edition

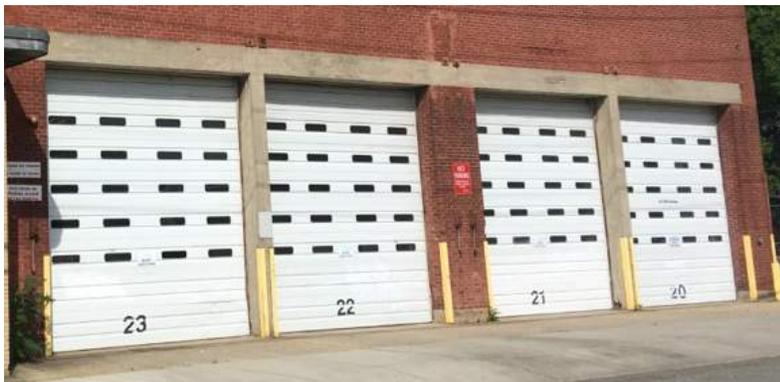
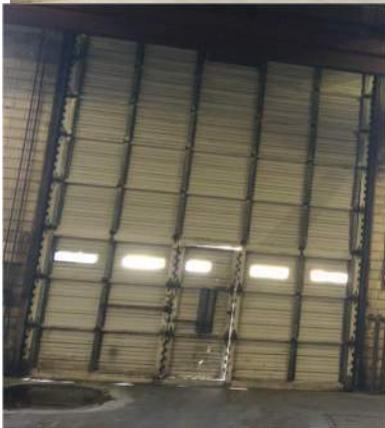
265 Melrose Street Maintenance Facility

Coding / Field Name	Asset Description
System Name	Overhead steel garage doors
Condition	2
Quantity	22
Unit Cost	Total: \$153,063
Year in Service	1995
Expected Useful Life	30 years
Remaining Useful Life	5 years, Estimated, Based on Date of Observation
Location	Building exterior
Basis of Costing	Square Foot Costs with RSMeans Data 2022 – 43 <sup>rd</sup> Edition

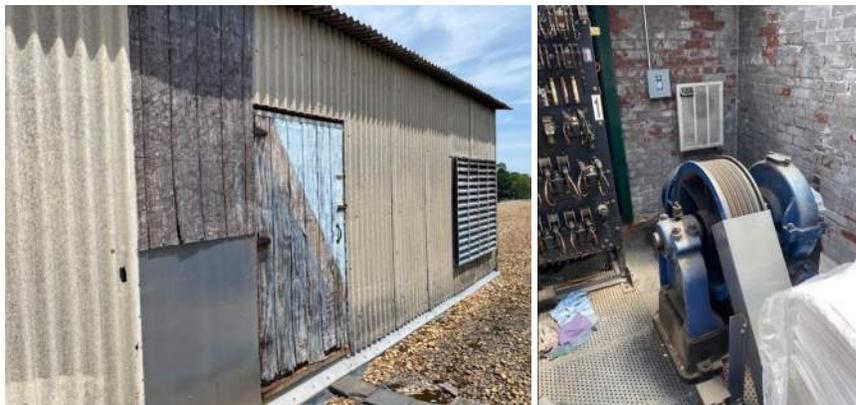
265 Melrose Street Maintenance Facility

Coding / Field Name	Asset Description
System Name	Roof head houses
Condition	1
Quantity	~600 sq. ft.
Unit Cost	\$25,248
Year in Service	N/A
Expected Useful Life	N/A
Remaining Useful Life	0 years, Estimated, Based on Date of Observation
Location	Roof
Basis of Costing	Square Foot Costs with RSMeans Data 2022 – 43 <sup>rd</sup> Edition

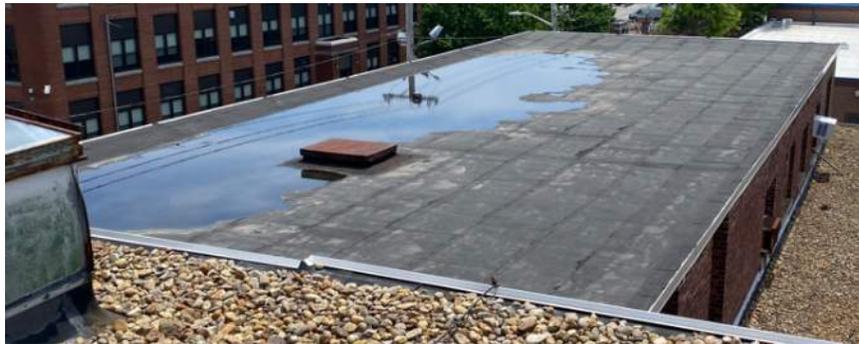
Coding / Field Name	Asset Description
System Name	Roof – Membrane
Condition	2
Quantity	~3,000 sq. ft.
Unit Cost	Total: \$22,872
Year in Service	2005
Expected Useful Life	20
Remaining Useful Life	5 years, Estimated, Based on Date of Observation
Location	Building structure
Basis of Costing	Square Foot Costs with RSMeans Data 2022 – 43 <sup>rd</sup> Edition

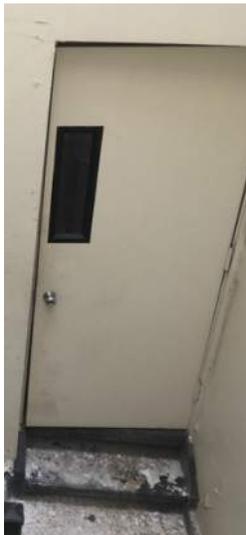
Coding / Field Name	Asset Description
System Name	Interior steel doors
Condition	1
Quantity	23
Unit Cost	Total: \$37,039.20
Year in Service	2010
Expected Useful Life	20
Remaining Useful Life	2 years, Estimated, Based on Date of Observation
Location	Building interior
Basis of Costing	Square Foot Costs with RSMeans Data 2022 – 43 <sup>rd</sup> Edition

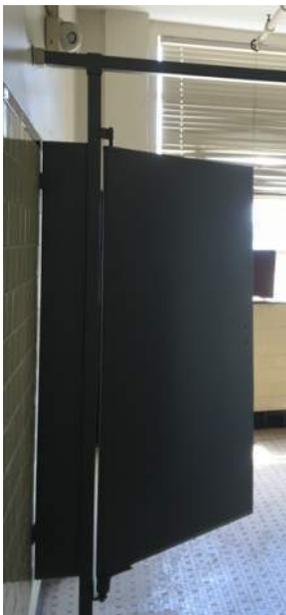
Coding / Field Name	Asset Description
System Name	Toilet partitions - metal
Condition	3
Quantity	5
Unit Cost	\$5289.84
Year in Service	2010
Expected Useful Life	15 years
Remaining Useful Life	5 years, Estimated, Based on Date of Observation
Location	Building interior
Basis of Costing	Square Foot Costs with RSMeans Data 2022 – 43 <sup>rd</sup> Edition

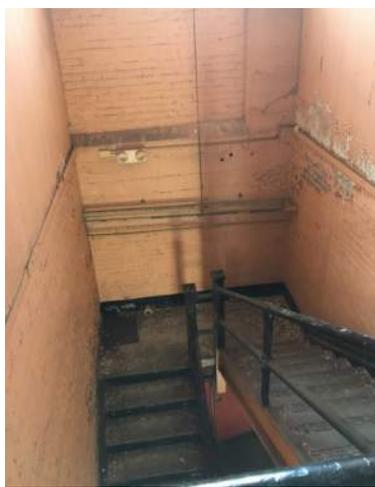
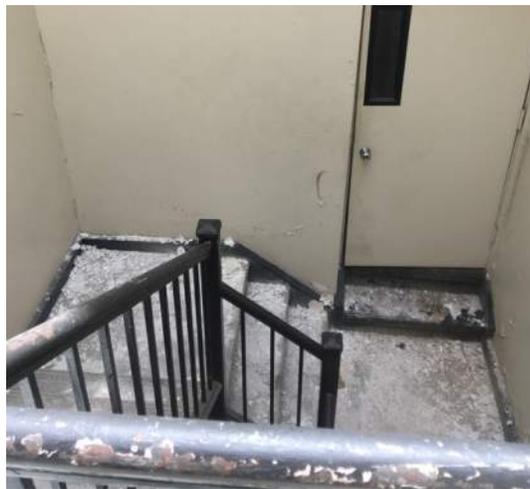
Coding / Field Name	Asset Description
System Name	Interior stairs, Fire Exit
Condition	1
Quantity	~2,000 sq. ft.
Unit Cost	\$33,825
Year in Service	1927
Expected Useful Life	50 years
Remaining Useful Life	0 years, Estimated, Based on Date of Observation
Location	Building interior
Basis of Costing	Square Foot Costs with RSMeans Data 2022 – 43 <sup>rd</sup> Edition

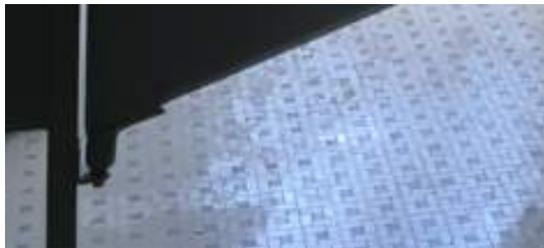
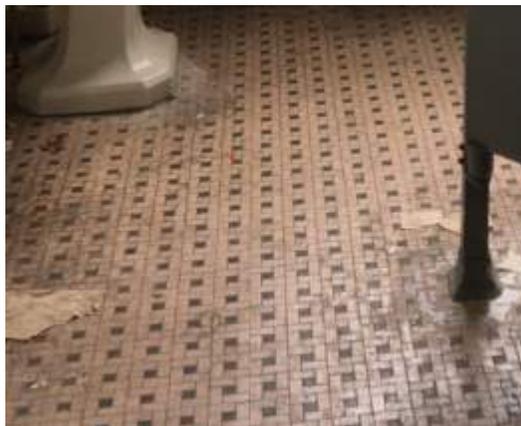
Coding / Field Name	Asset Description
System Name	Ceramic tile flooring
Condition	1
Quantity	2,000 sq. ft.
Unit Cost	\$27,226.41
Year in Service	1975
Expected Useful Life	75 years
Remaining Useful Life	10 years, Estimated, Based on Date of Observation
Location	Building interior
Basis of Costing	Square Foot Costs with RSMeans Data 2022 – 43 <sup>rd</sup> Edition

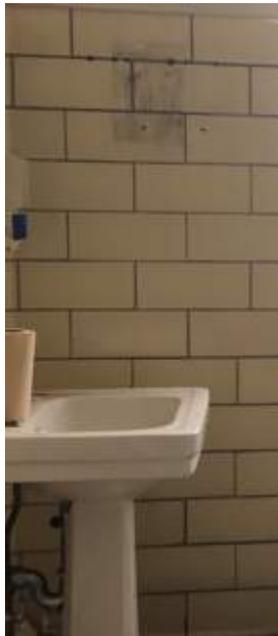
Coding / Field Name	Asset Description
System Name	Ceramic wall tile
Condition	1
Quantity	~2,000
Unit Cost	\$18,000
Year in Service	1975
Expected Useful Life	50 years
Remaining Useful Life	0 years, Estimated, Based on Date of Observation
Location	Building interior
Basis of Costing	Square Foot Costs with RSMeans Data 2022 – 43 <sup>rd</sup> Edition

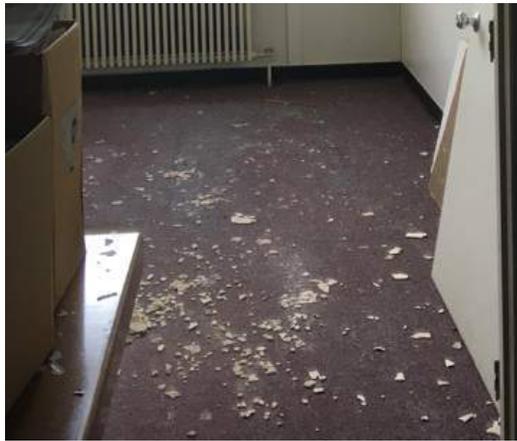
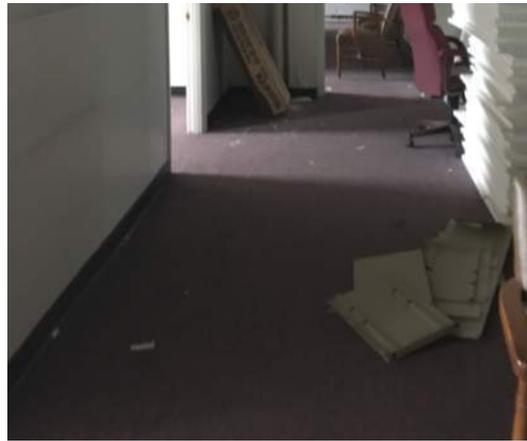
Coding / Field Name	Asset Description
System Name	Carpet flooring
Condition	1
Quantity	14,000 sq. ft.
Unit Cost	\$95,634
Year in Service	1975
Expected Useful Life	10 years
Remaining Useful Life	0 years, Estimated, Based on Date of Observation
Location	Building interior
Basis of Costing	Square Foot Costs with RSMeans Data 2022 – 43 <sup>rd</sup> Edition

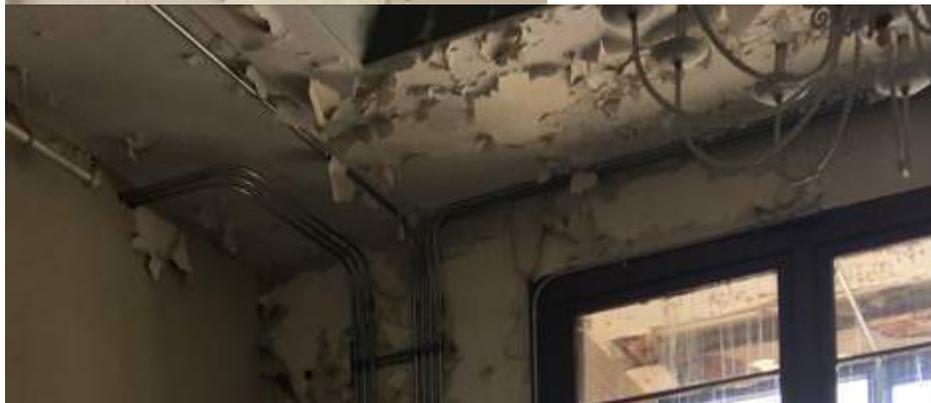
Coding / Field Name	Asset Description
System Name	Interior gypsum board ceilings
Condition	1
Quantity	~2,000 sq. ft.
Unit Cost	\$20,262
Year in Service	1927
Expected Useful Life	75 years
Remaining Useful Life	0 years, Estimated, Based on Date of Observation
Location	Building interior
Basis of Costing	Square Foot Costs with RSMMeans Data 2022 – 43 <sup>rd</sup> Edition

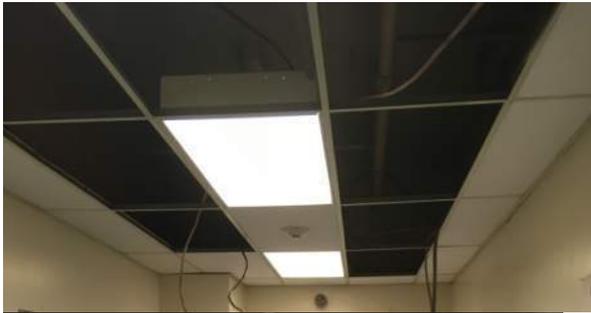
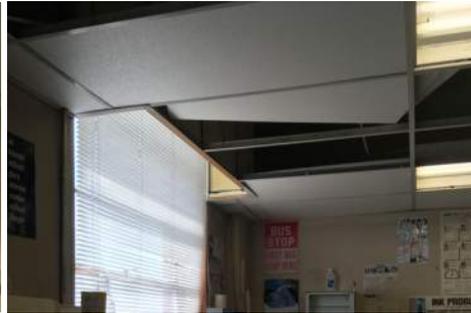
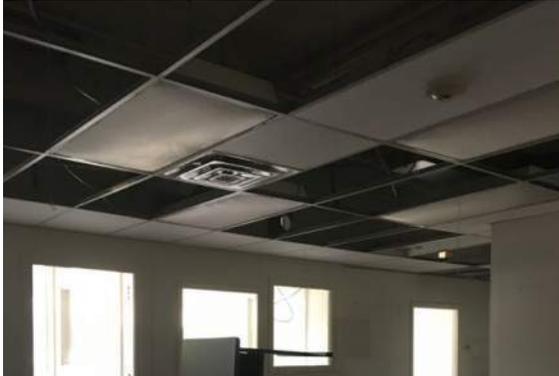
Coding / Field Name	Asset Description
System Name	Acoustic ceiling tile and grid systems.
Condition	1
Quantity	22,000 sq. ft.
Unit Cost	\$237,160.02
Year in Service	1975
Expected Useful Life	40 years
Remaining Useful Life	0 years, Estimated, Based on Date of Observation
Location	Building interior
Basis of Costing	Square Foot Costs with RSMeans Data 2022 – 43 <sup>rd</sup> Edition

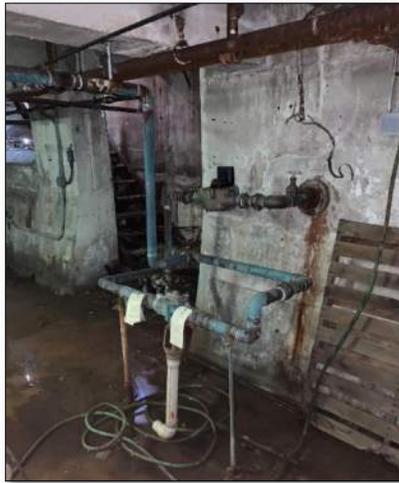
Figure 1: Water Service Entrance

The domestic water service is in a basement level. The service has a 2” copper line. There is a 2” water meter and a 2” reduced-pressure zone backflow preventer. The copper is slightly corroded but appears to be in fair condition. A pressure gauge at the service reads 78 psi. No pressure boosting pumps are present. The domestic water is

pipework with copper throughout the building. Maintenance was performed in a few sections. The older fittings were soldered, and the newer fittings are press-fit fittings. No insulation is present on hot or cold water piping.

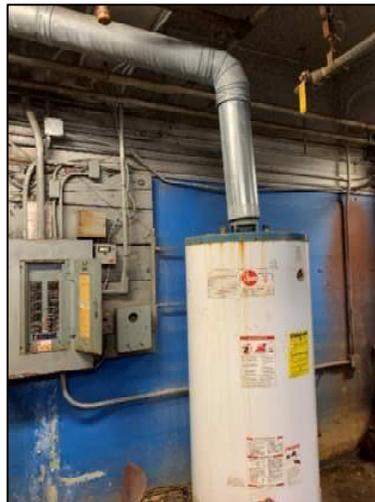
Figure 5: Abandoned Gas-Fired Water Heater in Abandoned Boiler Room

An abandoned, gas-fired water heater is in the abandoned boiler room. This water heater might have supplied hot water to the restrooms in the office area when the office portion of the building was operational.

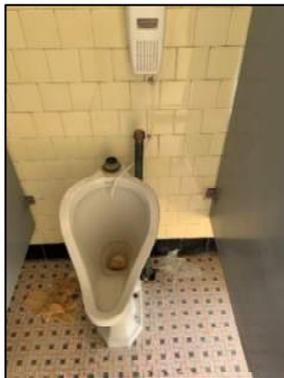
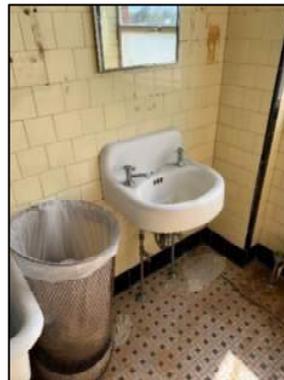
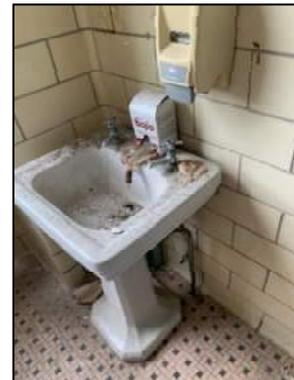
The observed abandoned plumbing fixtures are non-ADA compliant, are manually operated, and are not of the water-saving variety. There appeared to be no master mixing valve and no point-of-use mixing valves to provide scald protection.

Figure 6: Abandoned Urinal

Figure 7: Abandoned Lavatory

Figure 8: Abandoned Lavatory

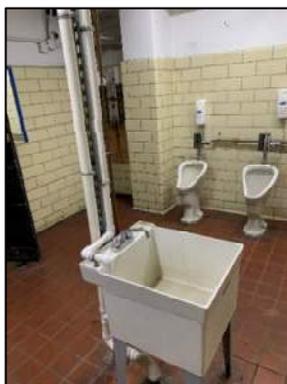
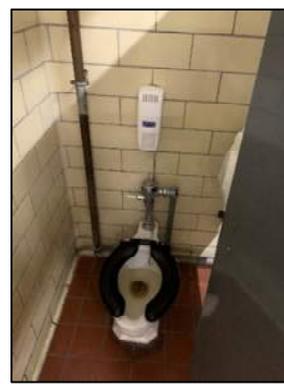
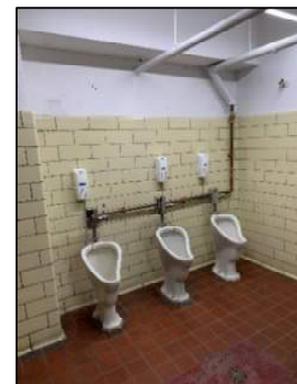
Coding / Field Name	Asset Description
Plumbing Fixtures	Water closets, lavatories, sinks, etc.
Condition	1-Poor
Quantity	~21,000 SF, ~20 Fixtures
Unit Cost	~\$4,000/Fixture and \$2.50/SF. Total: \$132,500
Year in Service	~1960s with sporadic modifications
Expected Useful Life (EUL)	~20 Years
Remaining Useful Life (RUL)	~0 Years
Location	Office Area
Basis of Costing	RMS Means Data with Contingencies Added

Figure 9: Garage Restroom

Figure 10: Garage Restroom

Figure 11: Garage Restroom

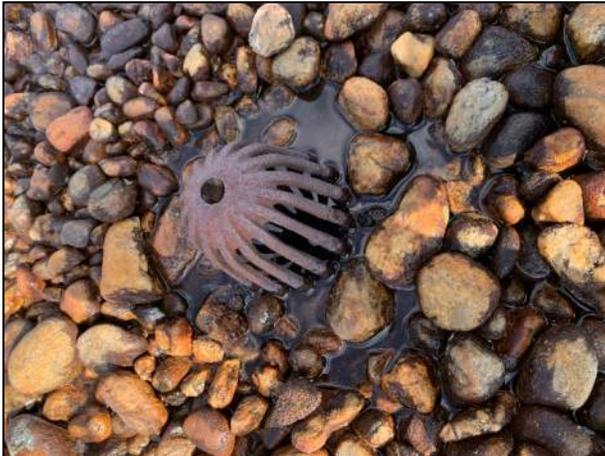
The storm drainage piping appeared to be original to the building. Most piping was bell and spigot cast iron, and some recent patching was done with PVC. The drains on the roof are original and some appear clogged. No secondary drainage was present.

Figure 12: Clogged Roof Drain

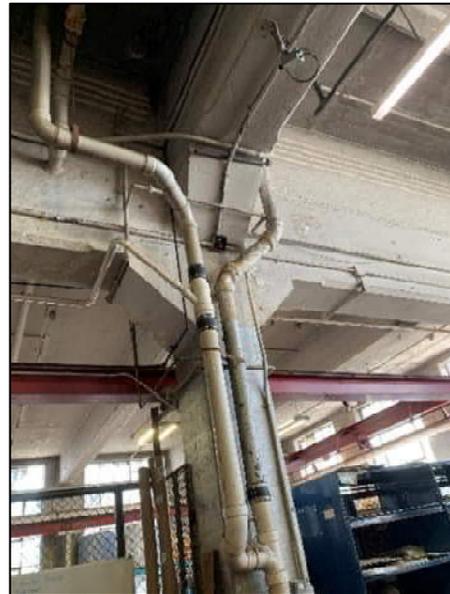
Figure 13: Storm Leaders - PVC and Cast Iron

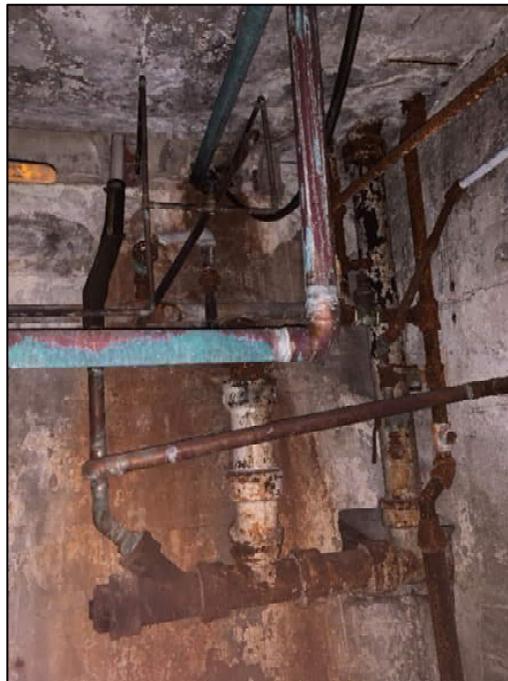
The sanitary piping is bell and spigot cast iron. The piping appeared to be original and is deteriorating in the basement, where one street lateral is observed.

Figure 14: Pipe Chase in Water Service Area. Sanitary Lateral

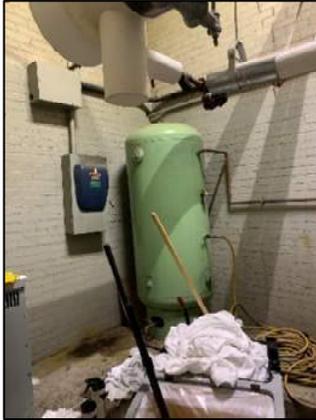
Figure 16: Compressed Air Tank

Coding / Field Name	Asset Description
Compressed Air Systems	Compressed Air System Equipment and Piping
Condition	4-Good
Quantity	Qty (1) System
Unit Cost	Total: \$200,000
Year in Service	~2010
Expected Useful Life (EUL)	~20 Years
Remaining Useful Life (RUL)	~8 Years
Location	Garage
Basis of Costing	Equipment

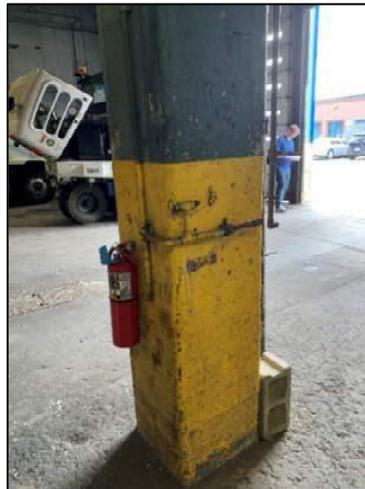
Figure 19: Compressed Air Drop for Hand Tools

A compressed air system is in a dedicated room. The system includes an air compressor, a filter, and a storage tank. The compressed air is only used for hand tools used by the technicians. Drops are located on columns in the garage bay. The compressed air system does not help control the steam system.

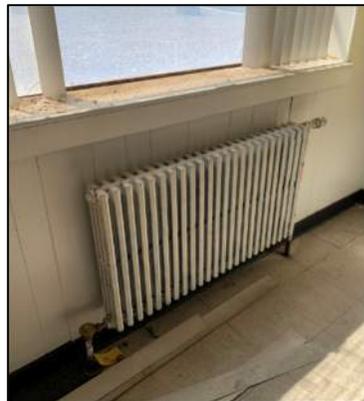
Figure 20: Steam Radiator in Breakroom

Coding / Field Name	Asset Description
Steam System	Steam boiler, piping, ancillary equipment, and terminal devices (radiators and fan coils).
Condition	Steam Boiler: 4-Good, Rest of System: 2-Marginal
Quantity	~71,000 square feet
Unit Cost	\$14/square foot for ~\$994,000
Year in Service	Boiler (2010), Other System Components ~1960s and 1997
Expected Useful Life (EUL)	Boiler ~30 Years, Other System Components ~30 Years
Remaining Useful Life (RUL)	Boiler ~20 years, Other System Components ~0 Years
Location	Boiler Room. See comments for further details.
Basis of Costing	RMS Means Data with Contingencies Added

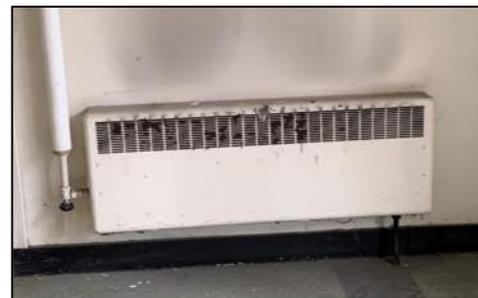
Figure 21: Steam Radiator in Lobby

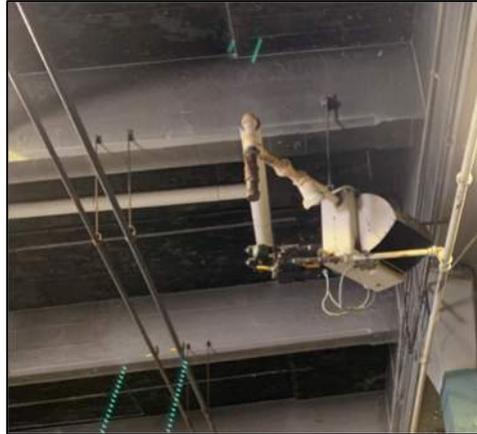
Figure 22: Steam Fan Coil in Garage

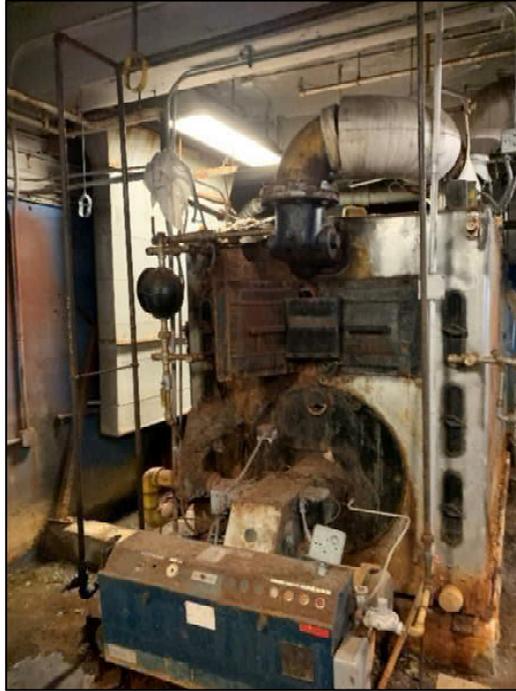
*Figure 24: Abandoned Boiler in Abandoned Boiler Room*

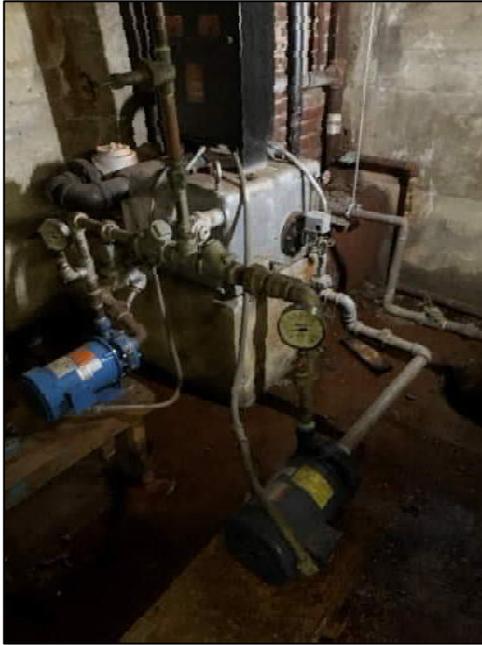
Condensate receivers are placed in various portions of the building. Some maintenance was observed, such as new pumps and motors.

Figure 26: Condensate Receiver in the Basement

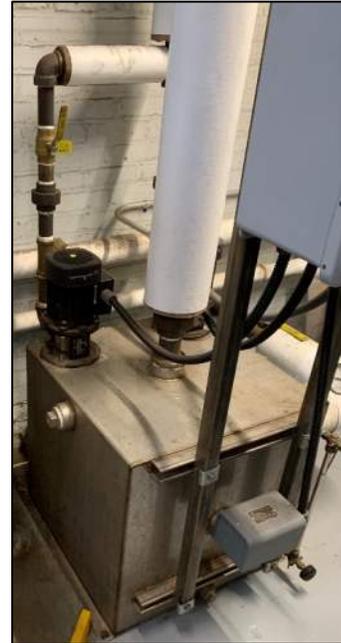
Figure 27: Condensate Receiver in the Boiler Room

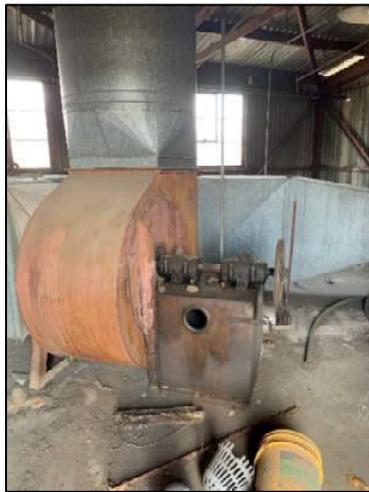
There is an abandoned paint booth on the North side of the building. The duct work in place feeds a large Air Handler that was abandoned in place on the roof. The sprinkler system was also disconnected for the penthouse where the air handler is housed (mentioned later in this report). Another large Air Handler was abandoned in place on the roof, and this air handler served the sheet metal shop and the glass shop.

Figure 28: Abandoned Air Handler for Spray Booth, Located on Roof

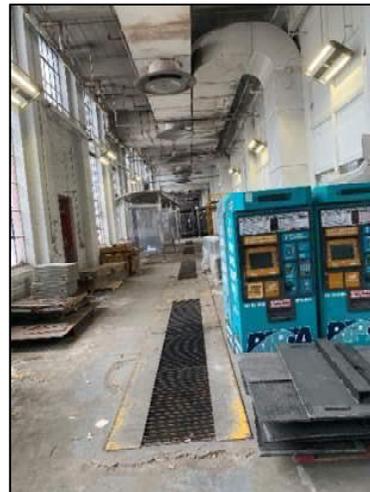
Figure 29: Spray Booth and Duct Distribution

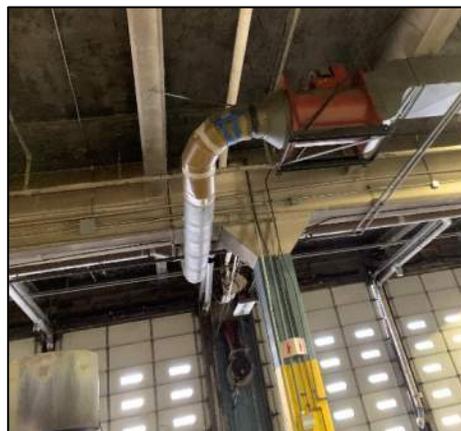
The garage has motor-driven exhaust fans that have some branch ducting. It appears the branch ducting was intended for localized exhaust, but the flexible ducting used for this purpose is not in place. It is unclear how the exhaust fans are controlled as there are no visible CO or NO2 controls that are typically in place and are mandated by current building codes. It is unclear how many exhaust fans are operational.

Figure 30: Garage Exhaust Fan

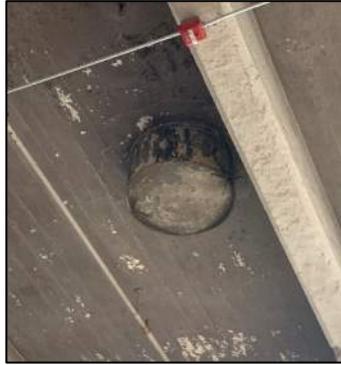
The garage also has exhaust ducts with dampers that lead to the roof. Some dampers are open, and some aren't. Some have strings tied to the damper levers. The mechanical exhaust fans were fitted to several of these ducts.

Figure 31: Garage Exhaust Duct Closed

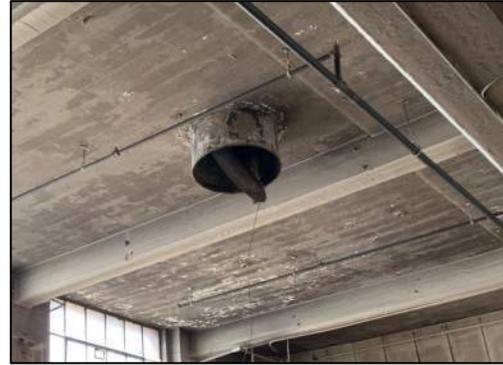
Figure 32: Garage Exhaust Duct Open

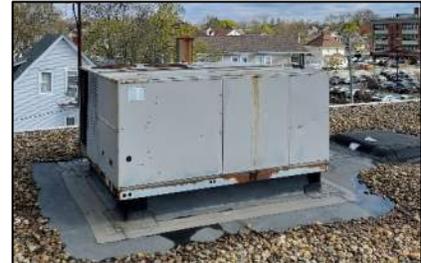
Figure 36: Abandoned Rooftop Unit

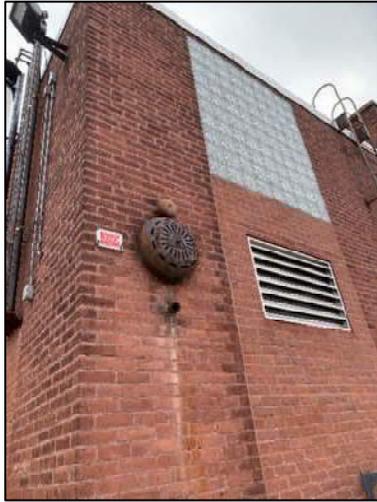
The sprinkler service enters the West side of the building into the Boiler Room. The main service is marked with a Post Indicator Valve (PIV). There is no Fire Department Connection, but there is an exterior bell.

Figure 42: Fire Sprinkler Service Alarm Bell

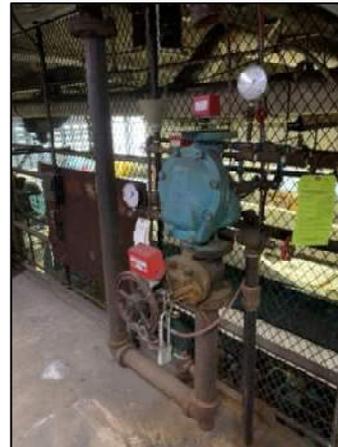
The Risers for the zones appear rather new. There are new flow switches and tamper switches in place. The riser check assemblies appear in good condition. There is an abandoned riser that previously served the air handler houses on the roof.

Figure 47: Abandoned Fire Sprinkler Riser

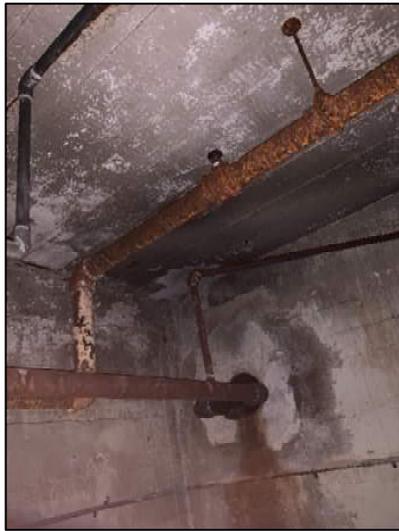
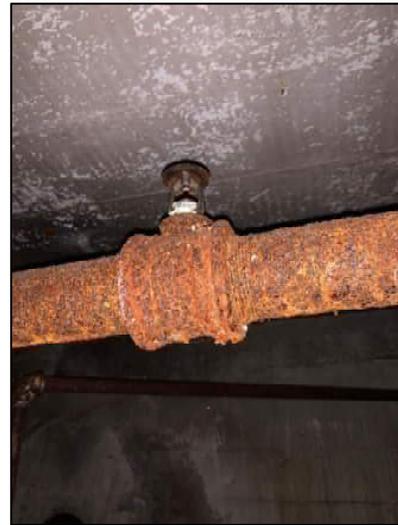
According to the maintenance team, sprinklers and branch piping have been replaced piecemeal. There are still very old sprinklers, which would require testing per NFPA 25 Table 5.1.1.2 to remain in use. Upright sprinklers are used in exposed areas. The piping is steel, which is in fair condition. The paint is gone for sprinkler piping in the basement and a good bit of corrosion is present.

Figure 48: Rusted Fire Sprinkler Line, Basement

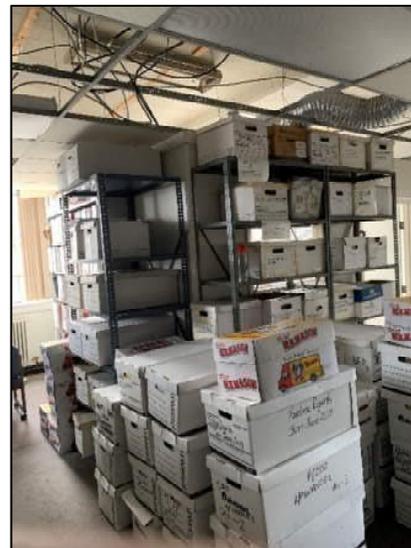
The office portion is not fully sprinklered. Sprinklers are present in the lobby and the corridor, but the offices, including a file storage area, do not have sprinklers.

Figure 51: Unsprinklered Storage Room, Office

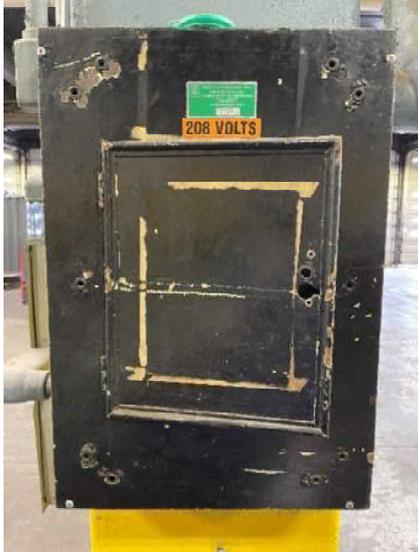
Figure 3: Deteriorating/Damaged Panelboard

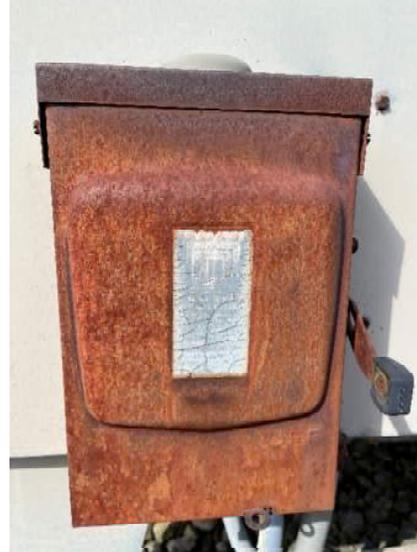
An existing 600V service was removed and replaced with a 600A, 480V service installed approximately 3-4 years ago. The service is fed from the main electrical room located in the building next door (269 Melrose) and enters a main disconnect located on the exterior (West side of the building) (*Figure 1*). Conduits enter building through boiler room and run to distribution panel on second floor mezzanine. The main objective of the new service was to feed new electrical vehicle charging stations and refeed existing Electrical distribution that was to remain. The new 480V, Main Distribution Panel ‘DP’ feeds an existing 600V elevator through a 30kVA step-up dry-type transformer. Additionally, Panel ‘DP’ (*Figure 2*) feeds a 120/208V Panelboard ‘LP8’ through a 75kVA step-down dry-type transformer. There was no access to Panel ‘LP8’, but it appears to feed the existing 120/208V panels throughout the building. Many older panelboards are deteriorating and/or are damaged (*Figure 3*) and several pieces of electrical equipment are longer in use and have been abandoned in place (*Figure 4*).

Figure 4: Abandoned equipment/disconnect

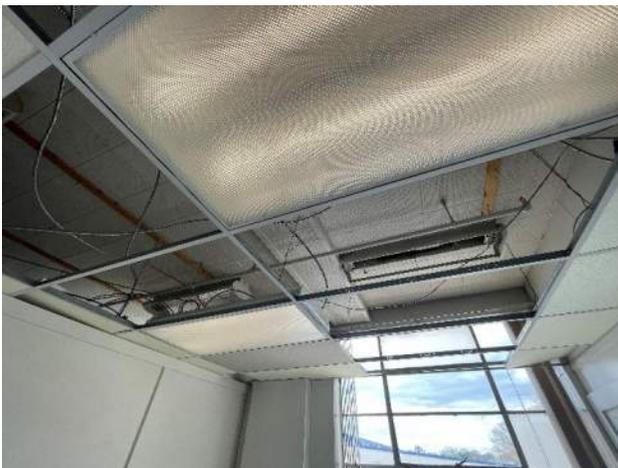
Storage/office spaces consist of fluorescent 2’X2’ and 2’X4’ troffer fixtures controlled by wall switch occupancy sensors (Figure 4). Some fixtures and controls are still operational, but the remaining system no longer in working condition. Older fixtures, before office fit-out were left abandoned in place above suspended ceiling (Figure 3). Some exit signs throughout the space were no longer illuminated (Figure 5) and are no longer operational. Emergency battery units (Figure 6) were observed throughout the space and appear to be operational, but are beyond their expected useful life.

Figure 3: Existing and abandoned fluorescent fixtures

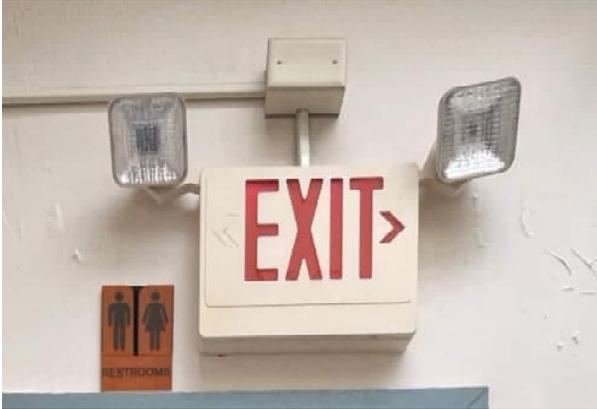
Figure 5: Unilluminated Exit sign

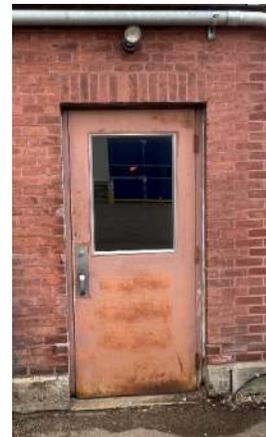
Figure 8: Emergency remote head

Coding / Field Name	Asset Description
Exterior Lighting System	Exterior wall pack fixtures, emergency remote heads
Condition	3 – Adequate
Quantity	Exterior Lighting System
Unit Cost	~ \$7,500
Year in Service	Lighting, Branch Wiring, and Associated controls ~ 15 years
Expected Useful Life (EUL)	Lighting, Branch Wiring, and Associated controls ~ 20 years
Remaining Useful Life (RUL)	Lighting, Branch Wiring, and Associated controls ~ 5 years; Estimation contingent on equipment meeting the American National Standards Institute/International Electrical Testing Association (ANSI/NETA) Standard for Maintenance Testing Specifications.
Location	Building Exterior
Basis of Costing	RMS Means Data with Contingencies Added

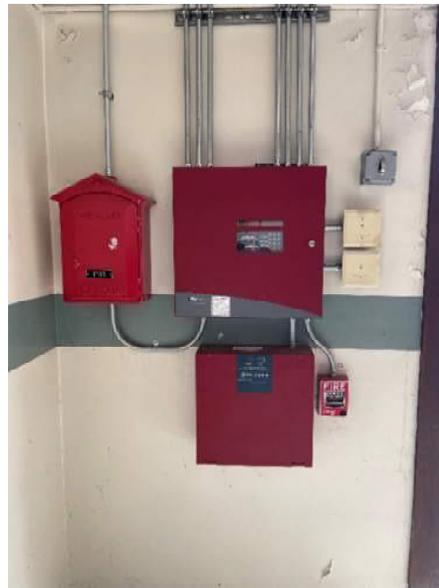
Figure 52: Fire Alarm System

Fire alarm system (*Figure 1*) consists of an addressable Fire Alarm Control Panel, battery cabinet, and devices manufactured by Honeywell. Connection to local fire department is through a Gamewell Master Box. Fire Alarm system and associated devices and wiring appear to be in working condition, however they are approaching their expected useful life based on industry standards. The system was last inspected 3-2-22.

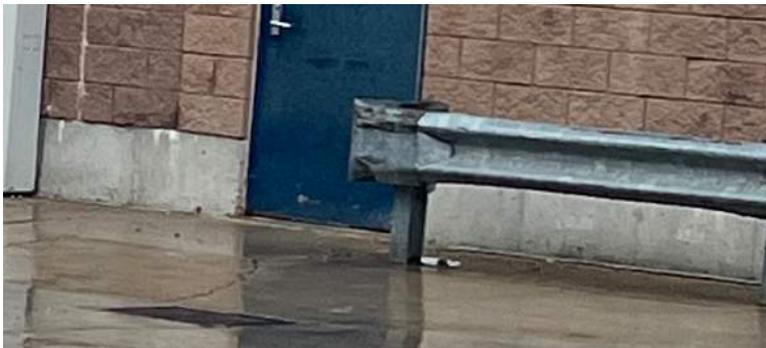
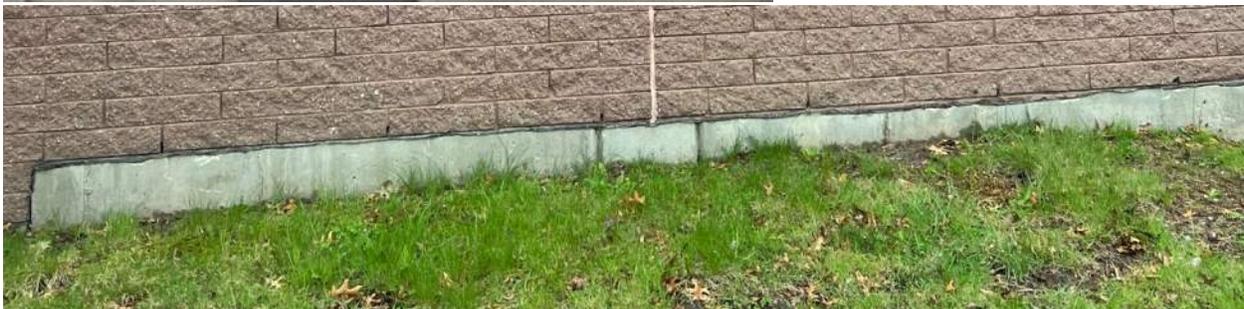
B. Coding / Field Name	Asset Description
System Name	Foundations
Condition	4
Quantity	~1,801 linear ft. at varying depths (accounted for in unit cost)
Unit Cost	Total: \$369,775.20
Year in Service	1990
Expected Useful Life	100 years
Remaining Useful Life	90 years, Estimated, Based on Date of Observation
Location	Substructure
Basis of Costing	Square Foot Costs with RSMeans Data 2022 – 43 <sup>rd</sup> Edition

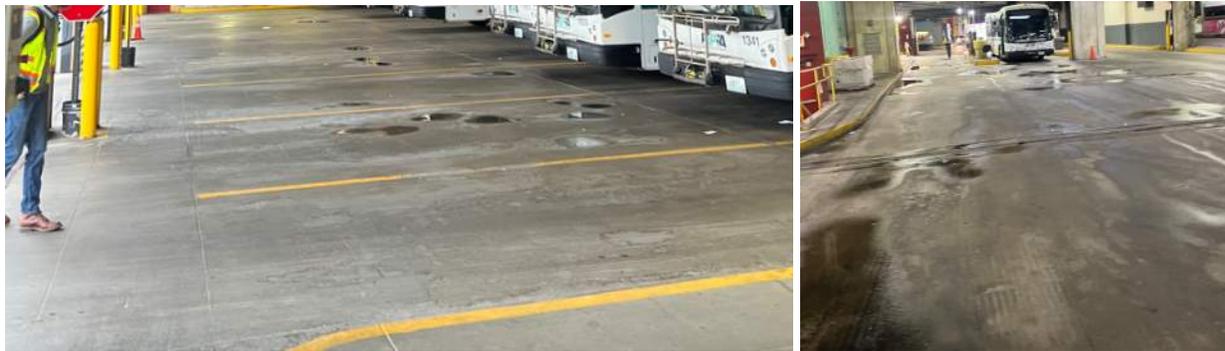
Coding / Field Name	Asset Description
System Name	Slabs on grade
Condition	4
Quantity	~94,402 sq. ft.
Unit Cost	Total: \$1,889,928.04
Year in Service	1990
Expected Useful Life	100 years
Remaining Useful Life	90 years, Estimated, Based on Date of Observation
Location	Substructure
Basis of Costing	Square Foot Costs with RSMMeans Data 2022 – 43 <sup>rd</sup> Edition

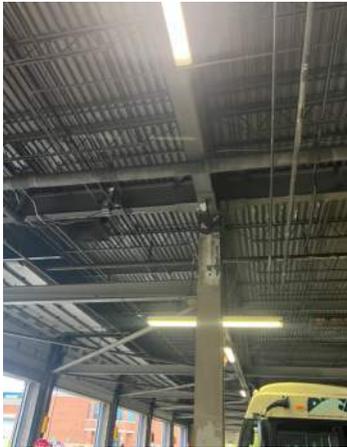
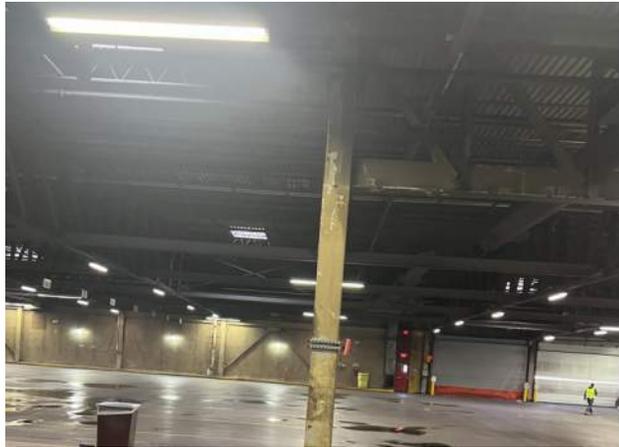
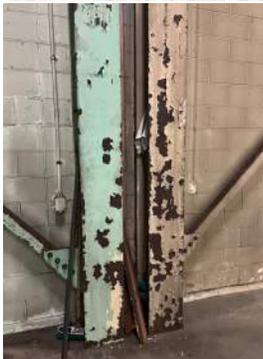
Coding / Field Name	Asset Description
System Name	Steel superstructure and metal roof decking.
Condition	4
Quantity	~94,402 sq. ft.
Unit Cost	Total: \$1,273,348.83
Year in Service	1990
Expected Useful Life	100 Years
Remaining Useful Life	80 years, Estimated, Based on Date of Observation
Location	Building structure
Basis of Costing	Square Foot Costs with RSMeans Data 2022 – 43 <sup>rd</sup> Edition

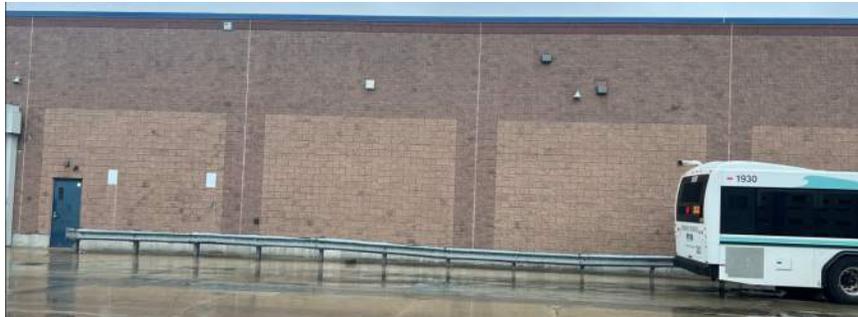
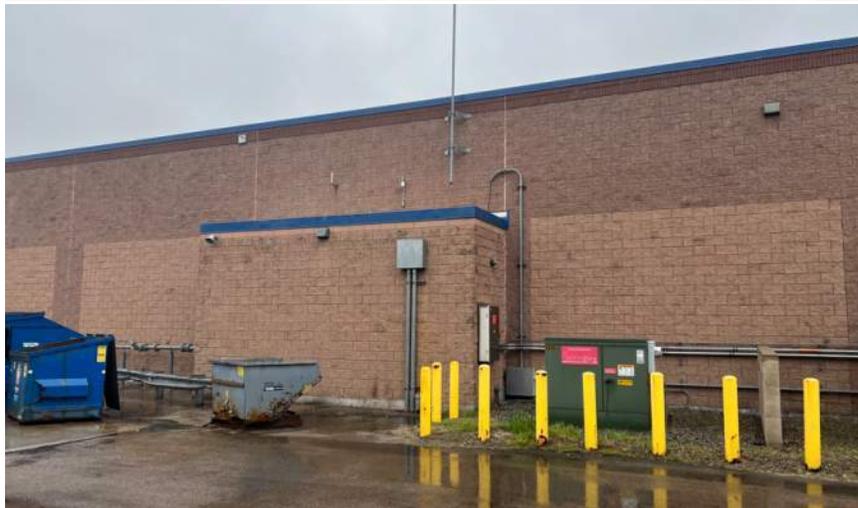
Coding / Field Name	Asset Description
System Name	Exterior split-face CMU
Condition	4
Quantity	~25,000 sq. ft.
Unit Cost	Total: \$520,000
Year in Service	1990
Expected Useful Life	100 years
Remaining Useful Life	90 years, Estimated, Based on Date of Observation
Location	Exterior walls
Basis of Costing	Square Foot Costs with RSMMeans Data 2022 – 43 <sup>rd</sup> Edition

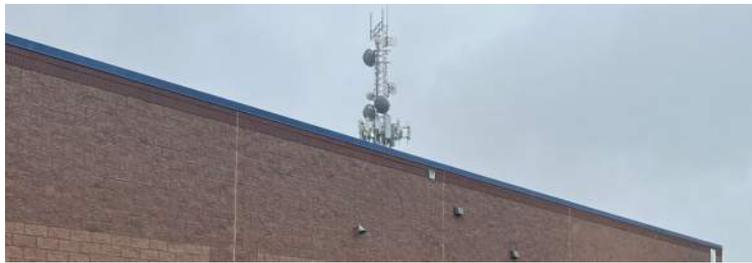
Coding / Field Name	Asset Description
System Name	Exterior brick
Condition	4
Quantity	~3,176.66 sq. ft.
Unit Cost	Total: \$91,487.81
Year in Service	1990
Expected Useful Life	100 years
Remaining Useful Life	90 years, Estimated, Based on Date of Observation
Location	Exterior
Basis of Costing	Square Foot Costs with RSMMeans Data 2022 – 43 <sup>rd</sup> Edition

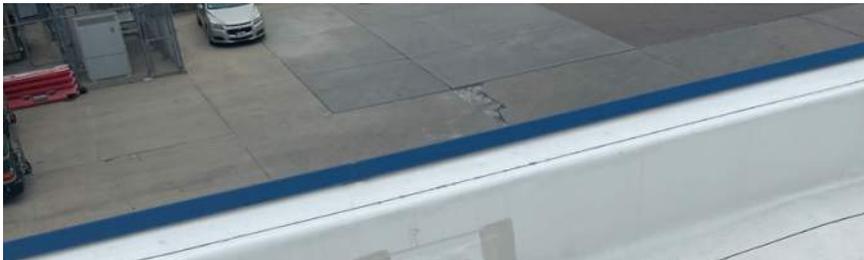
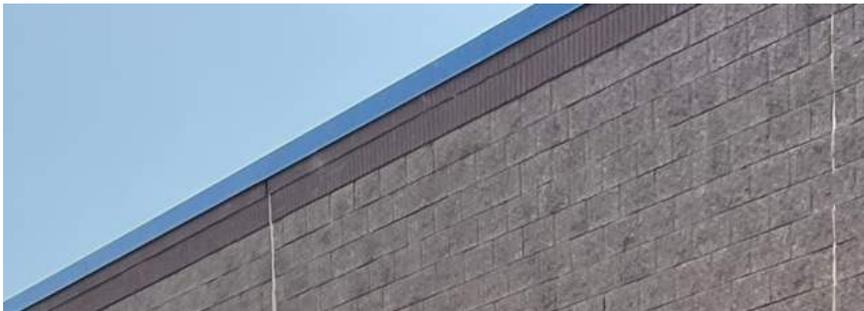
Coding / Field Name	Asset Description
System Name	Metal roof coping
Condition	4
Quantity	~1,538.33 linear ft.
Unit Cost	Total: \$45,073.06
Year in Service	1990
Expected Useful Life	80 years
Remaining Useful Life	65 years, Estimated, Based on Date of Observation
Location	Building roof edge
Basis of Costing	Square Foot Costs with RSMeans Data 2022 – 43 <sup>rd</sup> Edition

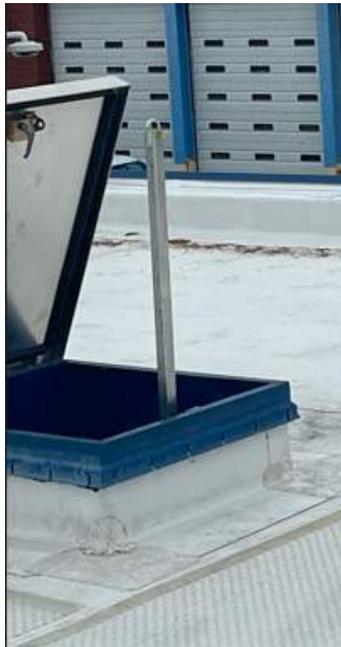
Coding / Field Name	Asset Description
System Name	Roof hatch
Condition	4
Quantity	1
Unit Cost	Total: \$3,085
Year in Service	1990
Expected Useful Life	50 years
Remaining Useful Life	35 years, Estimated, Based on Date of Observation
Location	Flat roof
Basis of Costing	Square Foot Costs with RSMMeans Data 2022 – 43 <sup>rd</sup> Edition

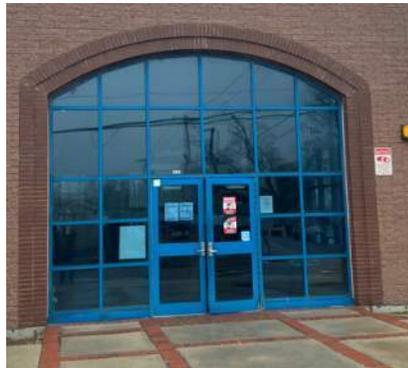
Coding / Field Name	Asset Description
System Name	Glazed aluminum curtainwall system
Condition	4
Quantity	~1,056.5 sq. ft.
Unit Cost	Total: \$29,772.88
Year in Service	1990
Expected Useful Life	70 years
Remaining Useful Life	60 years, Estimated, Based on Date of Observation
Location	Building exterior
Basis of Costing	Square Foot Costs with RSMeans Data 2022 – 43 <sup>rd</sup> Edition

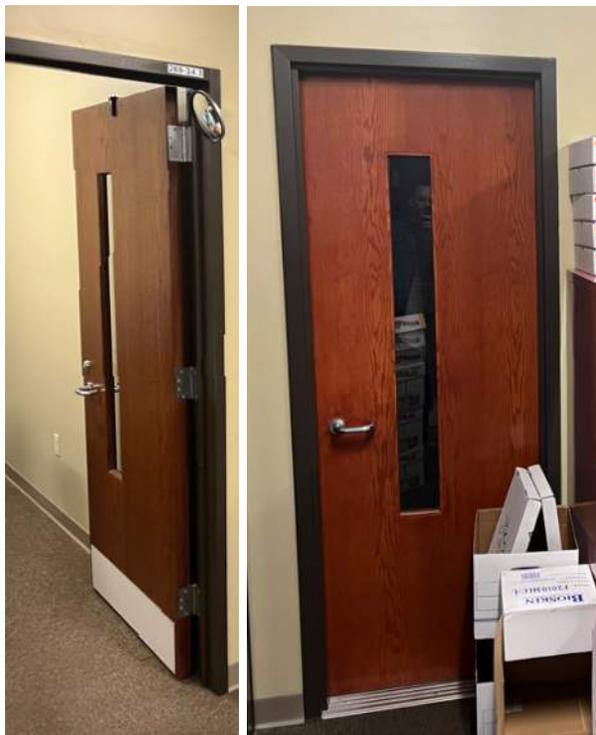
Coding / Field Name	Asset Description
System Name	Interior wood doors and frames
Condition	4
Quantity	30
Unit Cost	Total: \$39,303
Year in Service	1990
Expected Useful Life	40 years
Remaining Useful Life	35 years, Estimated, Based on Date of Observation
Location	Building interior
Basis of Costing	Square Foot Costs with RSMMeans Data 2022 – 43 <sup>rd</sup> Edition

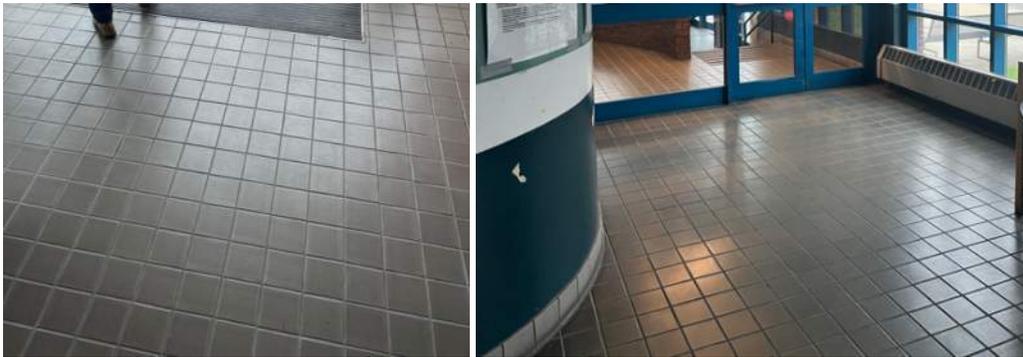
Coding / Field Name	Asset Description
System Name	Ceramic tile flooring and base
Condition	4
Quantity	~1,680 sq. ft.
Unit Cost	Total: \$22,870.18
Year in Service	1990
Expected Useful Life	75 years
Remaining Useful Life	65 years, Estimated, Based on Date of Observation
Location	Building interior
Basis of Costing	Square Foot Costs with RSMeans Data 2022 – 43 <sup>rd</sup> Edition

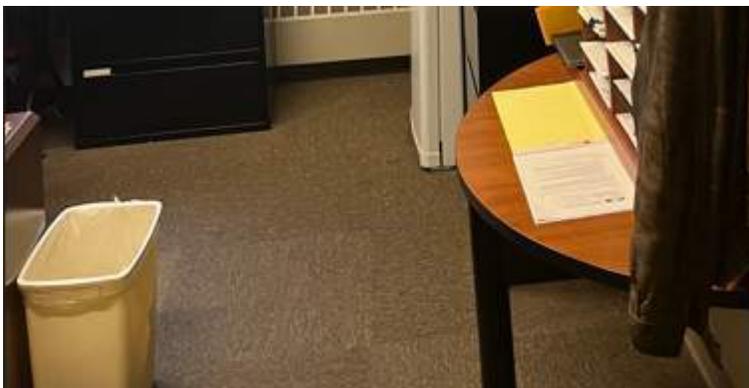
Coding / Field Name	Asset Description
System Name	Carpet tile flooring and base
Condition	3
Quantity	~2,360 sq. ft.
Unit Cost	Total: \$13,168.80
Year in Service	1990
Expected Useful Life	20 years
Remaining Useful Life	10 years, Estimated, Based on Date of Observation
Location	Building interior
Basis of Costing	Square Foot Costs with RSMeans Data 2022 – 43 <sup>rd</sup> Edition
