# Transit Asset Management Plan

October 1, 2022 – September 30, 2026

**RHODE ISLAND PUBLIC TRANSIT AUTHORITY**

# RITPA Transit Asset Management Facility Condition Assessment

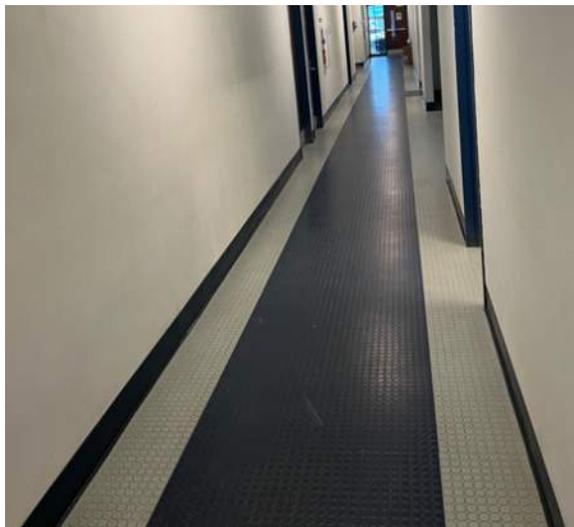
Coding / Field Name	Asset Description
System Name	Rubber flooring and base
Condition	4
Quantity	~4,480 sq. ft.
Unit Cost	Total: \$38,080
Year in Service	1990
Expected Useful Life	75 years
Remaining Useful Life	65 years, Estimated, Based on Date of Observation
Location	Building interior
Basis of Costing	Square Foot Costs with RSMeans Data 2022 – 43 <sup>rd</sup> Edition

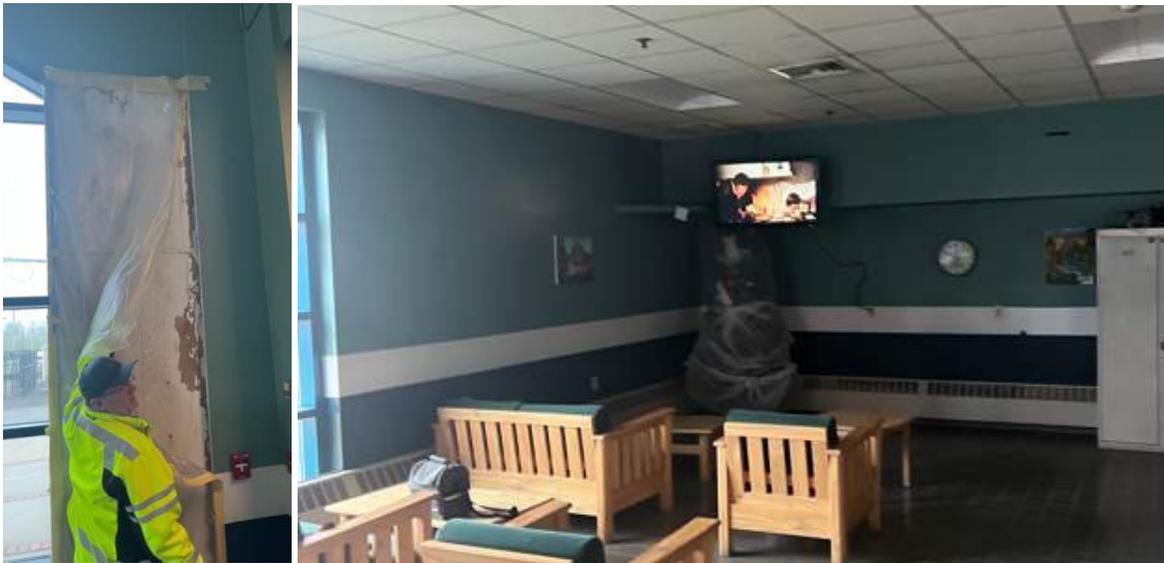
Coding / Field Name	Asset Description
System Name	Interior drywall partitions
Condition	3
Quantity	~13,320 sq. ft.
Unit Cost	Total: \$64,496
Year in Service	1990
Expected Useful Life	60 years
Remaining Useful Life	30 years, Estimated, Based on Date of Observation
Location	Building interior
Basis of Costing	Square Foot Costs with RSMeans Data 2022 – 43 <sup>rd</sup> Edition

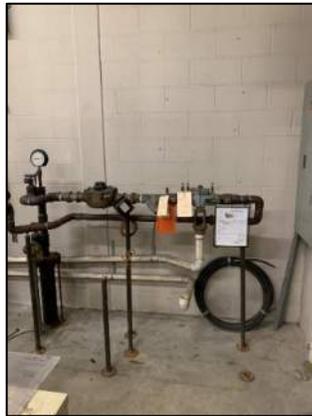
Figure 1: Domestic Water Service

The domestic water service is in the boiler room. The domestic water service lateral is 4". The domestic water meter, the reduced-pressure zone backflow preventer, and valving is 2". No pressure boosting pumps are present. The domestic water piping is done with copper. Most fittings are soldered, but there are press fittings used in places where recent repairs or additions were performed. Insulation is present on hot and cold-water piping.

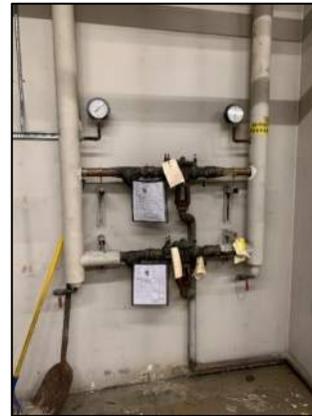
Figure 2: Non-Potable Water Backflow Preventers

A separate set of reduced-pressure zone backflow preventers are located on a branch from the main service. This branch is labelled "nonpotable water" and is routed to the garage for the Bus Wash.

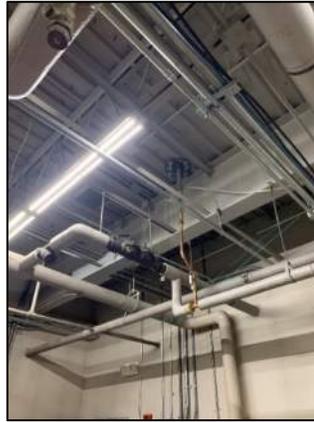
*Figure 3: Press-Connect Fittings on a Recently Installed Roof Hydrant*

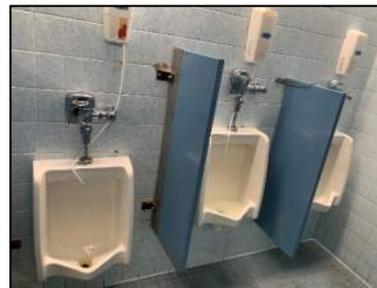
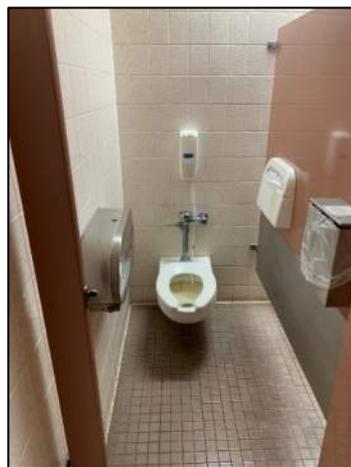
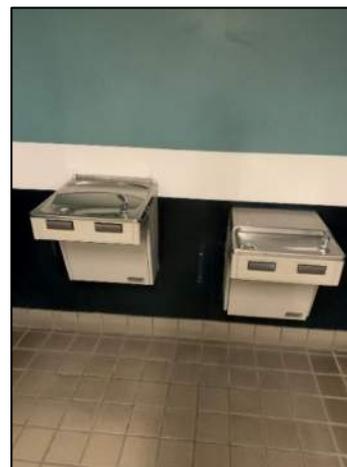
Most of the fixtures in the facility appear in good, working order. The fixtures are a variety of makes of touchless and manual controls due to repairs over the years.

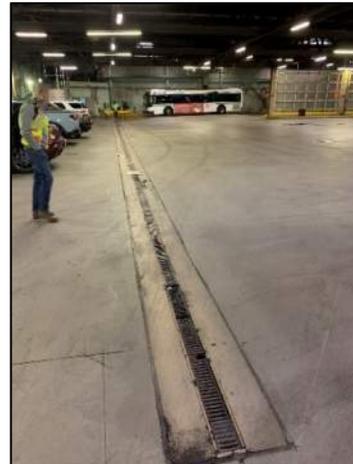
Figure 15: Trench Drain in Garage

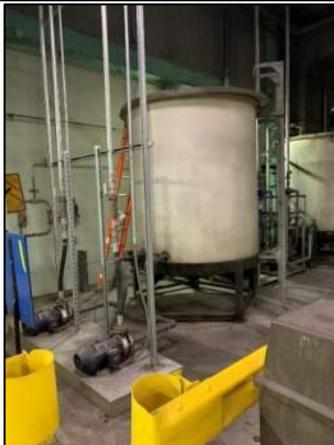
Figure 16: Bus Wash Reclamation System

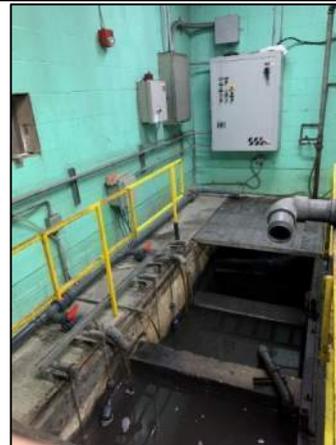
Figure 17: Bus Wash Water Reclamation Pit

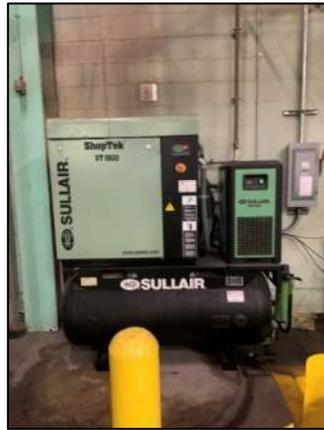
includes an air compressor, a filter/dryer, and a storage tank. The compressed air is routed to drops and cord reels. The compressed air used for hand tools and the air-operated diaphragm pumps pumping automotive fluids.

Figure 19: Compressed Air System

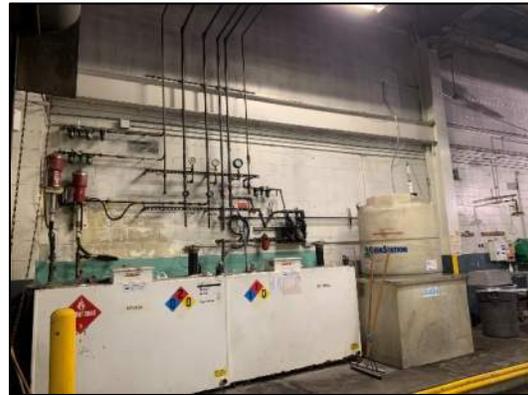
Figure 20: Lube System with Air-Operated Diaphragm Pumps

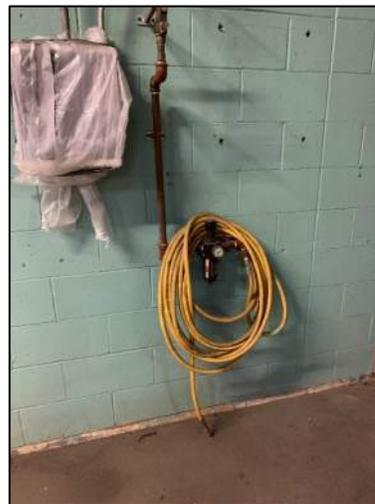
Figure 21: Compressed Air Drop

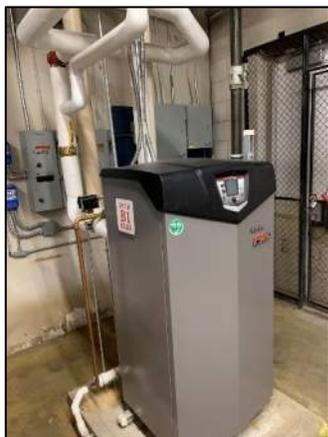
Figure 22: Hydronic Heating System Boiler

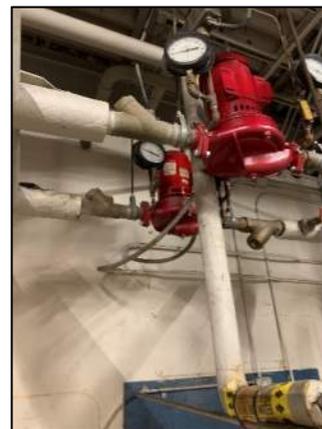
Figure 23: Hydronic Pumps

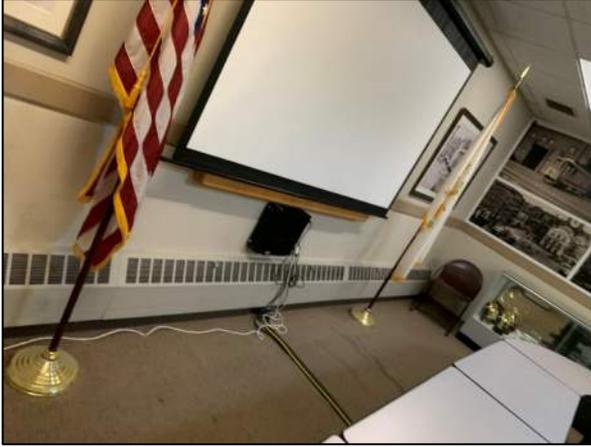
Figure 24: Baseboard Radiator in Conference Room

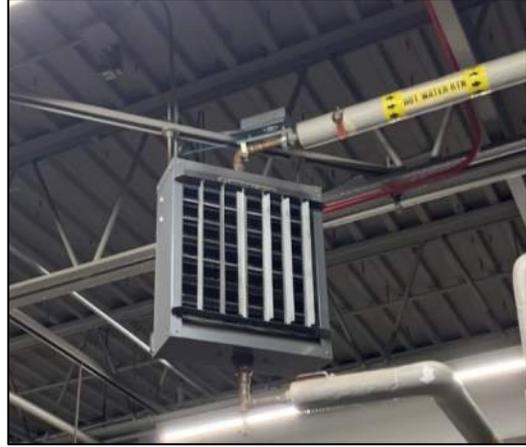
Figure 25: Hot-Water Unit Heater

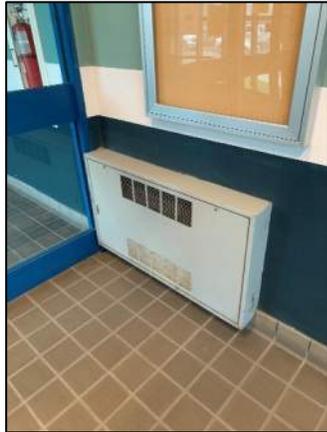
Figure 26: Panel Radiator

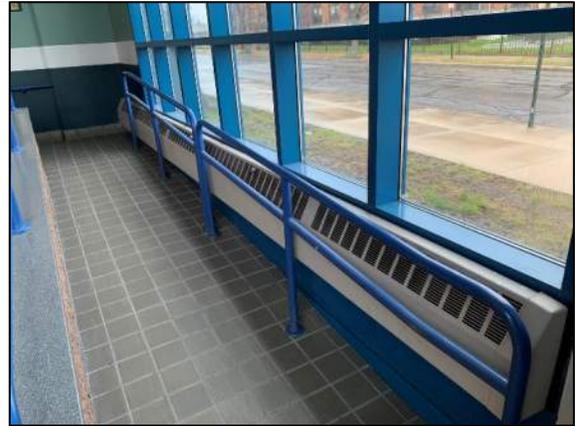
Figure 27: Baseboard Radiator in Lobby

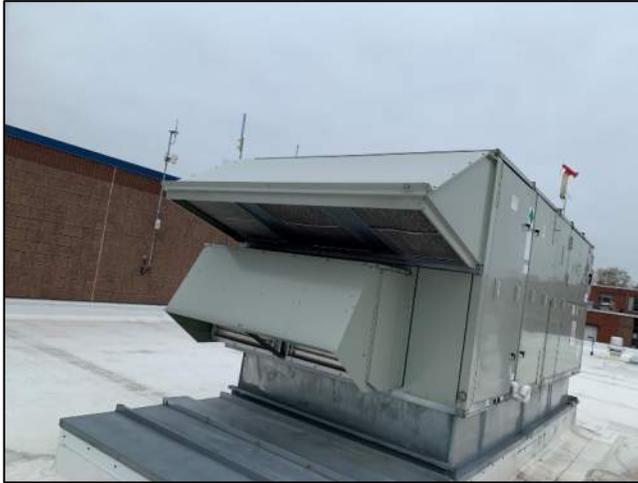
Figure 28: Rooftop Unit for Office

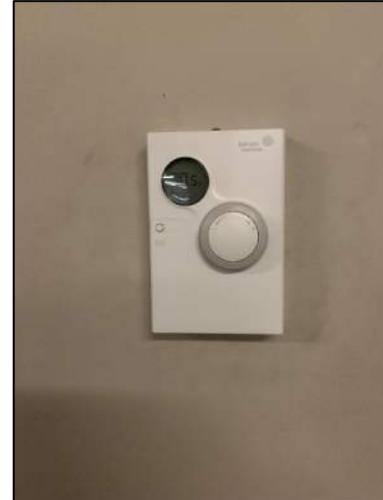
Figure 29: Thermostat for a Zone in the Office

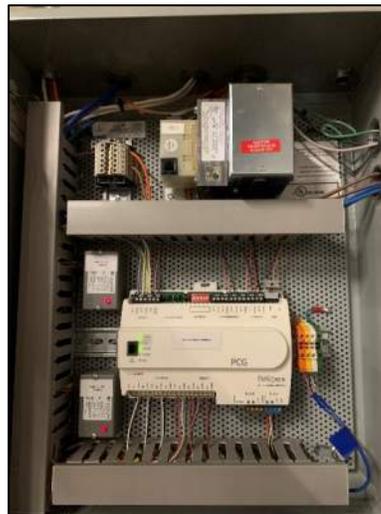
Figure 30: Johnson Controls BMS System Panel

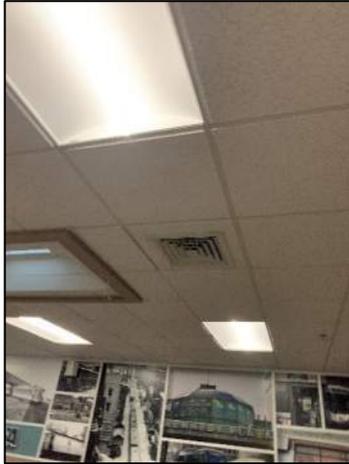
Figure 31: HVAC Diffuser in Office

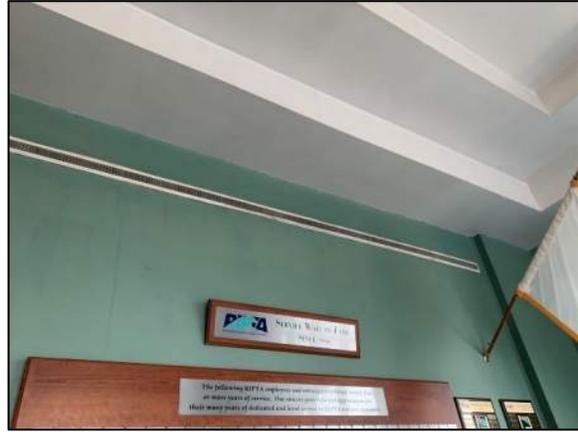
Figure 32: HVAC Diffuser in Lobby

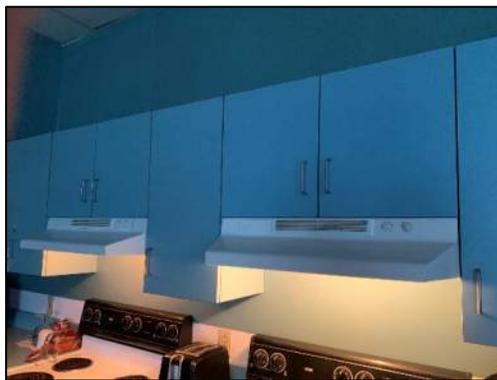
Figure 33: Recirculation-Type Hoods Over Stoves

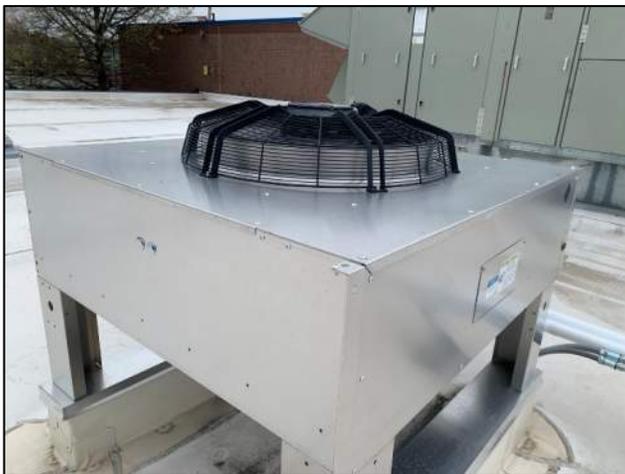
The IT room has a Liebert Cooling split-system with air distribution from a raised floor.

Figure 34: Condenser for Liebert System

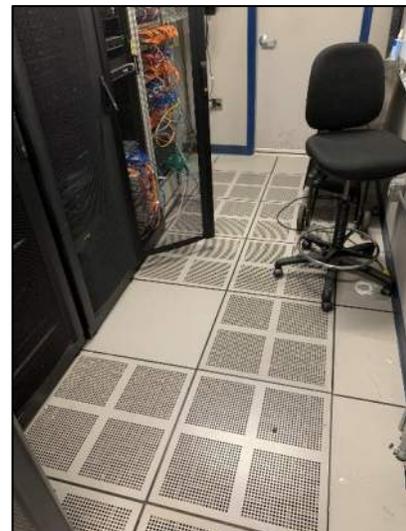
Figure 35: Air Diffusers for IT Room

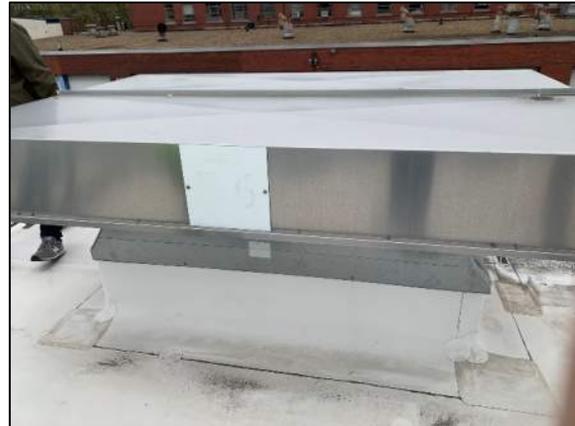
Figure 39: Makeup Air Unit Termination

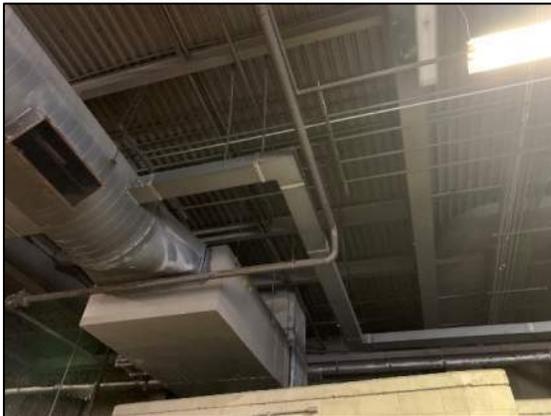
Figure 40: MAU Ducting to Other Spaces

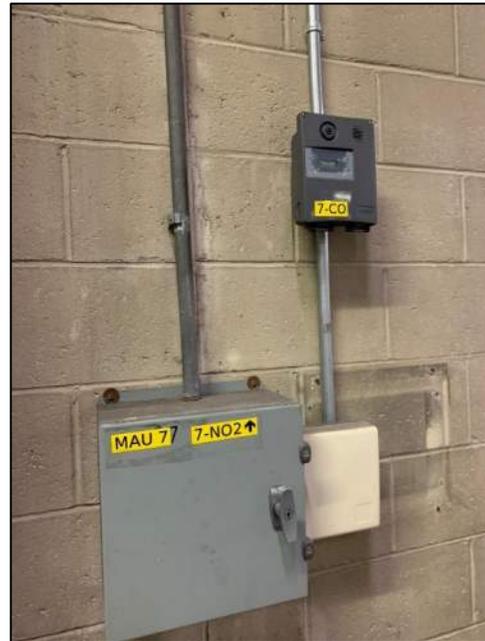
Figure 41: CO and NO<sub>2</sub> Controls

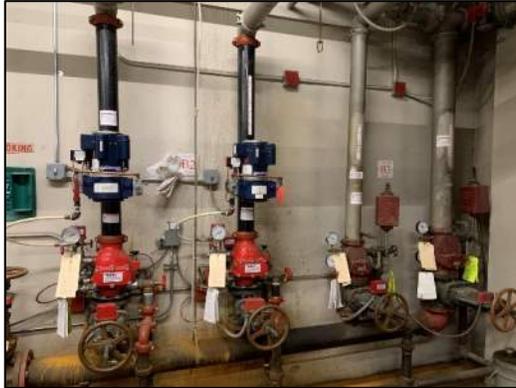
The riser check valve assemblies for the wet zones appear original to the building. The riser check valve assemblies for the dry zones appear to be recently installed. The dry-system air compressors are both single-phase, riser-mounted air compressors with a 1 HP motor. There are new flow switches and tamper switches in place.

Figure 44: Risers Off of Fire Service Mains

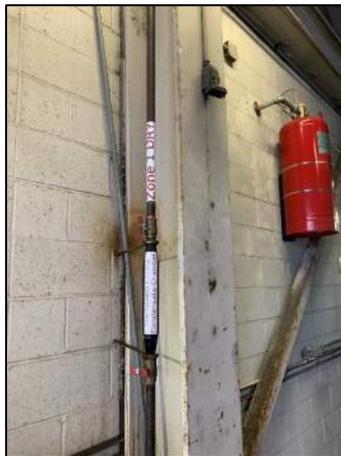
A dry, chemical system is in place at the fuel station on the North side of the facility.

Figure 46: Dry-Chemical Suppression System

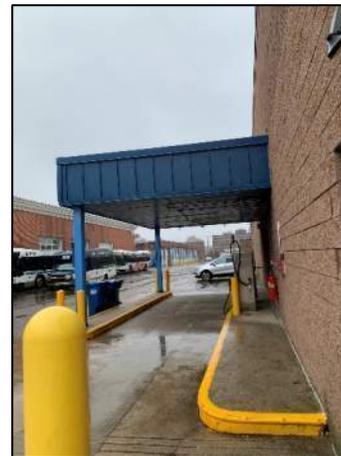
Figure 47: Dry-Chemical Suppression System

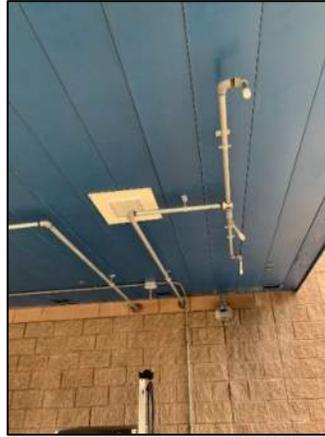
Figure 48: Dry-Chemical Suppression System

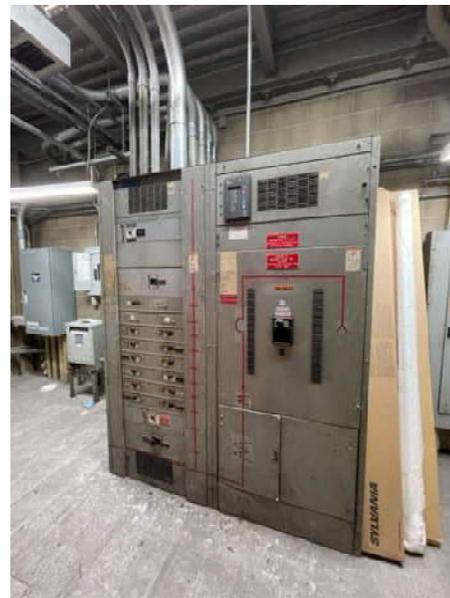
A 1,600A, 480V service installed approximately 33 years ago. The service is fed from the pad mounted transformer (North side of the building) (*Figure 4*) and enters the main switchboard (*Figure 2*) located in the Electrical Alcove. There is a PV Solar system (*Figure 1*) on the roof installed approximately 10 years ago. Maintenance mentioned shorting issues due to screws penetrating conduit when insulation was installed. Building has two backup generators. Many older panelboards are deteriorating and/or are damaged. Some panelboard covers are not secure and/or circuit breaker covers are missing leaving exposed live wires (*Figure 3*).

*Figure 2: Switchboard (277/480V)*

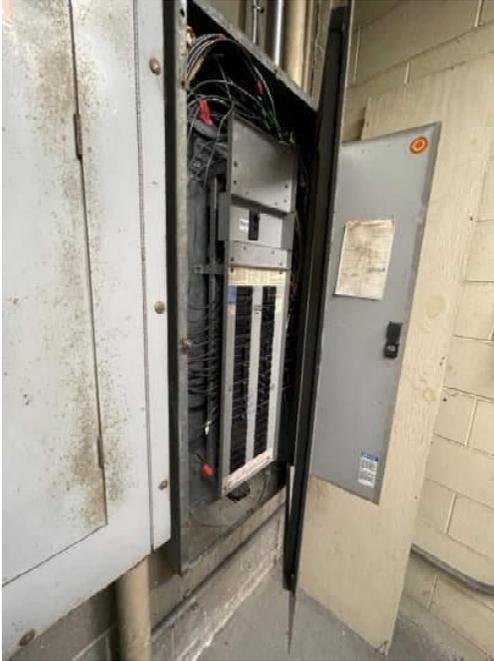
Figure 3: Deteriorating/Damaged Panelboard

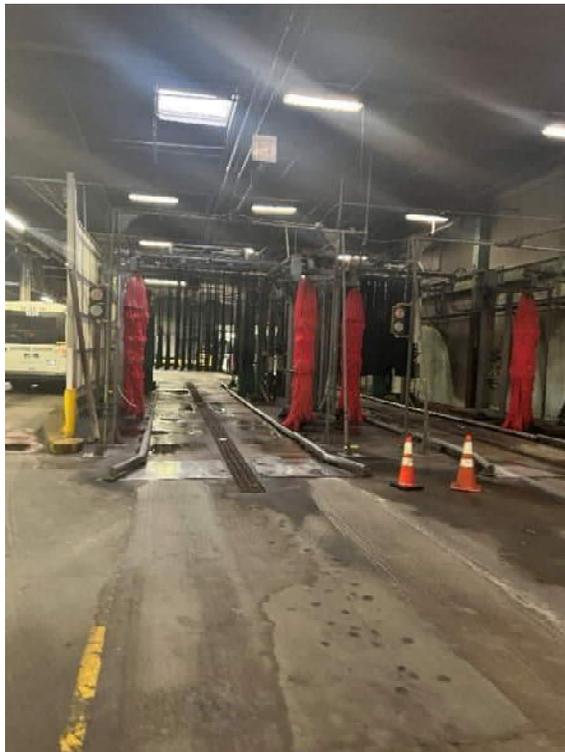
Coding / Field Name	Asset Description
System Name	Bus Wash
Condition	2
Quantity	2
Unit Cost	Total: \$99,172
Year in Service	1993
Expected Useful Life	25 years
Remaining Useful Life	4 years, Estimated, Based on Date of Observation
Location	Building exterior.
Basis of Costing	Square Foot Costs with RSMeans Data 2022 – 43 <sup>rd</sup> Edition

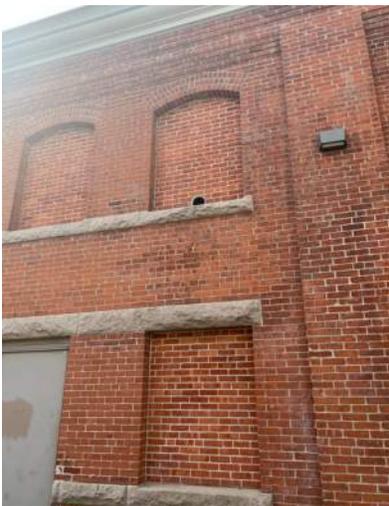
Coding / Field Name	Asset Description
System Name	Exterior brick (West elevation – original facade)
Condition	3
Quantity	~9,230 sq. ft.
Unit Cost	Total: \$265,824
Year in Service	N/A
Expected Useful Life	100 years
Remaining Useful Life	60 years, Estimated, Based on Date of Observation
Location	Exterior walls – West Elevation
Basis of Costing	Square Foot Costs with RSMeans Data 2022 – 43 <sup>rd</sup> Edition

No insulation on existing wall. Some cracks, pitting, and efflorescence staining observed.

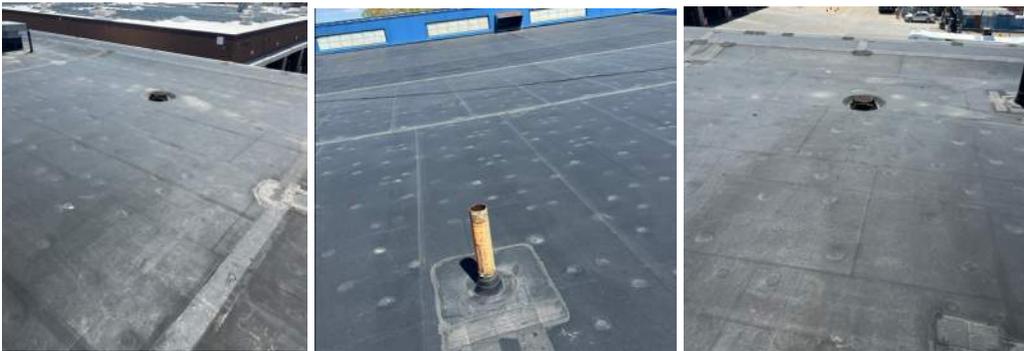
Coding / Field Name	Asset Description
System Name	Membrane roofing + rigid insulation
Condition	2
Quantity	~22,390 sq. ft.
Unit Cost	Total: \$170,691
Year in Service	2020
Expected Useful Life	40 years
Remaining Useful Life	10 years, Estimated, Based on Date of Observation
Location	Flat Roofs
Basis of Costing	Square Foot Costs with RSMeans Data 2022 – 43 <sup>rd</sup> Edition

Roof over compressor room leaking because EPDM roofing nails. Flat roof was just done.

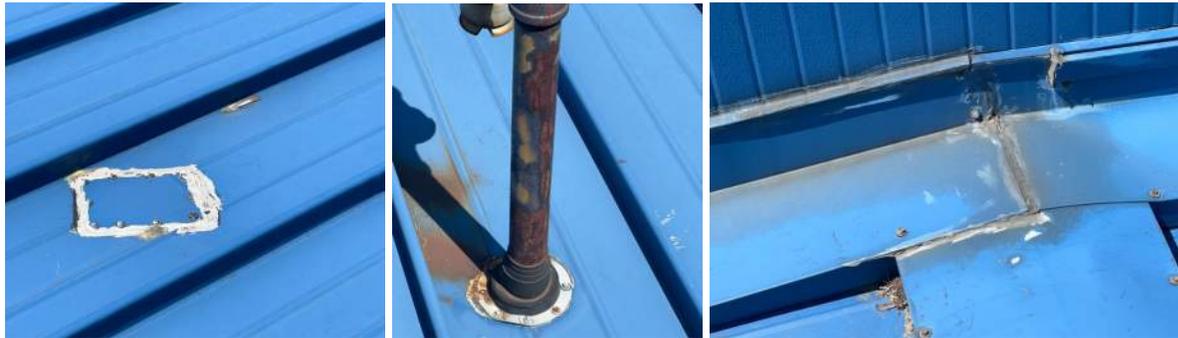
Coding / Field Name	Asset Description
System Name	Standing seam metal roof
Condition	3
Quantity	~72,370 sq. ft.
Unit Cost	Total: \$551,715.40
Year in Service	2000
Expected Useful Life	80 years
Remaining Useful Life	50 years, Estimated, Based on Date of Observation
Location	Sloped roofs
Basis of Costing	Square Foot Costs with RSMeans Data 2022 – 43 <sup>rd</sup> Edition

Rust / staining from roof elements. Sealants / joinery issues.

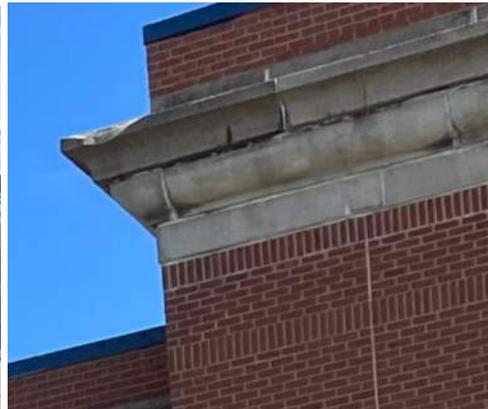
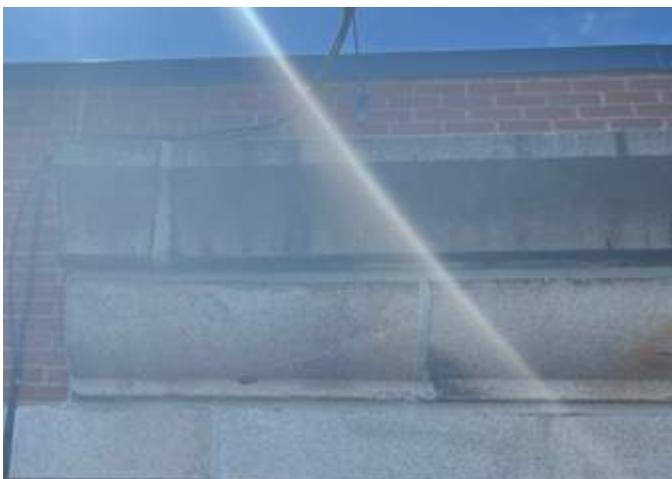
Coding / Field Name	Asset Description
System Name	Existing relocated granite cornice
Condition	2
Quantity	~875 sq. ft.
Unit Cost	Total: \$ 58,187.50
Year in Service	N/A
Expected Useful Life	100 years
Remaining Useful Life	20 years, Estimated, Based on Date of Observation
Location	Building roof edge
Basis of Costing	Square Foot Costs with RSMeans Data 2022 – 43 <sup>rd</sup> Edition

Cracking and staining evident.

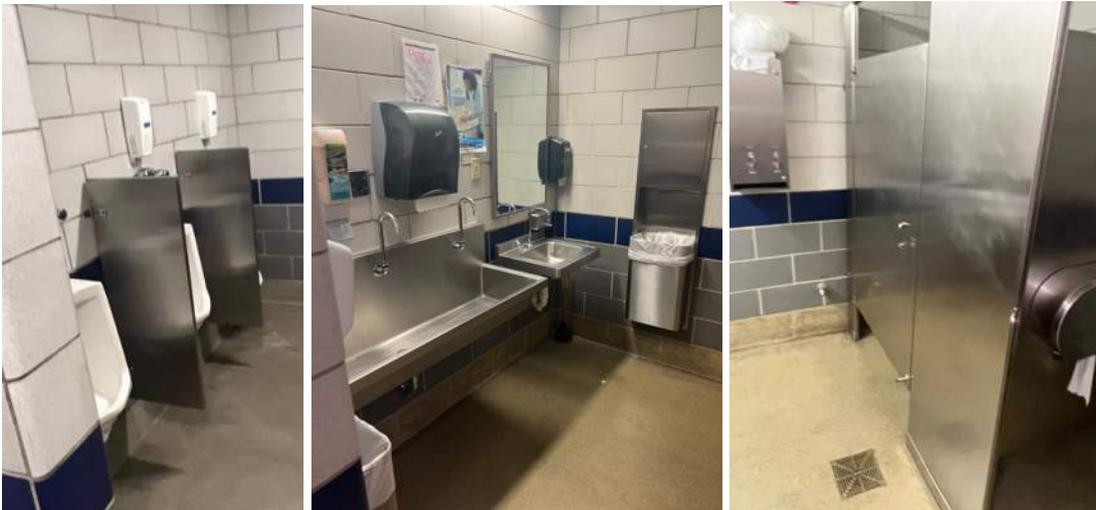
Coding / Field Name	Asset Description
System Name	Restroom & locker room fixtures and accessories
Condition	3
Quantity	2 restrooms and locker rooms
Unit Cost	Total: \$32,598
Year in Service	2000
Expected Useful Life	30 years
Remaining Useful Life	20 years, Estimated, Based on Date of Observation
Location	Building interior
Basis of Costing	Square Foot Costs with RSMeans Data 2022 – 43 <sup>rd</sup> Edition

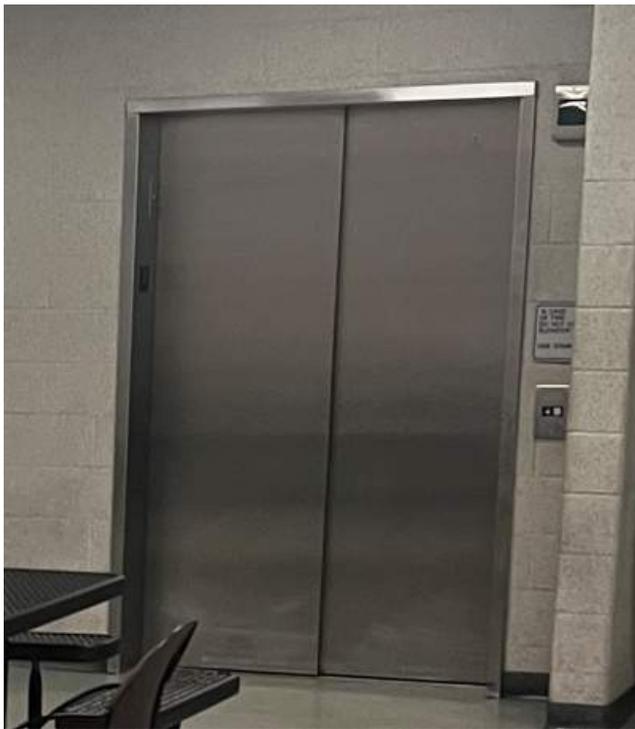
Coding / Field Name	Asset Description
System Name	Elevator
Condition	3
Quantity	1
Unit Cost	\$453,500
Year in Service	2000
Expected Useful Life	25 years
Remaining Useful Life	10 years, Estimated, Based on Date of Observation
Location	Building interior
Basis of Costing	Square Foot Costs with RSMeans Data 2022 – 43 <sup>rd</sup> Edition

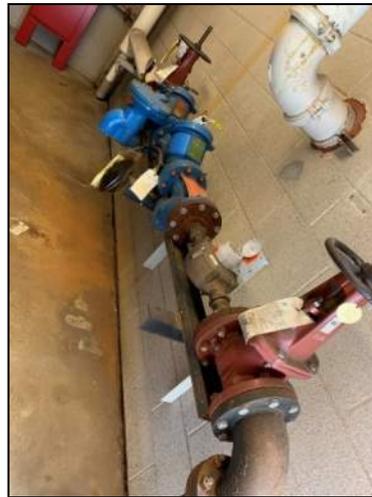
Figure 1: Domestic Water Service

The domestic water service is in the water room with the fire service equipment. The domestic water service lateral is 4". The domestic water meter is 1-1/2" and the reduced-pressure zone backflow preventer and valving match the lateral size of 4". No pressure boosting pumps are present. The domestic water is piped with copper throughout the building. The copper appears to be in fair condition. The fittings were soldered. Insulation is present on hot or cold-water piping.

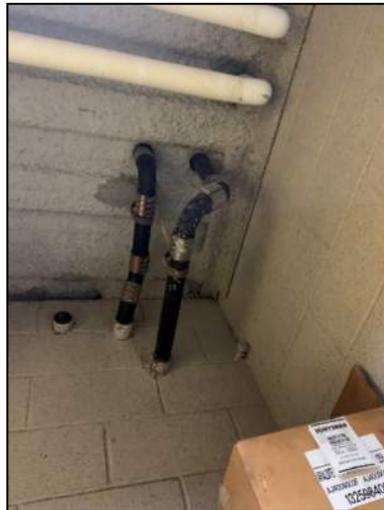
Figure 9: Sanitary Drainage Piping

The sanitary piping is no-hub cast iron. The piping appears in good, working order. A water-oil separator is present in the garage. This separator handles the runoff from the parts cleaning room, the bus bays, and other areas that have drains that could be contaminated with oil.

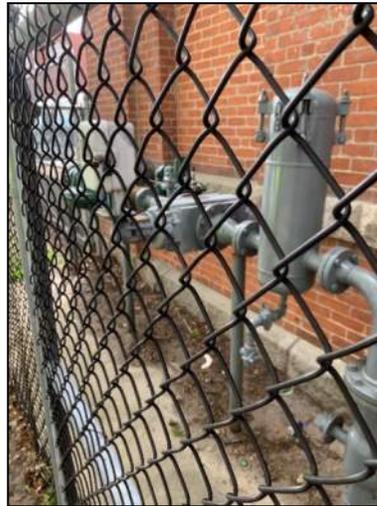
Figure 13: Gas Service Meter and Regulator

The building is served by a natural-gas system on the North side of the facility. The incoming service is ~2” and increases to ~3” after the compressors. A few items requiring gas are the boilers for the hydronic and domestic water and the boilers in the water treatment room.

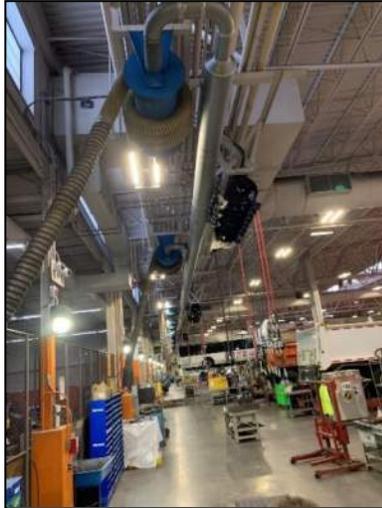
Figure 26: Localized Exhaust Systems

The garage is equipped with motor driven exhaust fans that have branch ducting with a rope-and-pulley system for localized exhaust. The local exhaust systems appear in good, working order. The fan drives for the exhaust systems are mounted on the roof. Some fans appear newer, and some appear to be original with the building.

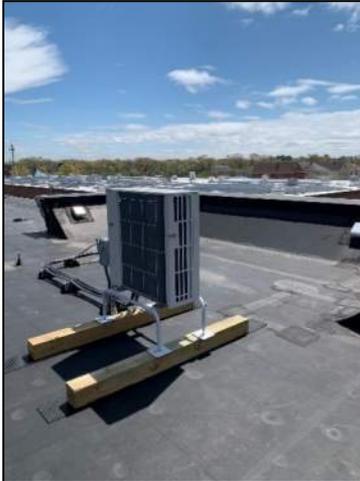
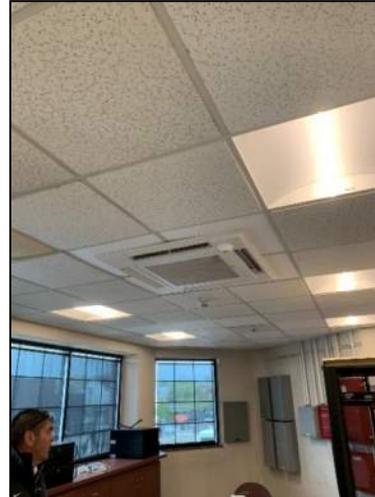
Several small VRF systems provide spot cooling for IT and computer rooms. The security room is equipped with one and various offices are as well.

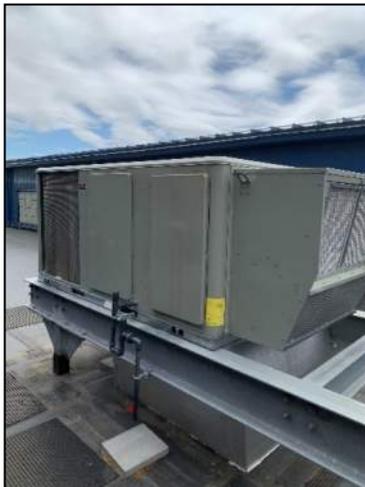
Figure 42: Roof Top Unit on Flat Roof

A roof top unit on the North side of the building provides local cooling for an occupied storage area.

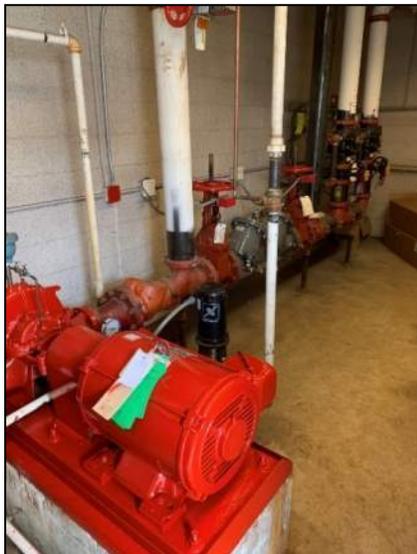
Figure 46: Fire Protection Service in the Water Room

The fire sprinkler system is a wet-pipe sprinkler system. The system is a central system located in the water room. An 8” service lateral immediately reduces to 6” inside the building. A 40hp, double-suction pump provides boosted pressure for the system. A jockey pump maintains pressure. A hose station is located outside the water room. The system has qty (3) risers. There appear to be around qty (6) zones. A Fire Department Connection is located on the opposite side of the building along Thackery St. There is no exterior alarm bell.

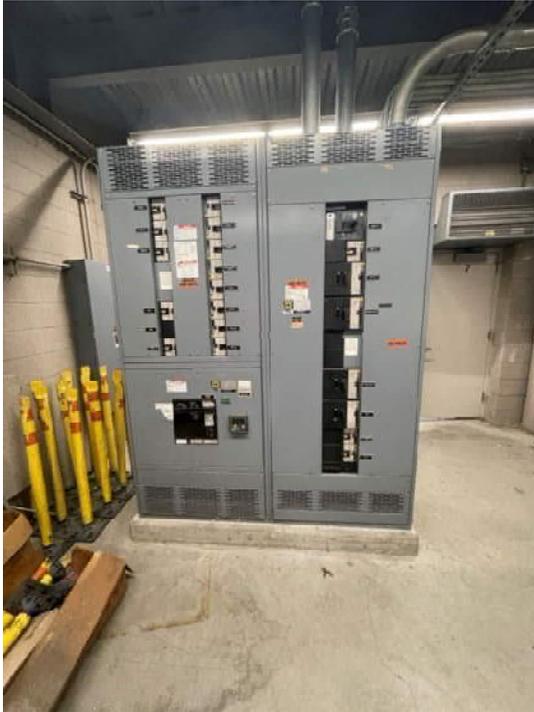
Figure 1: Switchboard (277/480V)

A 1,600A, 480V service installed approximately 20 years ago. The service is fed from the pad mounted transformer (South side of the building) (*Figure 2*) and enters the main switchboard (*Figure 1*) located in the Electrical Room. Building is served by a 265KW backup diesel generator (*Figure 4*). Many older panelboards are deteriorating and/or are damaged or abandoned in place (*Figure 3*).

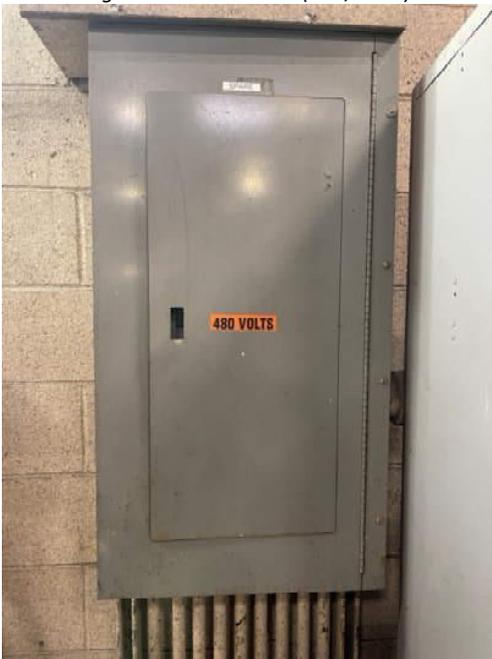
Figure 3: Abandoned/Damaged Panelboard

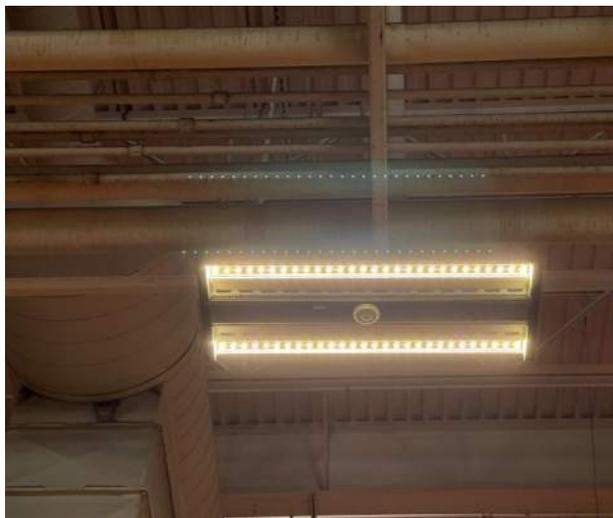
LED high-bay fixtures with integral occupancy sensors (*Figure 1*) are installed throughout the first-floor garage space. Older fluorescent fixtures were left in place (*Figure 2*). All exit signs throughout the space are illuminated and appear to be completely operational.

*Figure 1: LED High-bay fixtures with integral occupancy sensor*

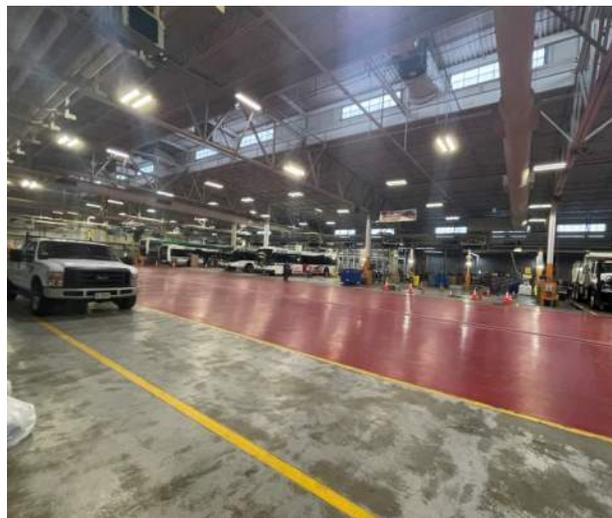
*Figure 2: LED High-bay and fluorescent fixtures*

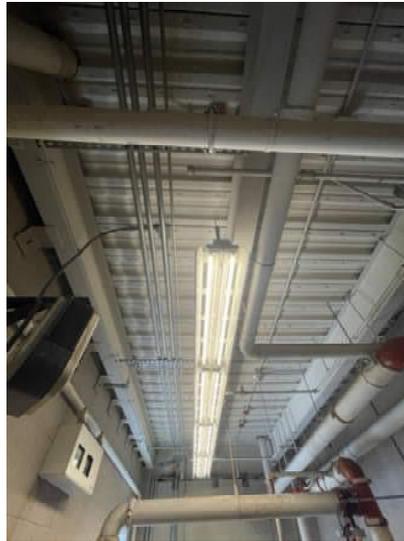
Figure 6: Fluorescent Fixtures

Storage/office spaces consist of LED 2’X2’ and 2’X4’ troffer fixtures (Figure 3) and linear LED fixtures controlled by a combination of toggle switches (Figure 7), ceiling mounted occupancy sensors (Figure 4), and wall switch occupancy sensors (Figure 8). Exit signs were observed throughout the space and appear to be fully operational (Figure 5). Emergency battery units were observed in some storage/mechanical/electrical rooms. In addition to emergency battery units, lighting fixtures throughout the office space are on generator backup. Fluorescent fixtures (Figure 6) are still operational throughout the office space and storage areas.

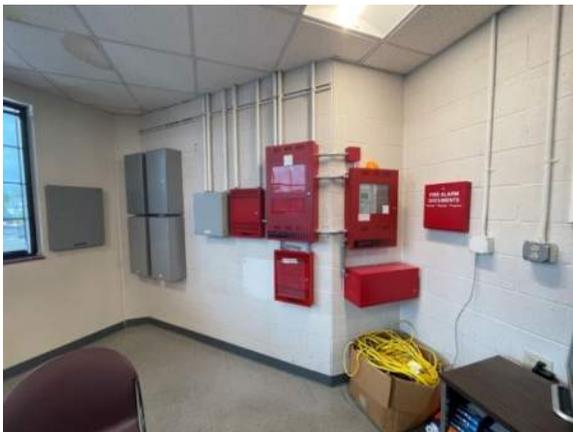
*Figure 1: Fire Alarm System*

Fire alarm system (*Figure 1*) consists of an addressable Fire Alarm Control Panel (Edwards EST-3) and associated devices manufactured by Edwards. Connection to local fire department is through a Gamewell Master Box. CO detection system is installed throughout the garage space (*Figure 2*). Fire Alarm system and associated devices and wiring appear to be in working condition, however some devices are approaching their expected useful life based on industry standards.

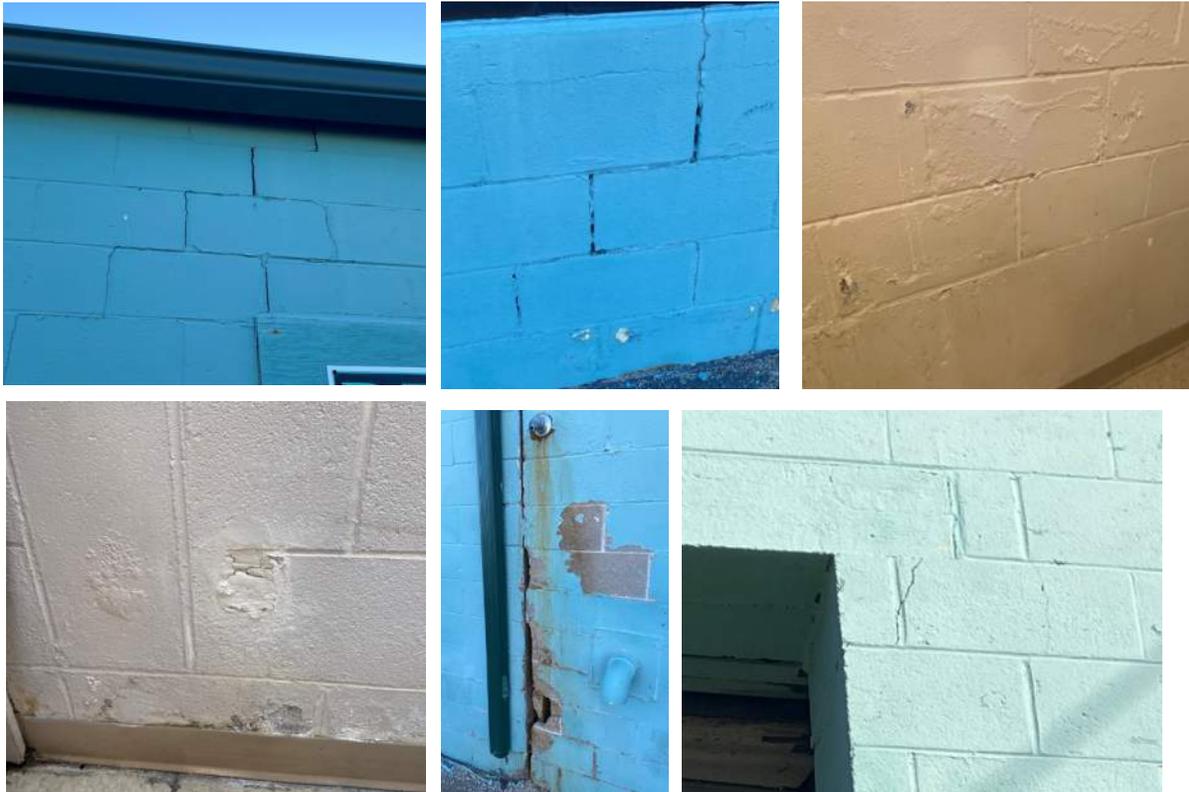
Various cracks, moisture damage, failing expansion joints, chipping, and deterioration.

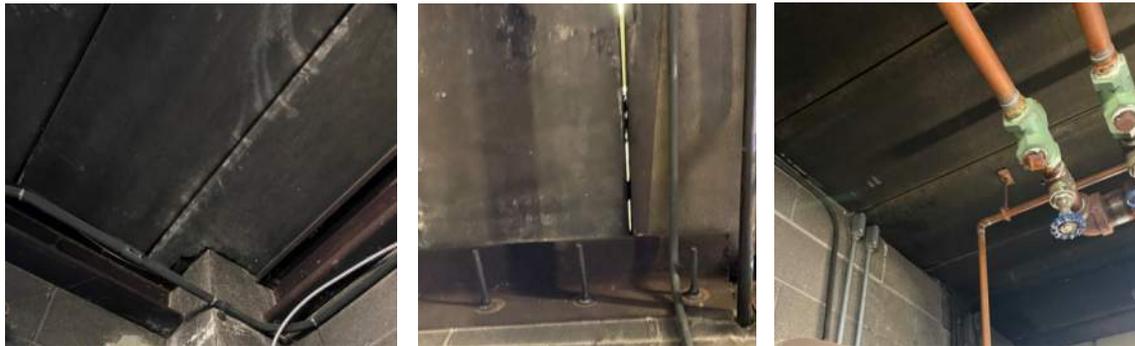
Some gaps between planks but overall fair condition.

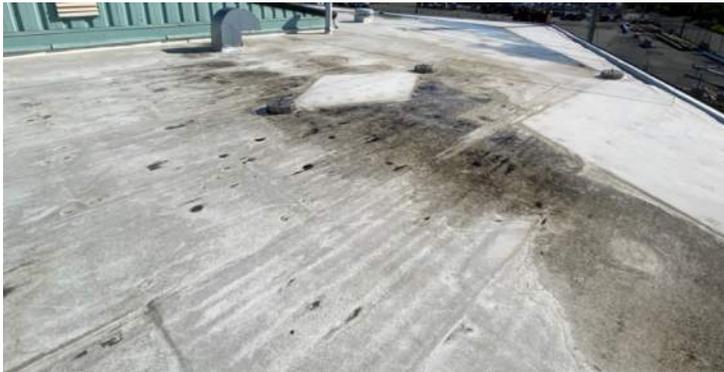
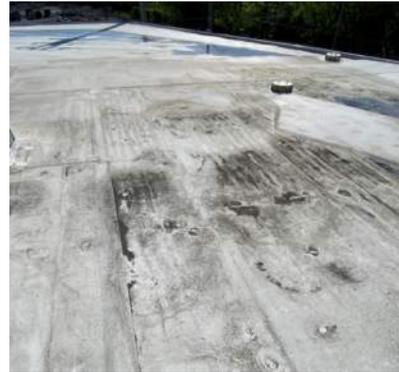
Evidence of ponding, membrane bubbling, staining, potentially blocked roof drains.

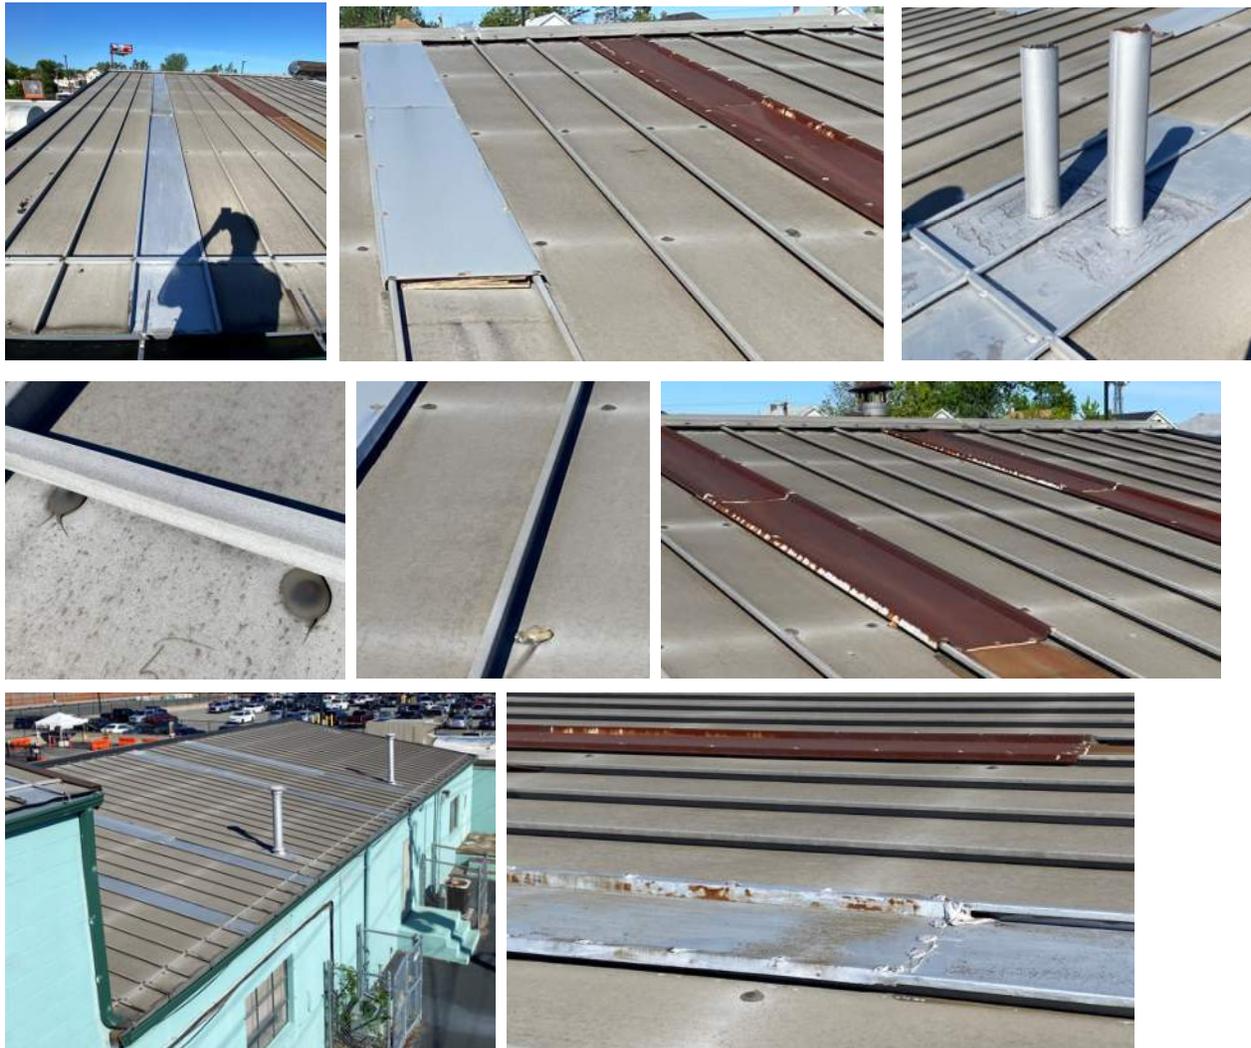
Coding / Field Name	Asset Description
System Name	Batten seam metal roof
Condition	2
Quantity	~7,750 sq. ft.
Unit Cost	Total: \$277,062.50
Year in Service	~1960s with Sporadic Modifications
Expected Useful Life	50 years
Remaining Useful Life	5 years, Estimated, Based on Date of Observation
Location	Inspection garages.
Basis of Costing	Square Foot Costs with RSMeans Data 2022 – 43 <sup>rd</sup> Edition

Leaking through fasteners, various inconsistent spot patches and repairs, rust and corrosion.

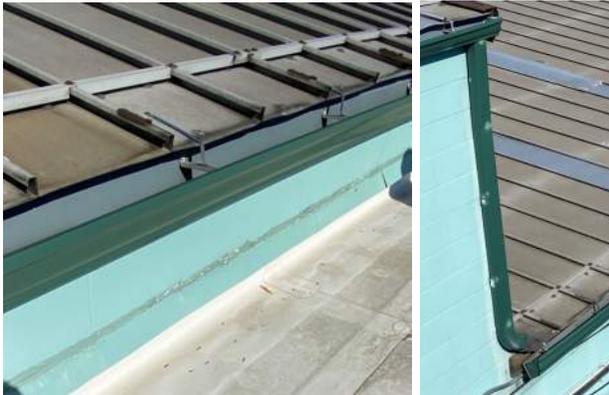
Coding / Field Name	Asset Description
System Name	Metal gutters and downspouts
Condition	4
Quantity	~450 linear ft.
Unit Cost	Total: \$8,752
Year in Service	~1960s with Sporadic Modifications
Expected Useful Life	50 years
Remaining Useful Life	30 years, Estimated, Based on Date of Observation
Location	Building roof edge.
Basis of Costing	Square Foot Costs with RSMeans Data 2022 – 43 <sup>rd</sup> Edition

Gutters and downspouts in fair condition but fasteners may require maintenance.

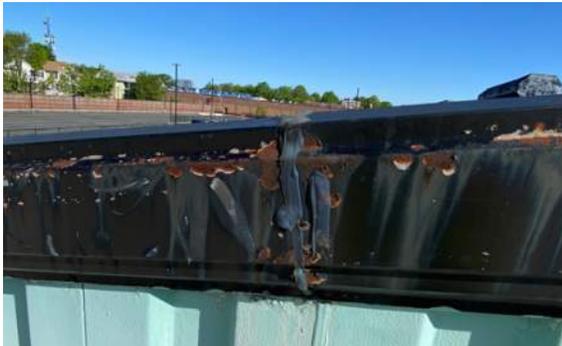
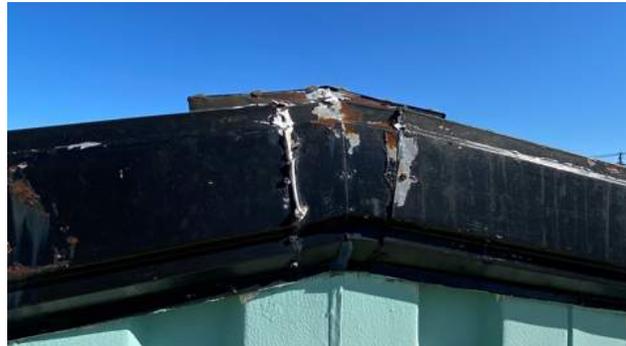
Coding / Field Name	Asset Description
System Name	Pitched roof metal fascia
Condition	2
Quantity	~150 linear ft.
Unit Cost	Total: \$4,530
Year in Service	~1960s with Sporadic Modifications
Expected Useful Life	40 years
Remaining Useful Life	5 years, Estimated, Based on Date of Observation
Location	Inspection garage pitched roof.
Basis of Costing	Square Foot Costs with RSMeans Data 2022 – 43 <sup>rd</sup> Edition

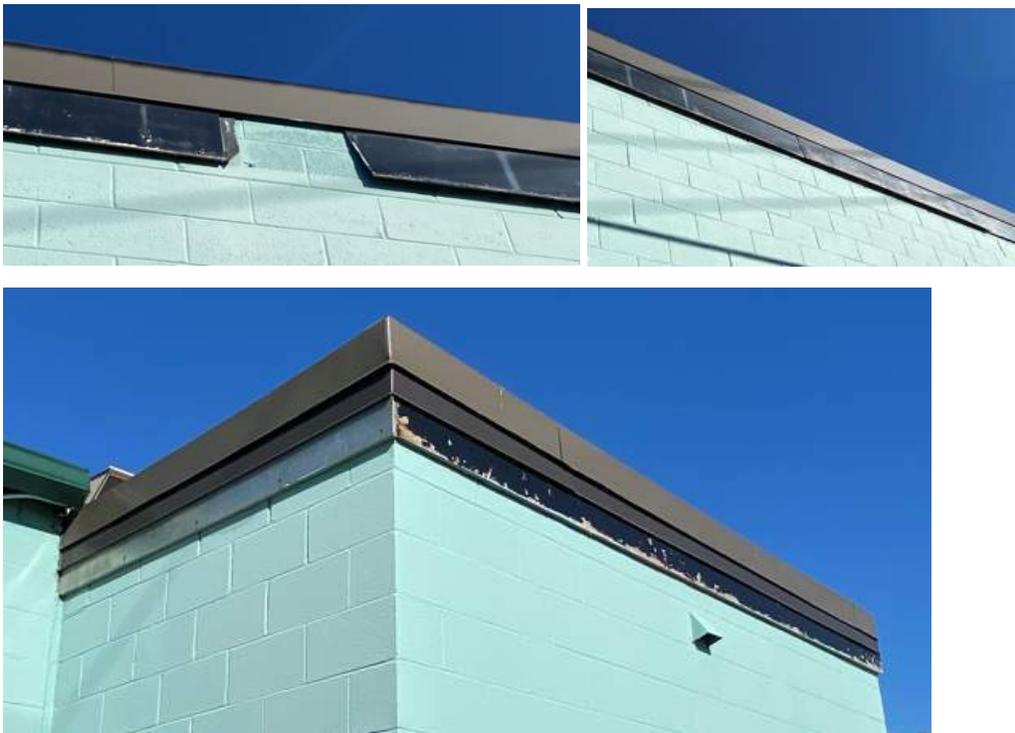
Coding / Field Name	Asset Description
System Name	Flat roof metal coping
Condition	4
Quantity	~500 linear ft.
Unit Cost	Total: \$9,175
Year in Service	~1960s with Sporadic Modifications
Expected Useful Life	40 years
Remaining Useful Life	30 years, Estimated, Based on Date of Observation
Location	Flat roof perimeter
Basis of Costing	Square Foot Costs with RSMeans Data 2022 – 43 <sup>rd</sup> Edition

Coping itself appears in fair condition but older fascia/coping and membrane flashing beneath top coping may have issues.
