# Transit Asset Management Plan

October 1, 2022 – September 30, 2026

**RHODE ISLAND PUBLIC TRANSIT AUTHORITY**

# RITPA Transit Asset Management Facility Condition Assessment

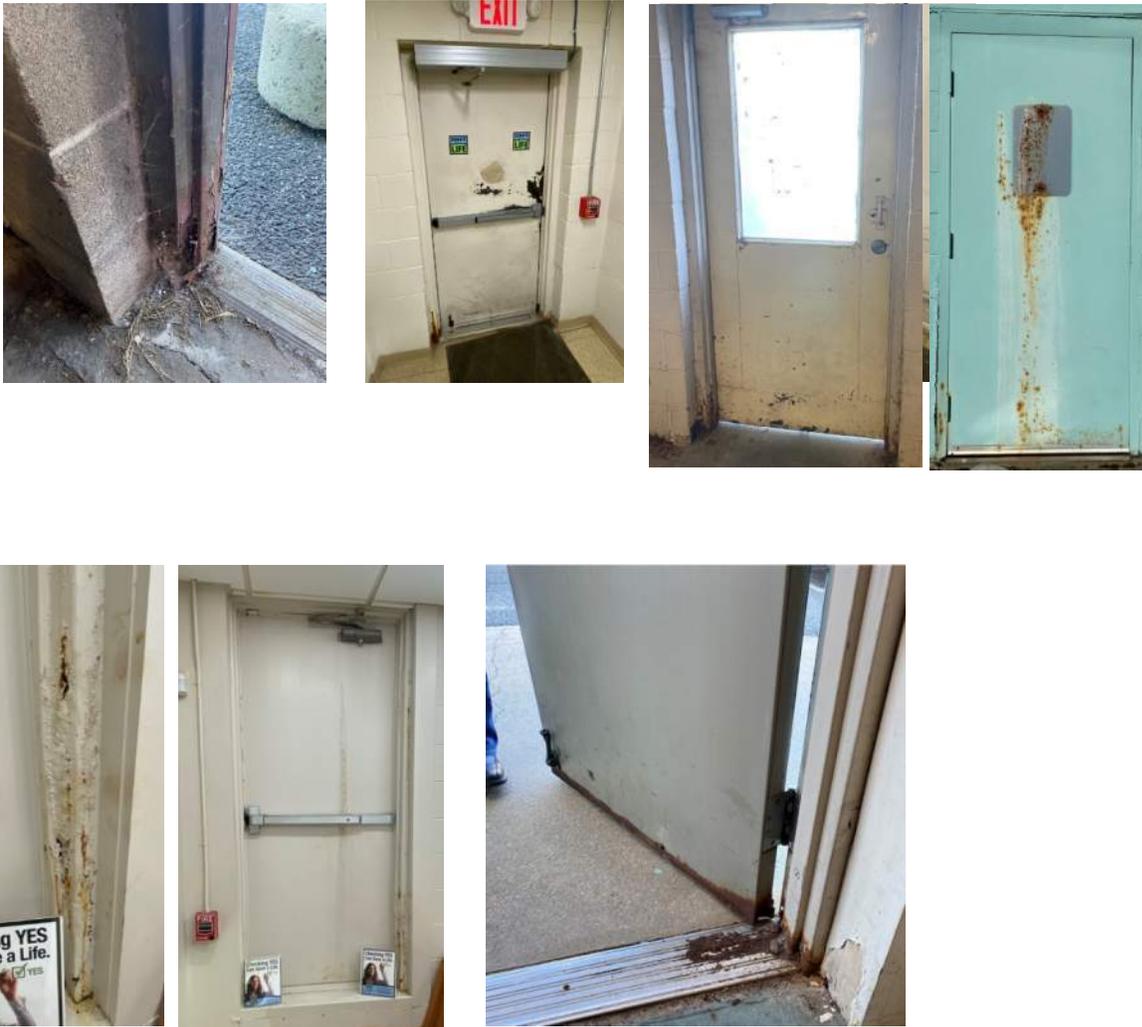
Coding / Field Name	Asset Description
System Name	Exterior steel doors and frames.
Condition	2
Quantity	8
Unit Cost	Total: \$ 4,372.50
Year in Service	~1960s with Sporadic Modifications
Expected Useful Life	50 years
Remaining Useful Life	5 years, Estimated, Based on Date of Observation
Location	Building exterior
Basis of Costing	Square Foot Costs with RSMeans Data 2022 – 43 <sup>rd</sup> Edition

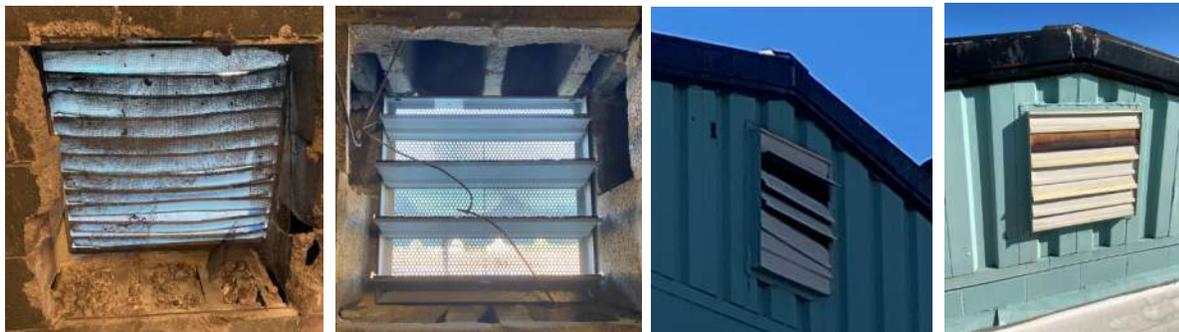
Coding / Field Name	Asset Description
System Name	Exterior louvers, frames, and bird/insect screens
Condition	2
Quantity	4
Unit Cost	Total: \$2,290.24
Year in Service	~1960s with Sporadic Modifications
Expected Useful Life	40 years
Remaining Useful Life	2 years, Estimated, Based on Date of Observation
Location	Exterior walls
Basis of Costing	Square Foot Costs with RSMeans Data 2022 – 43 <sup>rd</sup> Edition

Louver blades missing / unseated. Screens pulled away from screen. Damage to openings.

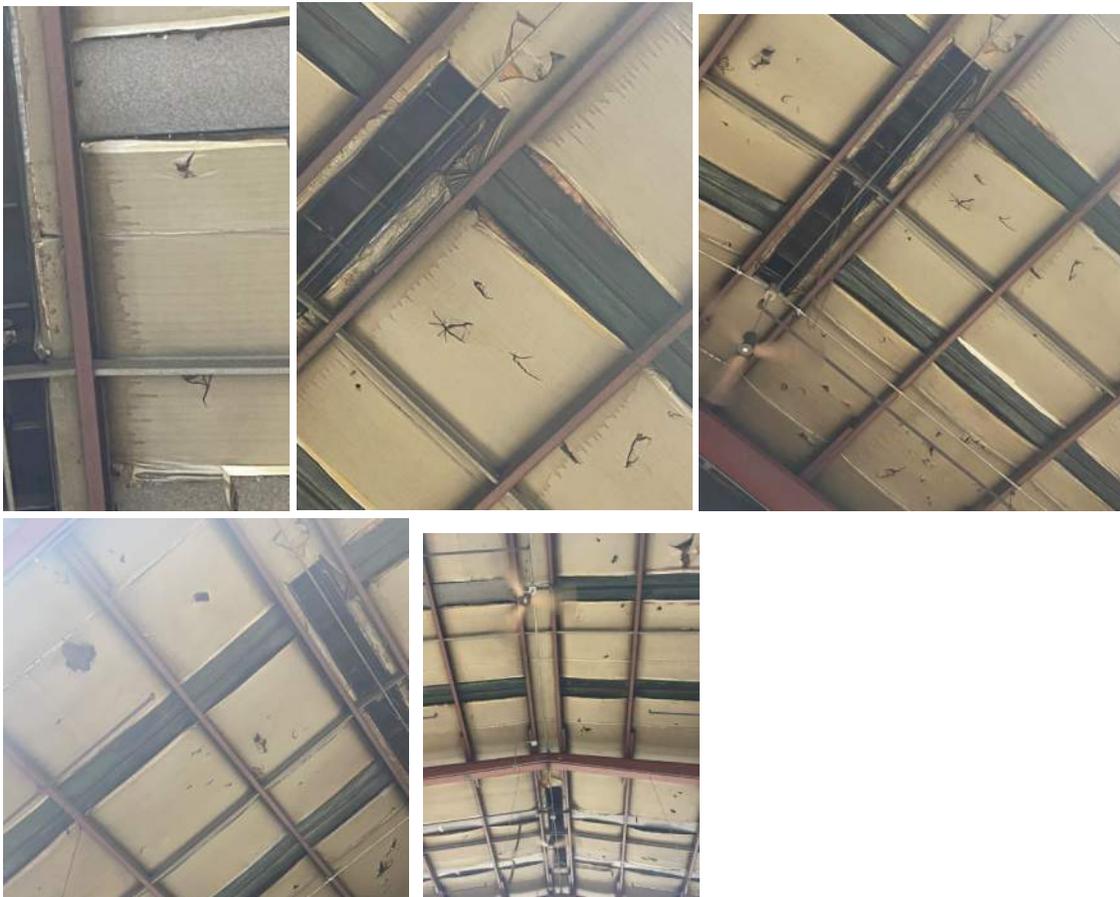
Coding / Field Name	Asset Description
System Name	Roof insulation
Condition	1
Quantity	~4,200 sq. ft.
Unit Cost	Total: \$45,276
Year in Service	~1960s with Sporadic Modifications
Expected Useful Life	40 years
Remaining Useful Life	2 years, Estimated, Based on Date of Observation
Location	Inspection Garage
Basis of Costing	Square Foot Costs with RSMeans Data 2022 – 43 <sup>rd</sup> Edition

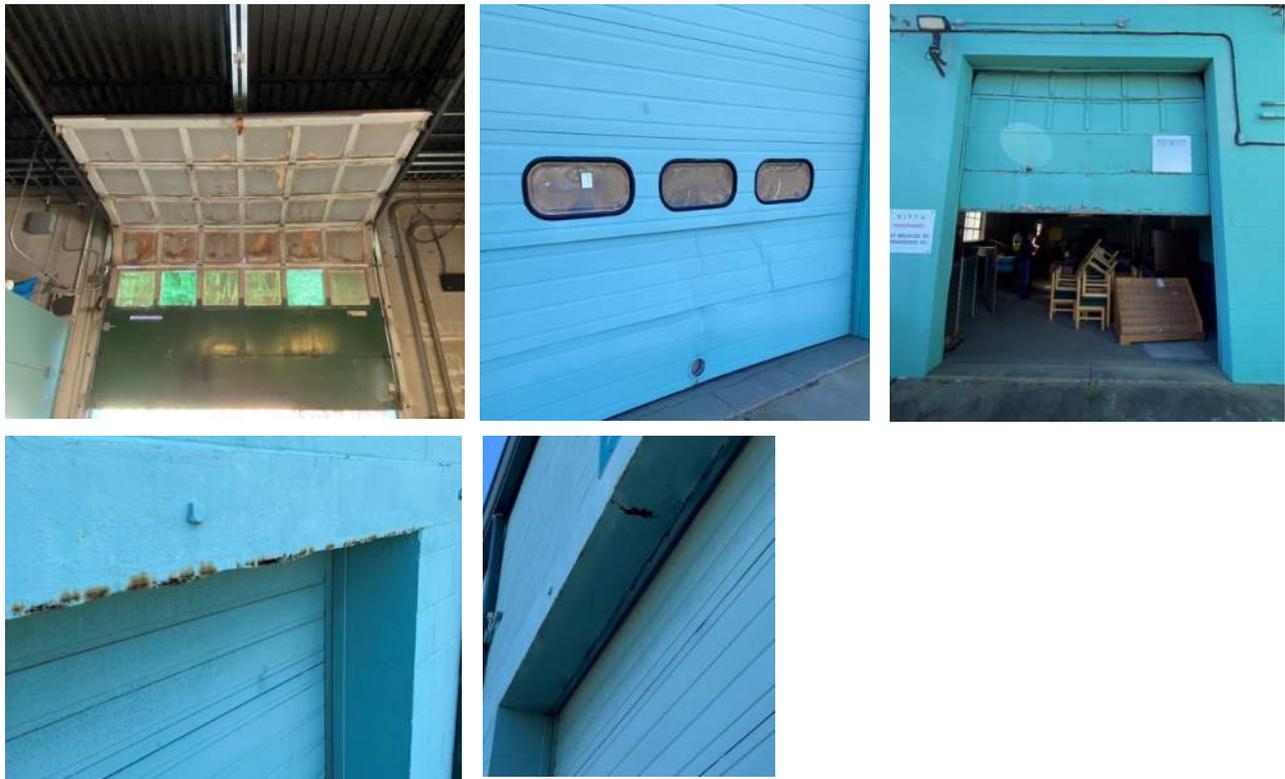
Coding / Field Name	Asset Description
System Name	Overhead garage doors
Condition	3
Quantity	7
Unit Cost	Total: \$55,650
Year in Service	~1960s with Sporadic Modifications
Expected Useful Life	40 years
Remaining Useful Life	15 years, Estimated, Based on Date of Observation
Location	Inspection garages, storage garage.
Basis of Costing	Square Foot Costs with RSMeans Data 2022 – 43 <sup>rd</sup> Edition

Inspection garage doors are better condition than storage garage. Denting, chipping, warping, corroded lintels.

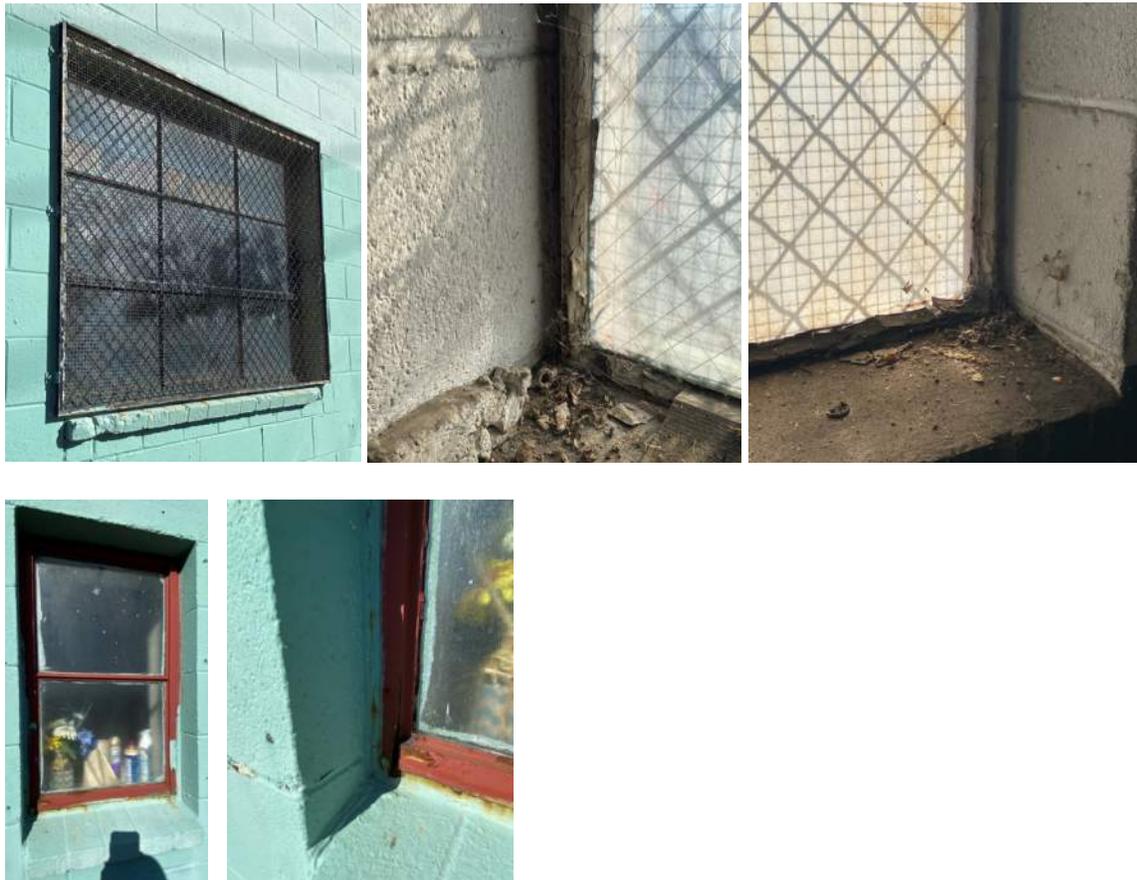
Coding / Field Name	Asset Description
System Name	Windows and frames
Condition	2
Quantity	15
Unit Cost	Total: \$45,210
Year in Service	~1960s with Sporadic Modifications
Expected Useful Life	40 years
Remaining Useful Life	7 years, Estimated, Based on Date of Observation
Location	Building exterior
Basis of Costing	Square Foot Costs with RSMeans Data 2022 – 43 <sup>rd</sup> Edition

Corroded sealant, damage to glazing.

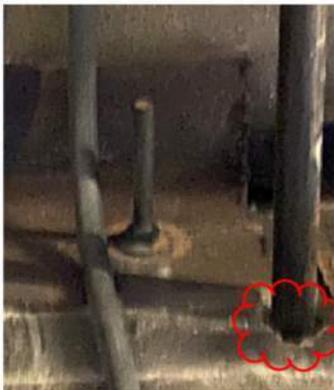
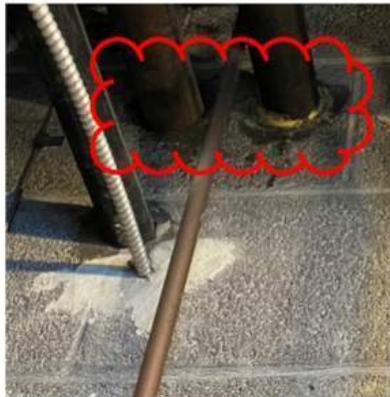
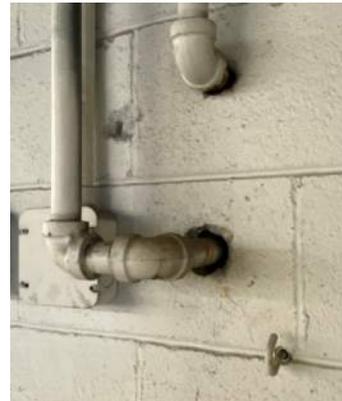
Coding / Field Name	Asset Description
System Name	Through-wall piping and conduit penetrations.
Condition	2
Quantity	~50 sq. ft.
Unit Cost	Total: \$2,567
Year in Service	~1990s with Sporadic Modifications
Expected Useful Life	30 years
Remaining Useful Life	5 years, Estimated, Based on Date of Observation
Location	Boiler / utility spaces. Inspection bays. Other.
Basis of Costing	Square Foot Costs with RSMeans Data 2022 – 43 <sup>rd</sup> Edition

Through-wall penetration sealants and sleeving deteriorating or not installed. Potential issues with penetration of fire-rated ceiling, wall, etc. assemblies.

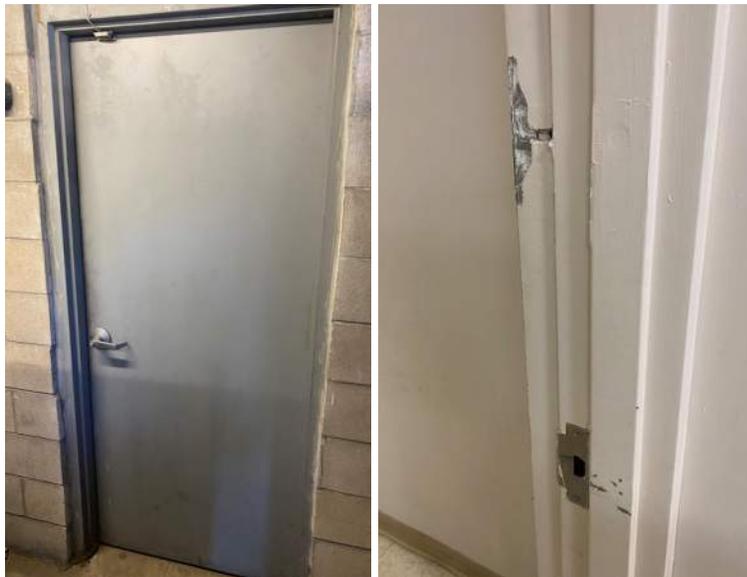
Coding / Field Name	Asset Description
System Name	Interior Steel doors and frames
Condition	3
Quantity	14
Unit Cost	Total: \$23,212
Year in Service	~1990s with Sporadic Modifications
Expected Useful Life	40 years
Remaining Useful Life	15 years, Estimated, Based on Date of Observation
Location	Building interior
Basis of Costing	Square Foot Costs with RSMeans Data 2022 – 43 <sup>rd</sup> Edition

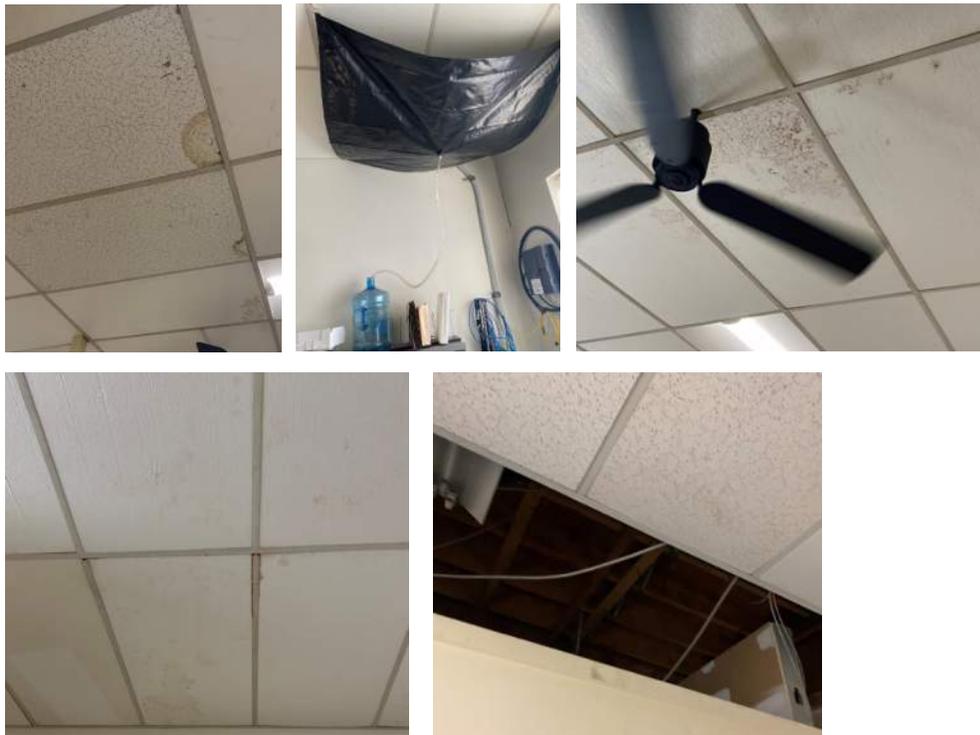
Coding / Field Name	Asset Description
System Name	Acoustic ceiling tiles and grids
Condition	2
Quantity	~7,500 sq. ft.
Unit Cost	Total: \$80,850
Year in Service	~1990s with Sporadic Modifications
Expected Useful Life	40 years
Remaining Useful Life	5 years, Estimated, Based on Date of Observation
Location	Office and administrative spaces.
Basis of Costing	Square Foot Costs with RSMeans Data 2022 – 43 <sup>rd</sup> Edition

Water damage, missing tiles, corroded grids.

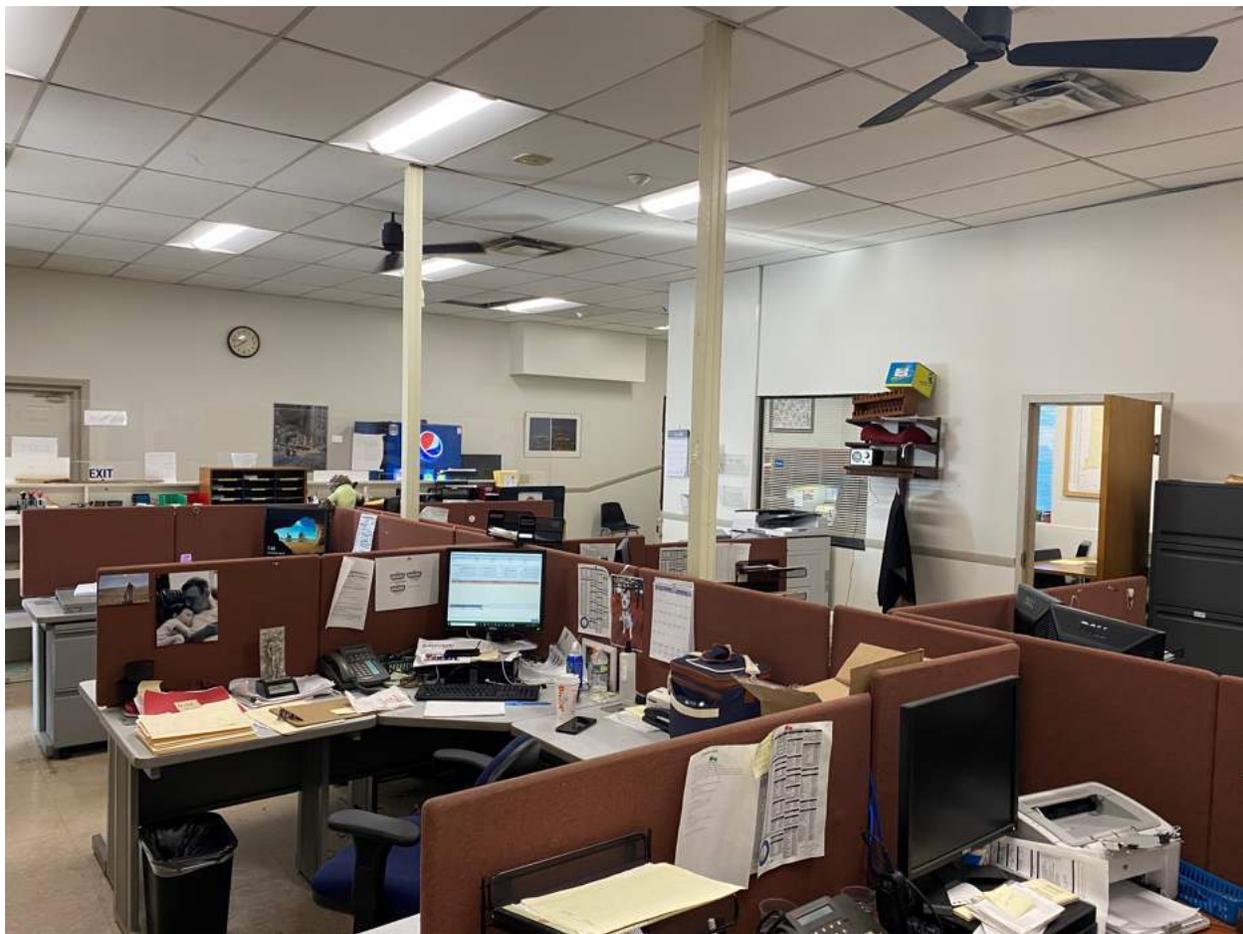
Coding / Field Name	Asset Description
System Name	Interior furniture and fixtures.
Condition	3
Quantity	~5,000 sq. ft.
Unit Cost	Total: \$293,467.80
Year in Service	~1990s with Sporadic Modifications
Expected Useful Life	45 years
Remaining Useful Life	15 years, Estimated, Based on Date of Observation
Location	Office and administrative areas.
Basis of Costing	Square Foot Costs with RSMeans Data 2022 – 43 <sup>rd</sup> Edition

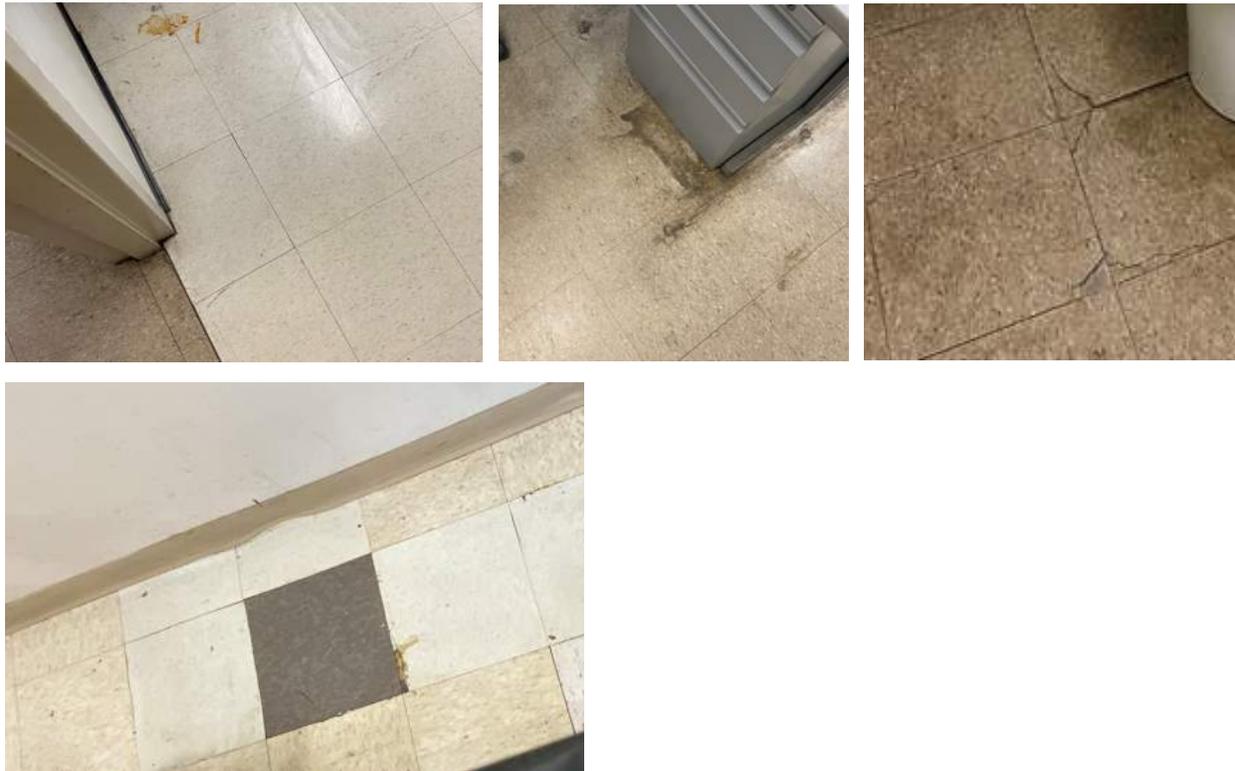
Coding / Field Name	Asset Description
System Name	VCT Flooring and rubber base.
Condition	2
Quantity	~7,500 sq. ft.
Unit Cost	Total: \$52,125
Year in Service	~1990s with Sporadic Modifications
Expected Useful Life	50 years
Remaining Useful Life	5 years, Estimated, Based on Date of Observation
Location	Office and administrative areas.
Basis of Costing	Square Foot Costs with RSMeans Data 2022 – 43 <sup>rd</sup> Edition

Cracked / missing tiles, damaged tiles, discoloration, staining.

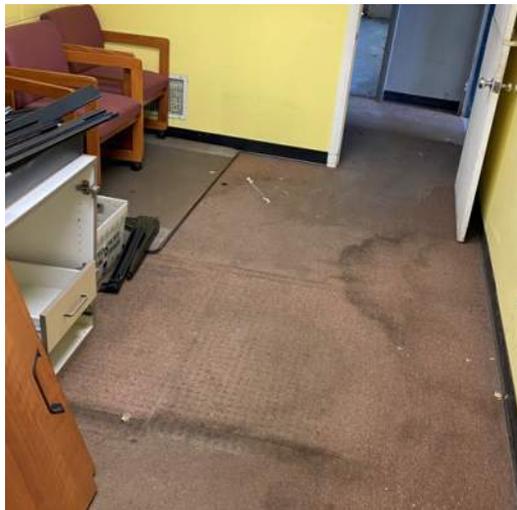
Coding / Field Name	Asset Description
System Name	Carpet flooring
Condition	1
Quantity	~600 sq. ft.
Unit Cost	Total: \$3,384
Year in Service	~1990s with Sporadic Modifications
Expected Useful Life	30 years
Remaining Useful Life	0 years, Estimated, Based on Date of Observation
Location	Office spaces.
Basis of Costing	Square Foot Costs with RSMeans Data 2022 – 43 <sup>rd</sup> Edition

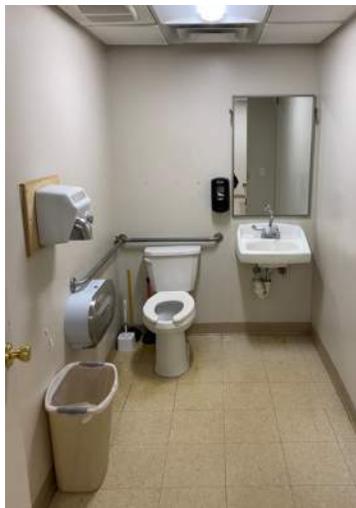
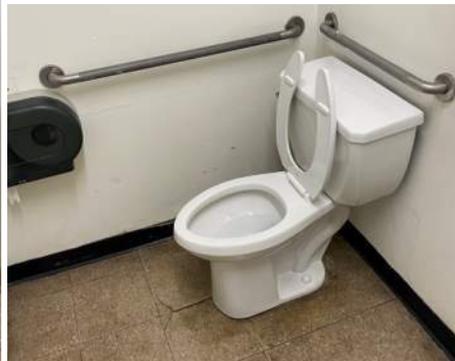
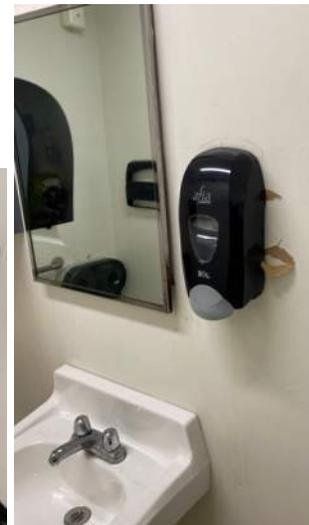
Coding / Field Name	Asset Description
System Name	Restroom fixtures and accessories
Condition	3
Quantity	2 restrooms
Unit Cost	\$3,348.10
Year in Service	~1990s with Sporadic Modifications
Expected Useful Life	30 years
Remaining Useful Life	15 years, Estimated, Based on Date of Observation
Location	Restrooms
Basis of Costing	Square Foot Costs with RSMeans Data 2022 – 43 <sup>rd</sup> Edition

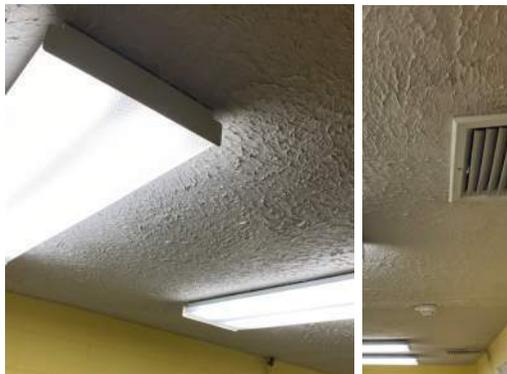
Coding / Field Name	Asset Description
System Name	Plaster ceilings
Condition	3
Quantity	~600 sq. ft.
Unit Cost	Total: \$6,012
Year in Service	~1990s with Sporadic Modifications
Expected Useful Life	50 years
Remaining Useful Life	15 years, Estimated, Based on Date of Observation
Location	Office / vending spaces.
Basis of Costing	Square Foot Costs with RSMeans Data 2022 – 43 <sup>rd</sup> Edition

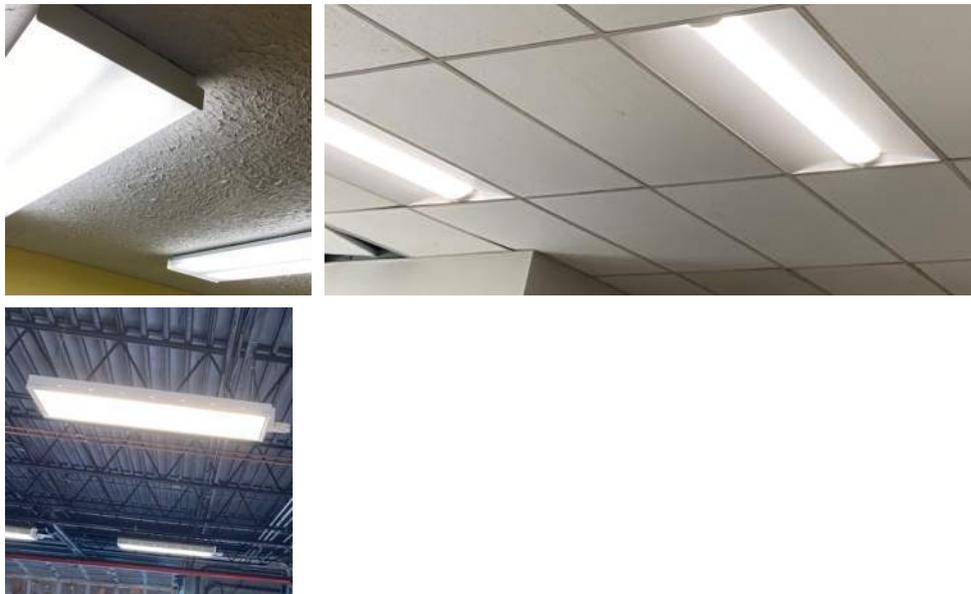
Coding / Field Name	Asset Description
System Name	Interior lighting fixtures
Condition	4
Quantity	~50
Unit Cost	Total: \$6,346
Year in Service	~1990s with Sporadic Modifications
Expected Useful Life	50 years
Remaining Useful Life	20 years, Estimated, Based on Date of Observation
Location	Building interior
Basis of Costing	Square Foot Costs with RSMeans Data 2022 – 43 <sup>rd</sup> Edition

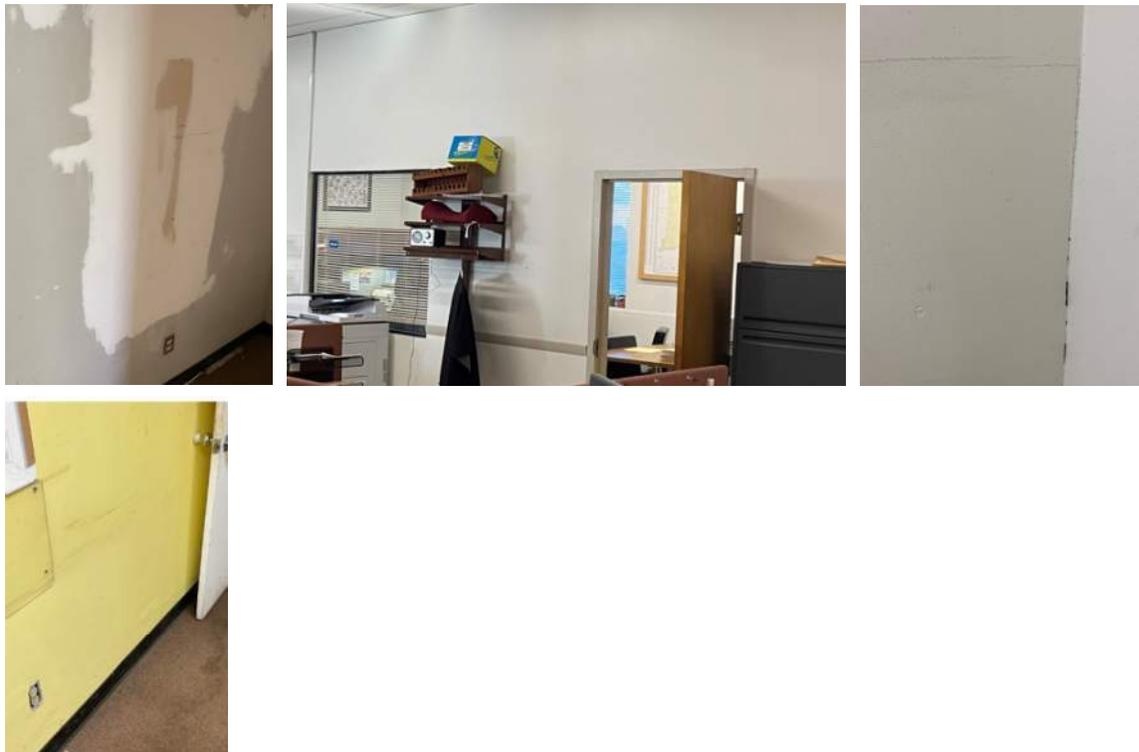
Coding / Field Name	Asset Description
System Name	Interior drywall Partitions
Condition	3
Quantity	~2000 sq. ft.
Unit Cost	Total: \$15,700
Year in Service	~1960s with Sporadic Modifications
Expected Useful Life	60 years
Remaining Useful Life	15 years, Estimated, Based on Date of Observation
Location	Building interior
Basis of Costing	Square Foot Costs with RSMeans Data 2022 – 43 <sup>rd</sup> Edition

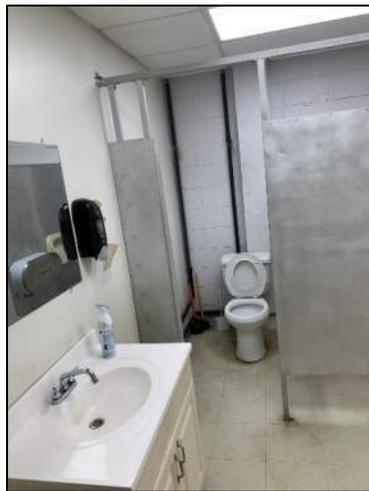
Figure 4: Floor Mounted Water Closet

The plumbing fixtures are dated. Most are manually operated, are not ADA compliant, and are not water-saving fixtures.

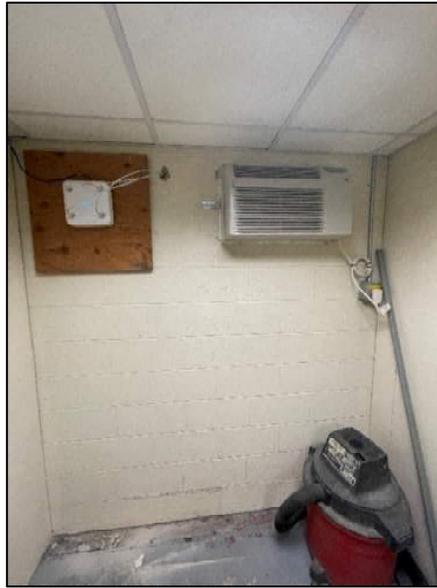
The IT room is equipped with a window-unit air conditioner.

Figure 21: Window-Unit in IT Room

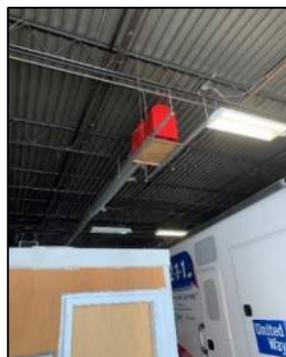
The shop is equipped with an exhaust fan that was ducted for use with trunks for local exhaust. These ducts are now missing, and it is not clear if the system is still operational.

Figure 22: Exhaust Fan

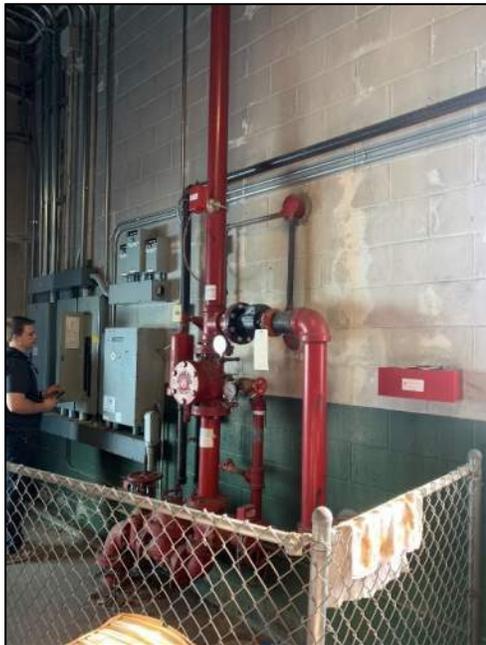
The fire sprinkler system is a wet-pipe system served by a 6” lateral. A Fire Department Connection is located on the street side of the shop where an alarm bell is situated. The shop appears to be fully sprinklered, but the office areas are not sprinklered.

Figure 23: Fire-Service Main

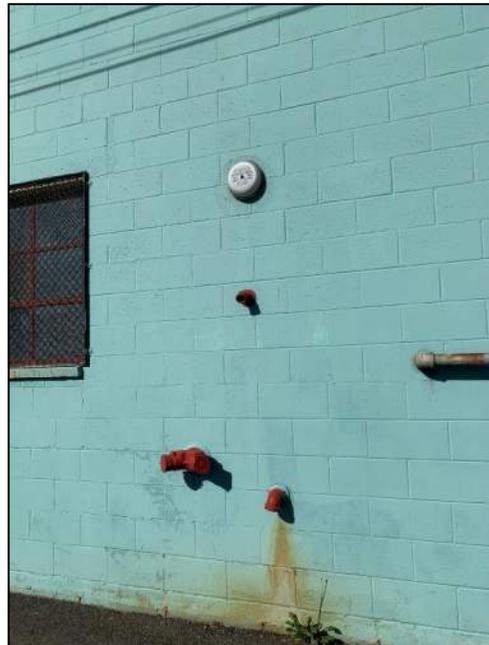
Figure 24: Alarm Bell and Fire-Department Connection

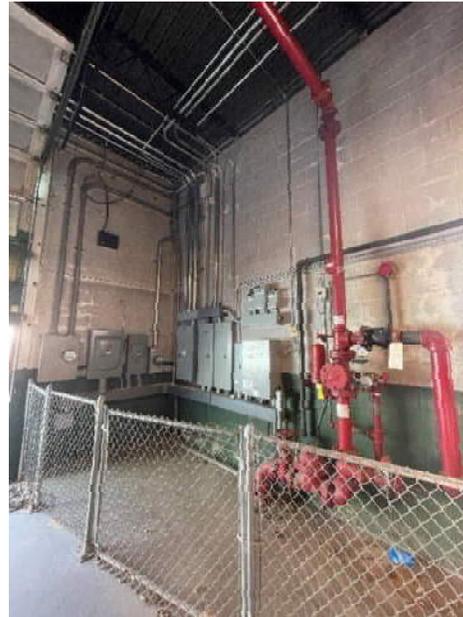
A 400A, 3 phase service installed over 30 years ago. The service is fed from the pole mounted transformers (North side of the building) (*Figure 1*) and enters the main disconnect (*Figure 3*) and distribution equipment (*Figure 2*) located in the fenced off Electrical area. Building is served by a backup generator (*Figure 4*). Many older panelboards are deteriorating and/or are damaged or abandoned in place (*Figure 5*).

Figure 2: Distribution Equipment

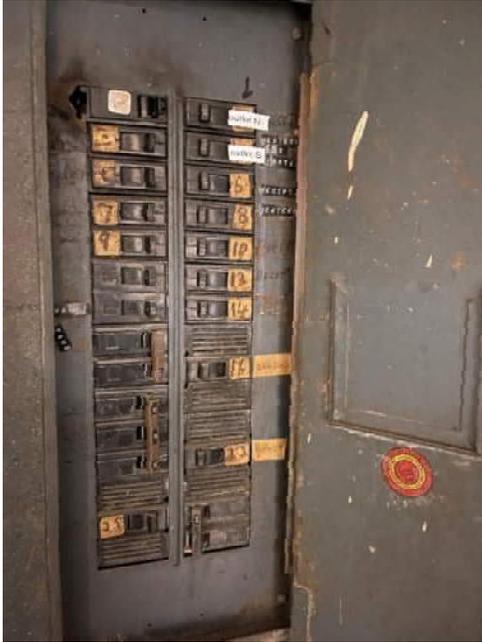
*Figure 5: Deteriorating panelboard*

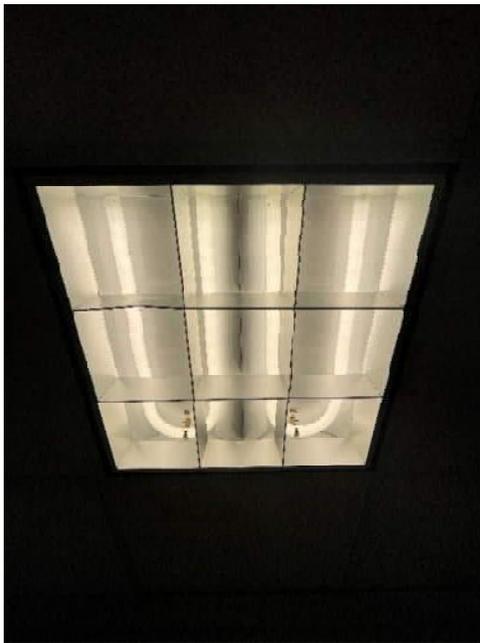
Storage/office spaces consist of LED 2’X2’ and 2’X4’ troffer fixtures (Figure 3) and linear LED fixtures controlled by a combination of toggle switches, ceiling mounted occupancy sensors (Figure 4), and wall switch occupancy sensors (Figure 8). Exit signs were observed throughout the space and appear to be fully operational (Figure 5). Emergency battery units (Figure 6) were observed in some storage/mechanical/electrical rooms. In addition to emergency battery units, lighting fixtures throughout the office space are on generator backup. Fluorescent fixtures (Figure 7) are still operational throughout the office space and storage areas.

Figure 7: Fluorescent Fixture

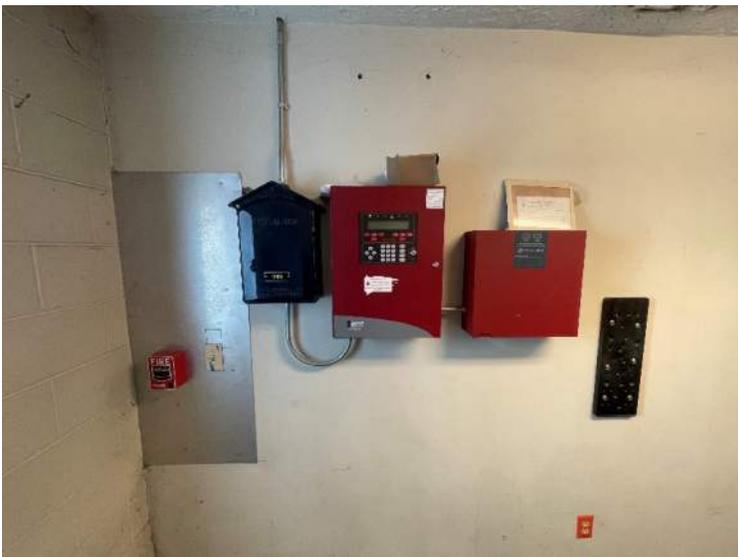
Fire alarm system (*Figure 1*) consists of an addressable Fire Alarm Control Panel, battery cabinet, and associated devices manufactured by Honeywell. Connection to local fire department is through a Gamewell Master Box. Fire Alarm system and associated devices and wiring appear to be in working condition, however some devices are approaching their expected useful life based on industry standards.

*Figure 1: Fire Alarm System*

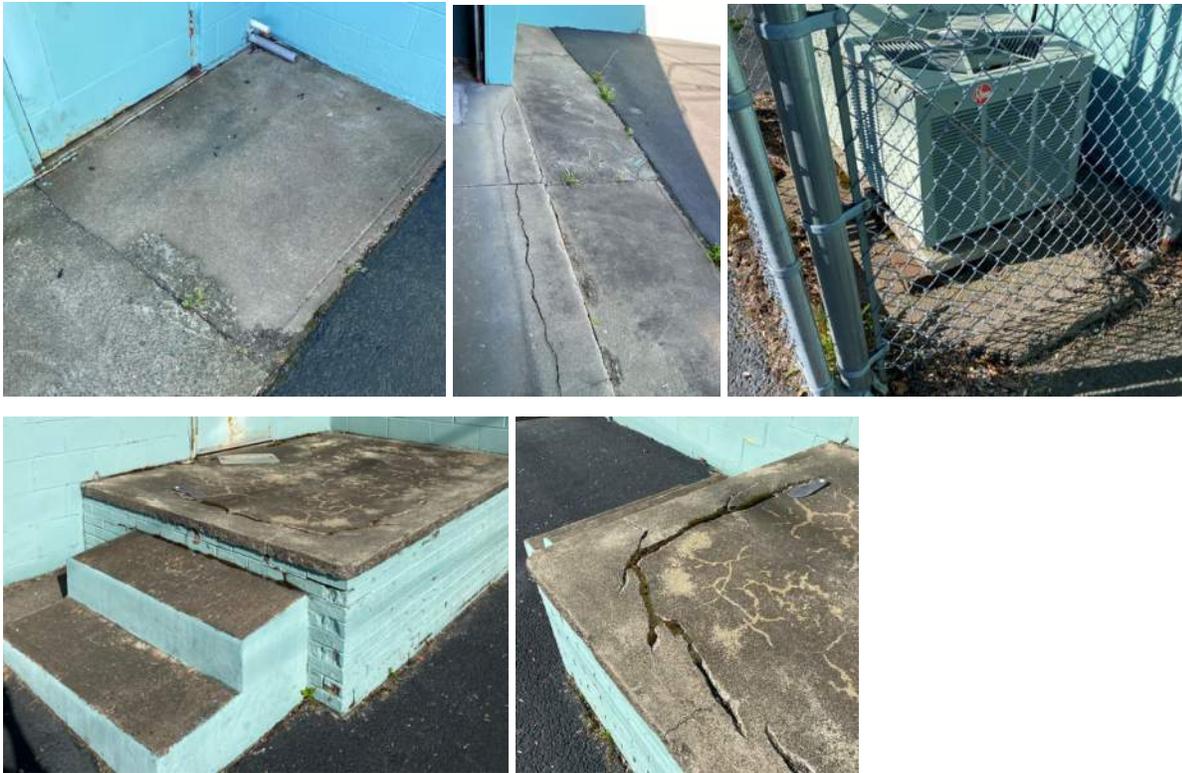
Cracking, settling, chipping.

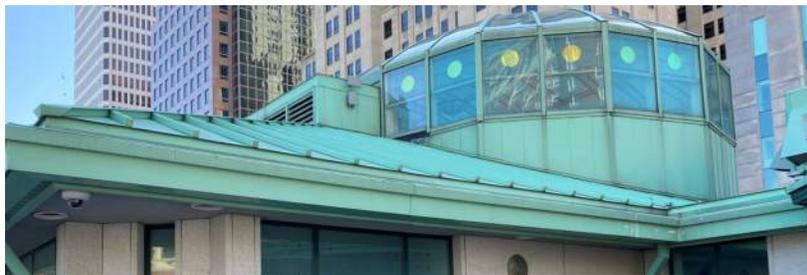
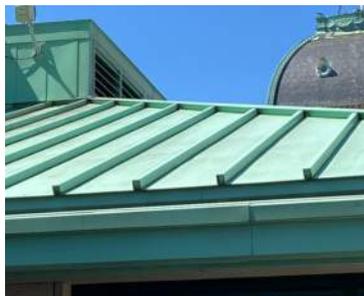
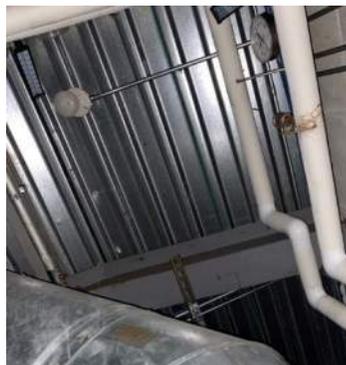
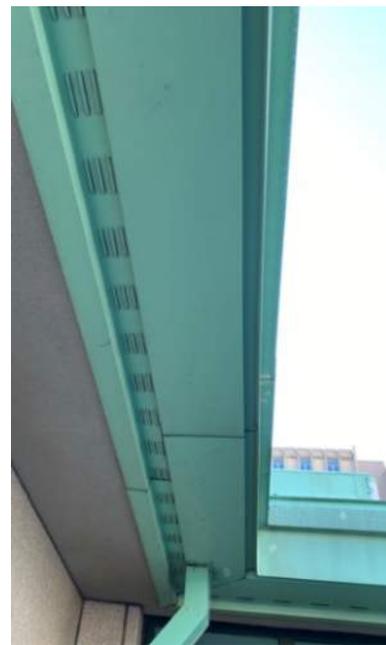
Roof and accessories in fair condition. Some staining evident.

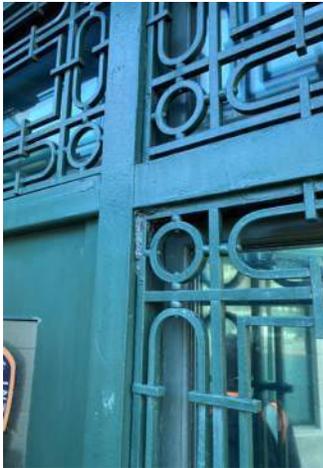
Coding / Field Name	Asset Description
System Name	Exterior ornamental metal work
Condition	3
Quantity	~650 sq. ft.
Unit Cost	Total: \$32,500
Year in Service	2001
Expected Useful Life	50 years
Remaining Useful Life	29 years, Estimated, Based on Date of Observation
Location	Building exterior
Basis of Costing	Square Foot Costs with RSMeans Data 2022 – 43 <sup>rd</sup> Edition

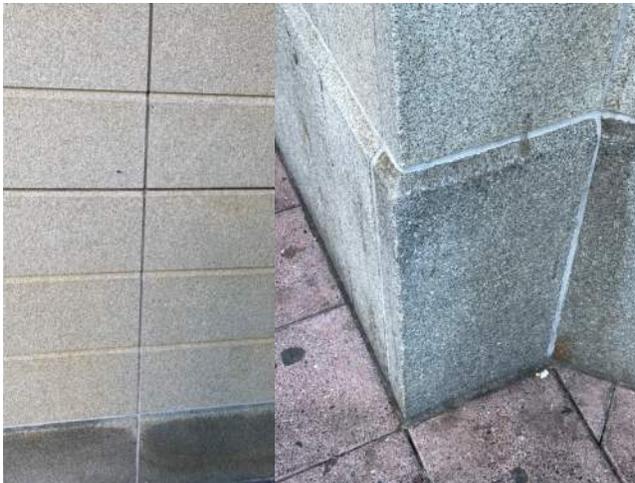
Coding / Field Name	Asset Description
System Name	Exterior granite cladding and base
Condition	4
Quantity	~1,300 sq. ft.
Unit Cost	Total: \$110,500
Year in Service	2001
Expected Useful Life	100 years
Remaining Useful Life	79 years, Estimated, Based on Date of Observation
Location	Building exterior
Basis of Costing	Square Foot Costs with RSMMeans Data 2022 – 43 <sup>rd</sup> Edition

Generally in fair condition. Regular maintenance and cleaning are crucial to prolonging life of this exterior in high traffic site.

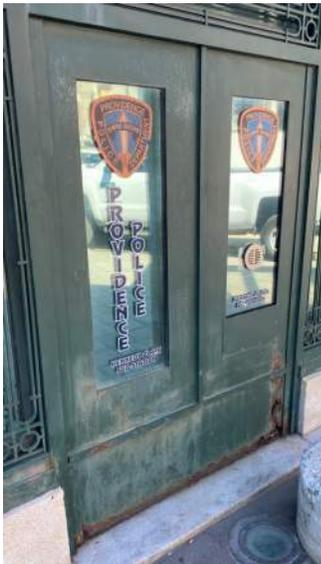
Coding / Field Name	Asset Description
System Name	Exterior Steel Wall Panels
Condition	3
Quantity	12
Unit Cost	Total: \$8423.54
Year in Service	2001
Expected Useful Life	50 years
Remaining Useful Life	29 years, Estimated, Based on Date of Observation
Location	Building exterior
Basis of Costing	Square Foot Costs with RSMMeans Data 2022 – 43 <sup>rd</sup> Edition

Rust and wear evident.

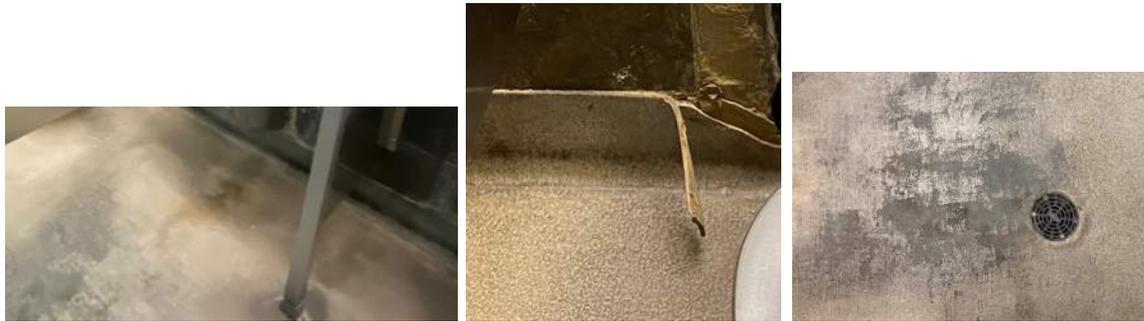
Coding / Field Name	Asset Description
System Name	Epoxy flooring and cove base
Condition	2
Quantity	~1000 sq. ft.
Unit Cost	Total: \$12,451
Year in Service	2001
Expected Useful Life	40 years
Remaining Useful Life	5 years, Estimated, Based on Date of Observation
Location	Restrooms / maintenance areas.
Basis of Costing	Square Foot Costs with RSMeans Data 2022 – 43 <sup>rd</sup> Edition

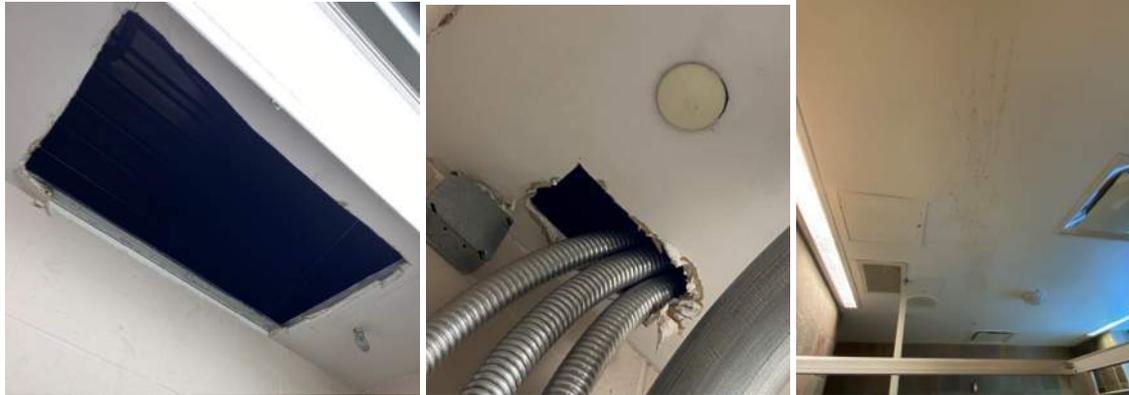
Coding / Field Name	Asset Description
System Name	Gypsum ceilings
Condition	2
Quantity	~1000 sq. ft.
Unit Cost	Total: \$12,345
Year in Service	2001
Expected Useful Life	20 years
Remaining Useful Life	5 years, Estimated, Based on Date of Observation
Location	Building interior
Basis of Costing	Square Foot Costs with RSMMeans Data 2022 – 43 <sup>rd</sup> Edition

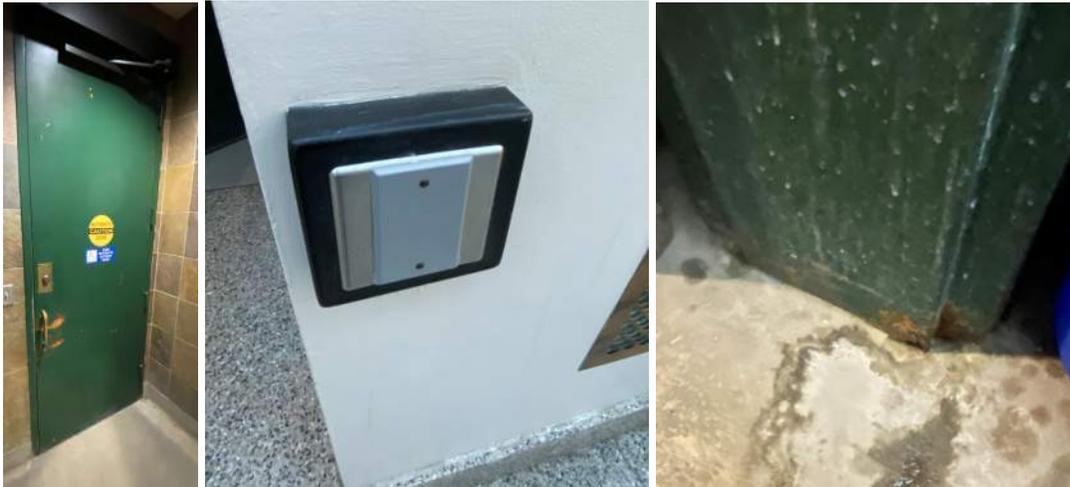
Coding / Field Name	Asset Description
System Name	Interior steel doors and frames.
Condition	3
Quantity	~10
Unit Cost	Total: \$28,820
Year in Service	2001
Expected Useful Life	50 years
Remaining Useful Life	29 years, Estimated, Based on Date of Observation
Location	Building interior
Basis of Costing	Square Foot Costs with RSMeans Data 2022 – 43 <sup>rd</sup> Edition

Ada push buttons not operable on some doors.

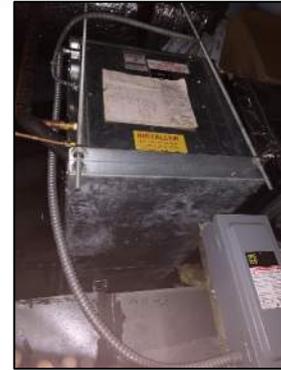
Figure 8: Unitary Air-Conditioning Unit in Attic Above Boiler Room

Due to the issues with the cooling system, the unitary air-conditioning units are no longer used for cooling and heating. The fans operate to provide ventilation, but the cooling and supplemental heating are provided by an exterior mounted unitary air-conditioner (a rooftop unit) and by a split system variable refrigerant flow (VRF) system consisting of Qty (4) wall-mounted indoor units and Qty (1) roof-mounted condenser.

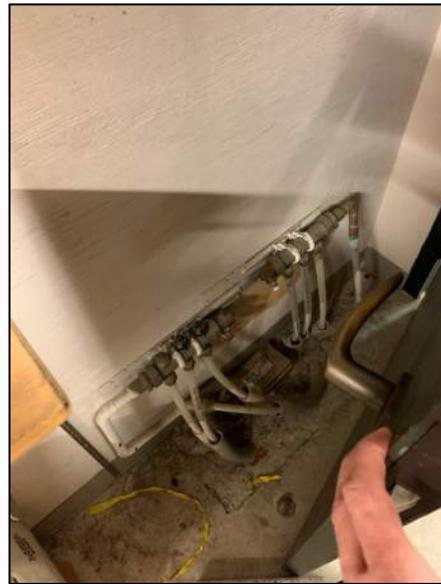
Figure 21: Abandoned Snow Melt Manifold

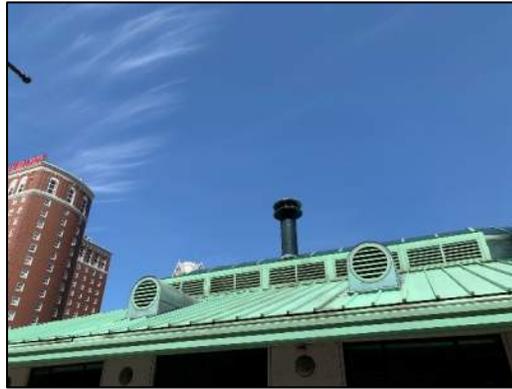
The boiler room has an attic above it, and combustion air is brought in via louvers to the exterior. The boiler exhaust is ducted straight up through the attic.

*Figure 22: Boiler Exhaust and Louvered Exterior for Mechanical Space*

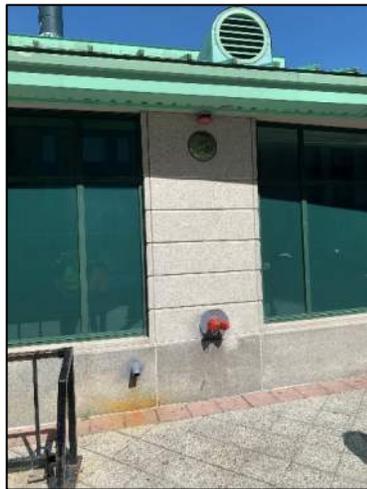
Figure 23: Fire Department Connection and Bell

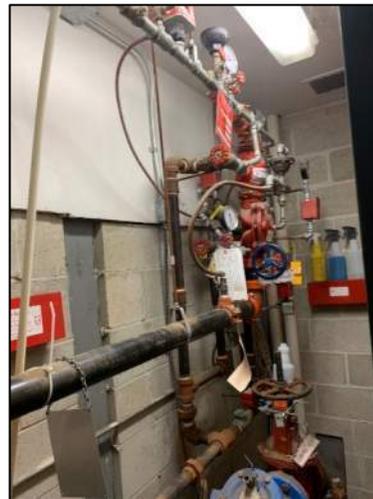
The fire sprinkler system is a wet-pipe system served by a 6” lateral and a 4” double-check valve assembly. The engineered drawings called for an Inergen system to protect the Central Dispatch Room and the Telephone/Electrical Room, but this system has since been converted to a pre-action system connected to the wet-pipe sprinkler system. A Fire Department Connection is located on the street side where an alarm bell is situated.

Figure 24: Fire Service

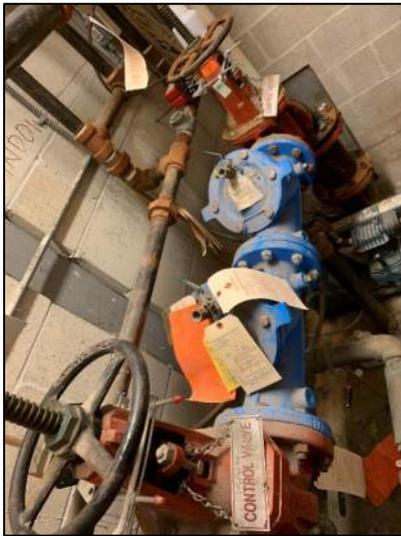
Figure 25: Fire Service Double Check Valve Assembly

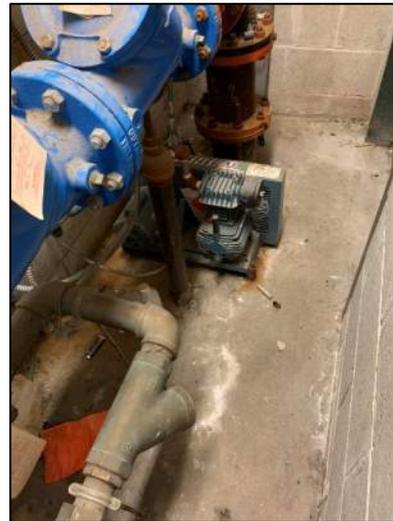
Figure 26: Air Compressor for Pre-Action System

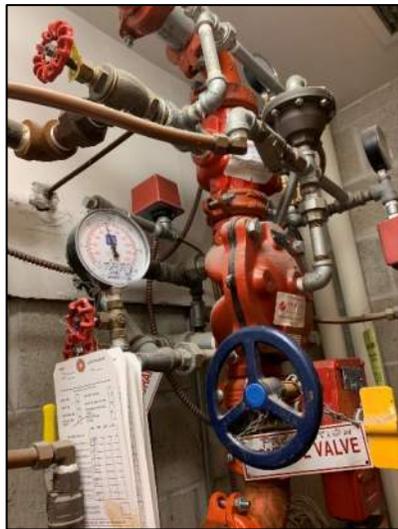
Figure 27: Pre-action System at Service

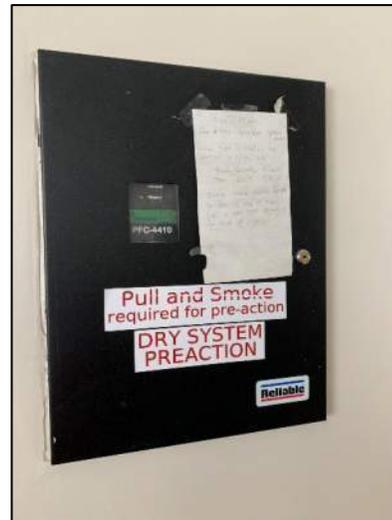
Figure 28: Pre-action System Controls

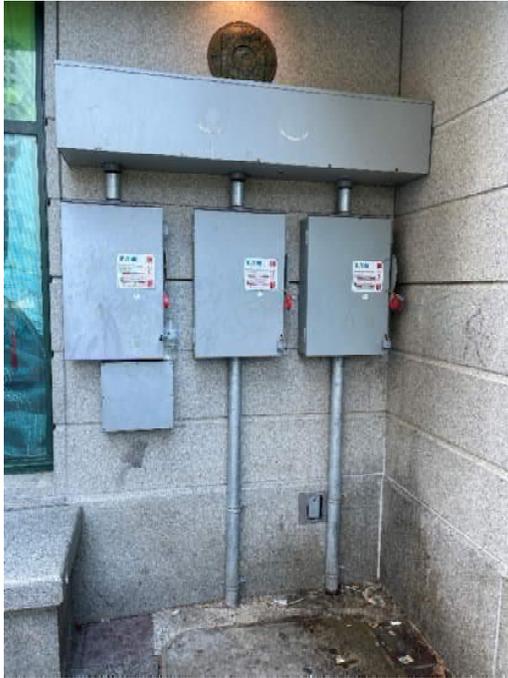
It appears that three 200A, 208V services enter the building through 3 disconnect switches (Figure 1) located on the North side of the building into the main Electric Room (Figures 2-3) installed approximately 20 years ago. Building is served by a 37.5KW backup generator (Figure 4). Distribution equipment appears to be in adequate condition but is approaching its expected useful life based on industry standards.

Figure 1: Main Service Disconnects
