# Transit Asset Management Plan

October 1, 2022 – September 30, 2026

**RHODE ISLAND PUBLIC TRANSIT AUTHORITY**

# RITPA Transit Asset Management Facility Condition Assessment

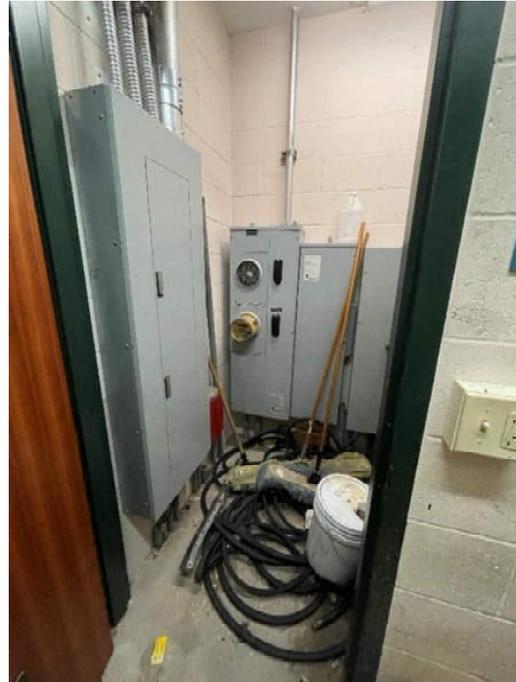
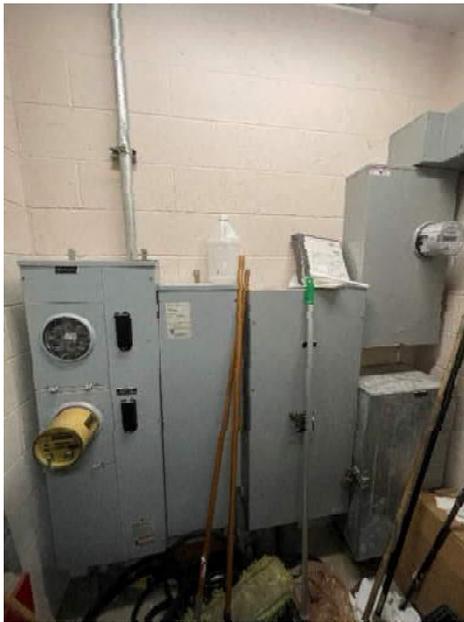
It appears that three 200A, 208V services enter the building through 3 disconnect switches (Figure 1) located on the North side of the building into the main Electric Room (Figures 2-3) installed approximately 20 years ago. Building is served by a 37.5KW backup generator (Figure 4). Distribution equipment appears to be in adequate condition but is approaching its expected useful life based on industry standards.

Figure 2: Main Electric Room (1)

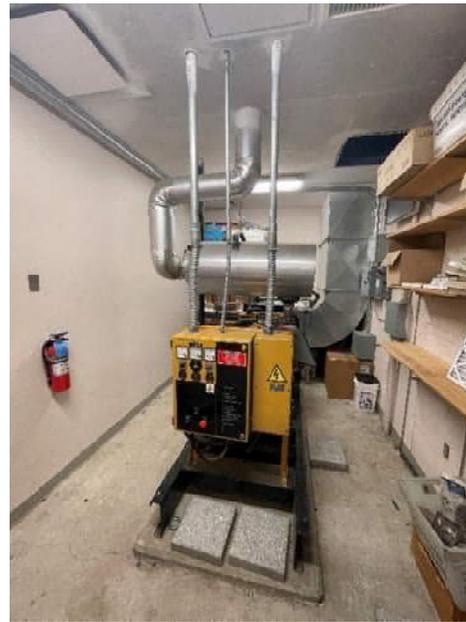
Figure 4: Generator

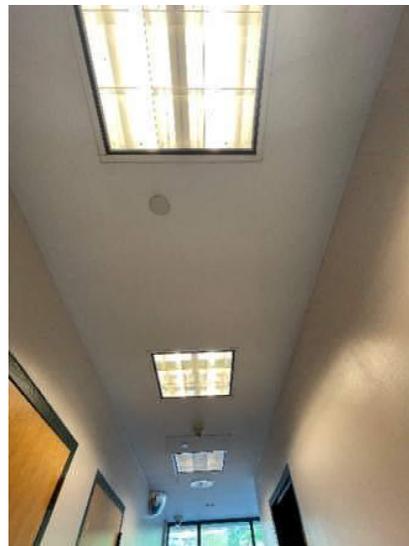
Figure 2: 2’X2’ Fluorescent fixtures

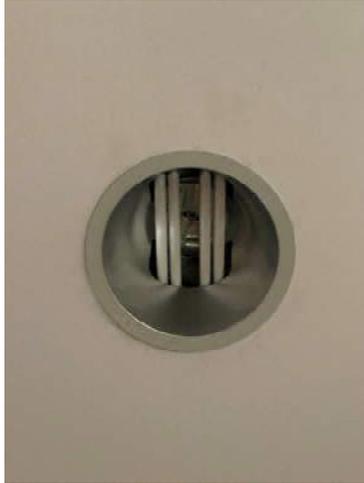
Figure 3: Fluorescent downlight fixtures

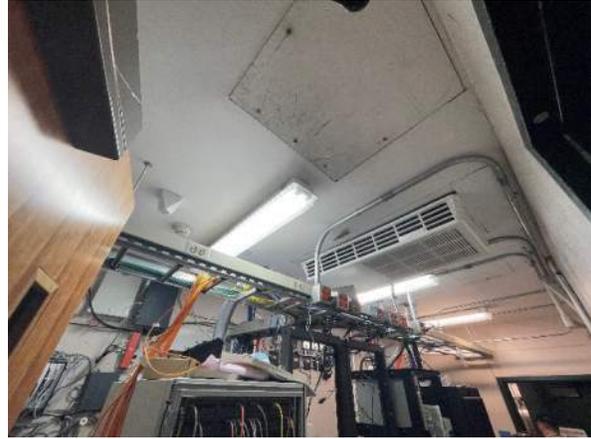
Figure 4: Fluorescent linear fixtures

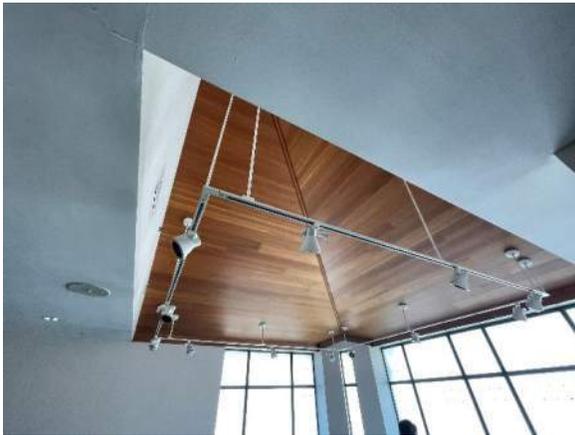
Figure 5: Track Lighting

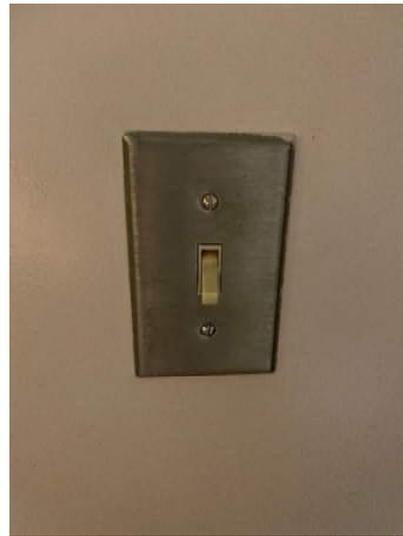
Figure 6: Toggle Switch

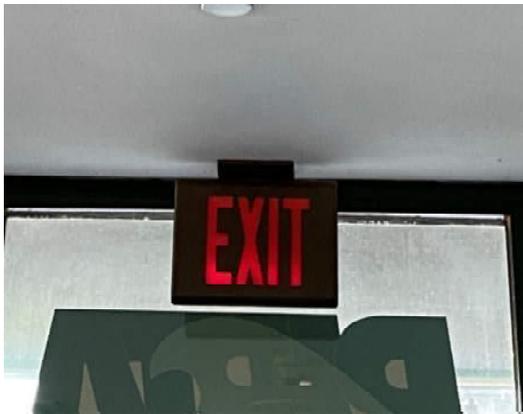
Figure 7: Exit Sign

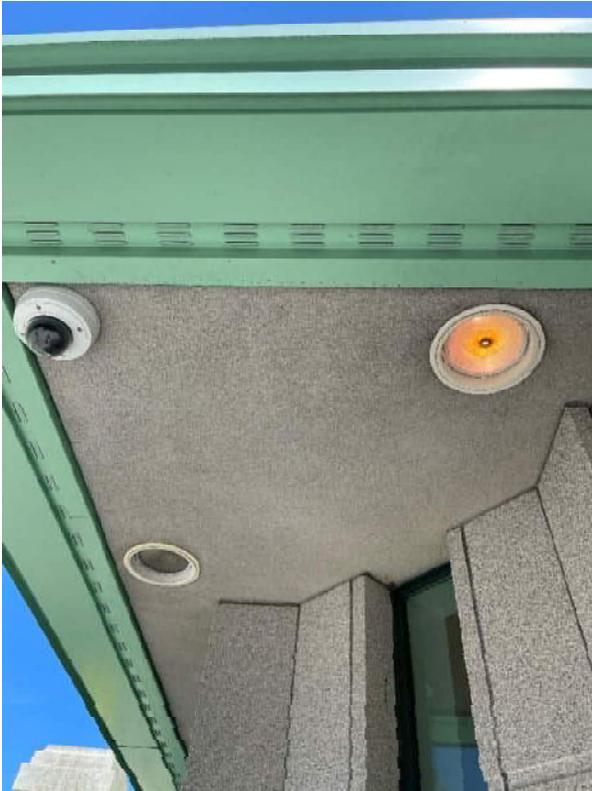
Exterior downlights (*Figure 8*) are installed along perimeter of building. Inground LED RGB fixtures (*Figure 9*) are installed throughout plaza to provide accent lighting.

*Figure 8: Exterior downlights*

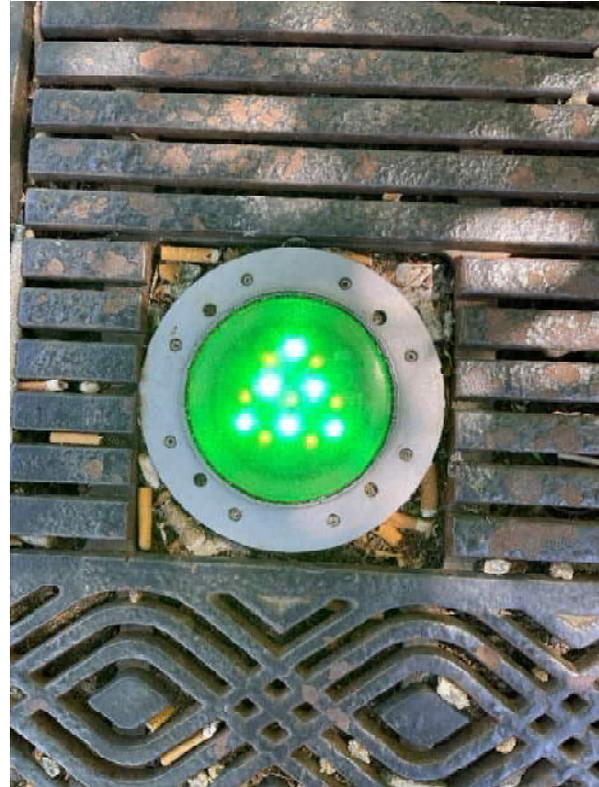
*Figure 9: In ground LED RGB fixtures*

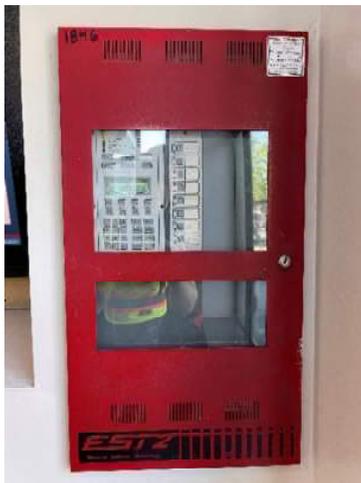
Fire alarm system consists of an addressable Fire Alarm Control Panel (Edwards EST-2) (Figure 1) and devices manufactured by EdwardsI. Fire Alarm system and associated devices and wiring appear to be in working condition, however they are approaching their expected useful life based on industry standards.

Figure 1: Fire Alarm Control Panel

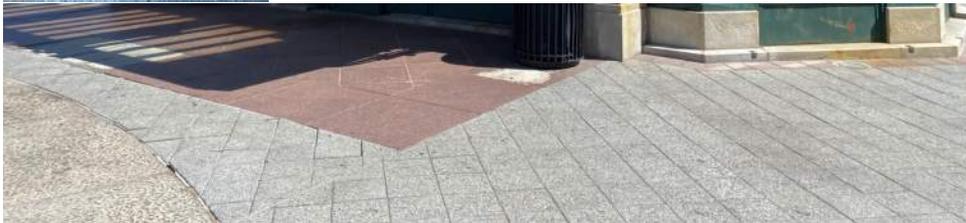
Many surfaces and textures create accessibility / tripping concerns. Maintenance is difficult with many connecting surfaces requiring differing treatment.

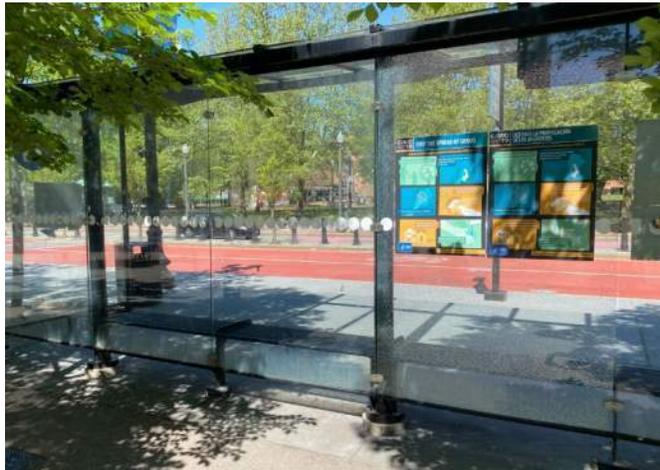
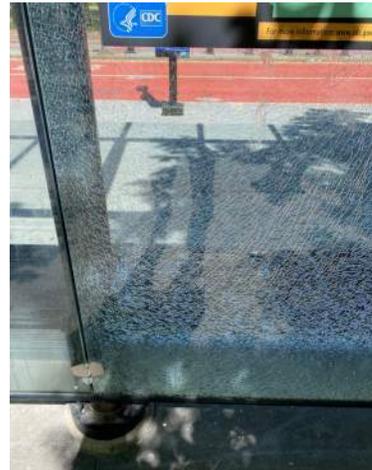
Glazing material resulting in cracked units.

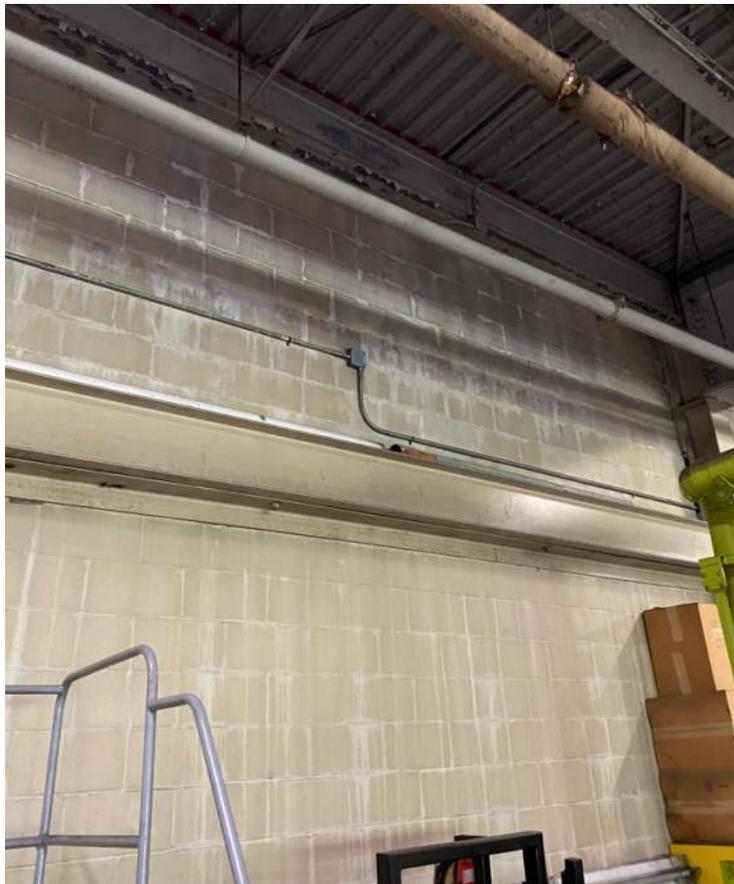
CMU walls appear in fair condition, however there is evidence of potential moisture buildup and efflorescence staining. Weep holes were not observed on the exterior, which are called for in the original construction documents.

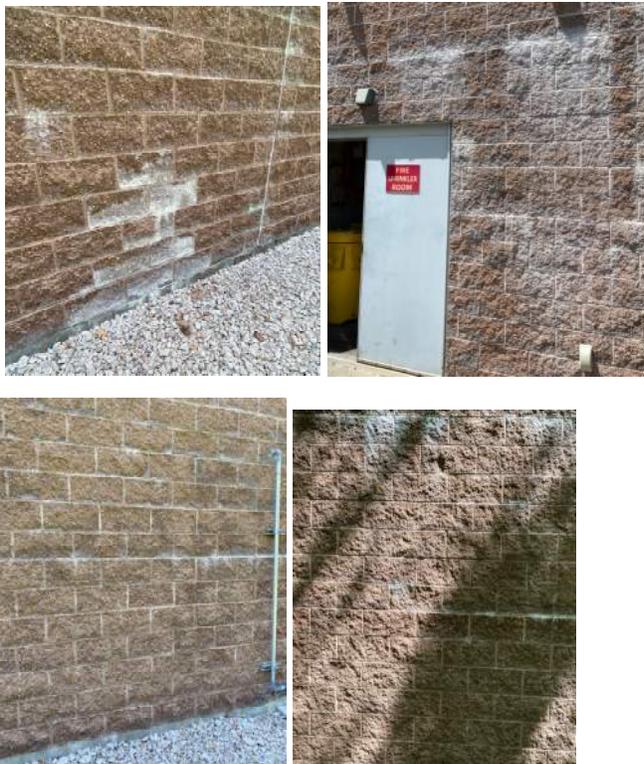
Split-face CMU walls appear in fair condition, however there is evidence of potential moisture buildup and efflorescence staining. Weep holes were not observed on the exterior, which are called for in the original construction documents.

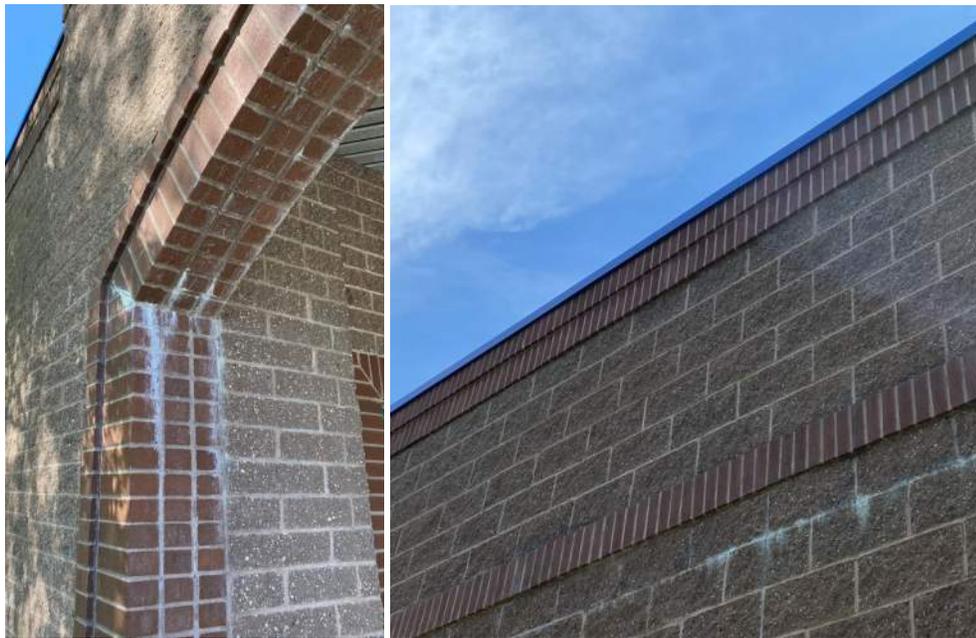
Exterior brick work appears in fair condition, however there is some evidence of potential moisture buildup and efflorescence staining.

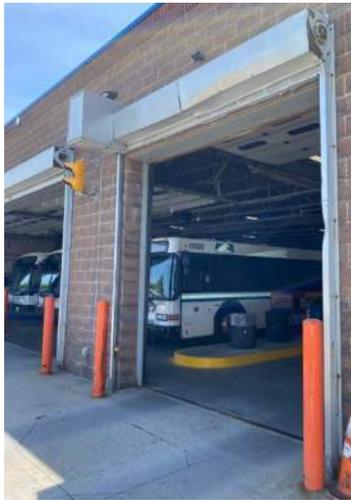
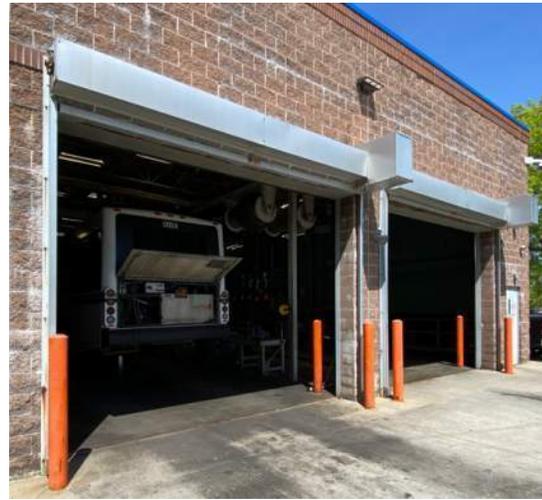
Some denting and rust evident.

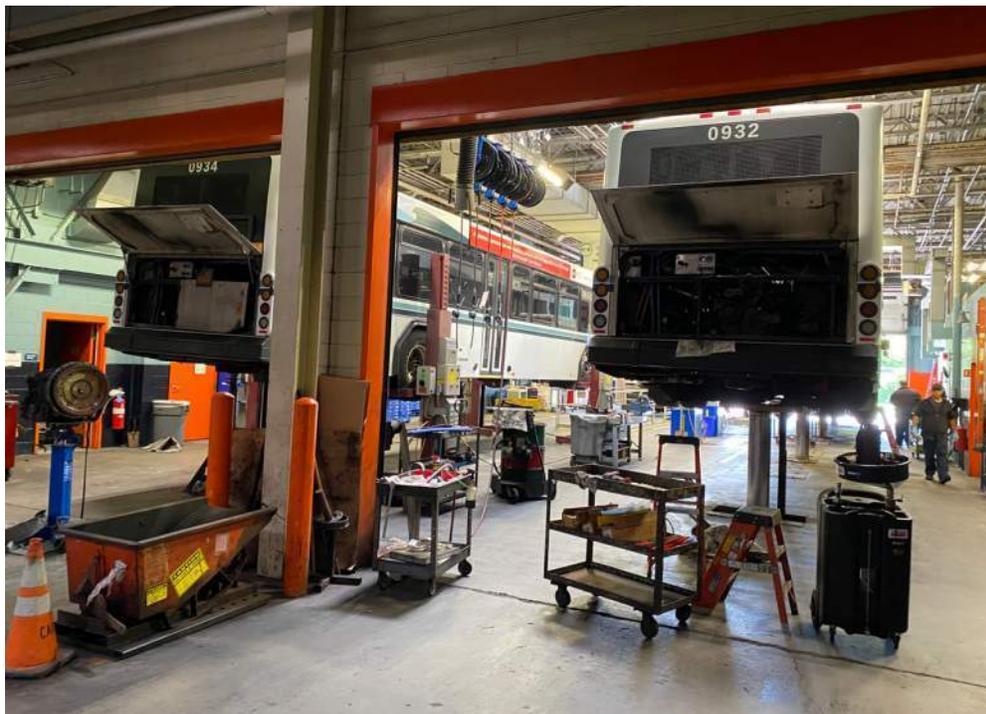
Coding / Field Name	Asset Description
System Name	Overhead garage doors
Condition	3
Quantity	2
Unit Cost	Total: \$8,695
Year in Service	1993
Expected Useful Life	40 years
Remaining Useful Life	20 years, Estimated, Based on Date of Observation
Location	Maintenance garage.
Basis of Costing	Square Foot Costs with RSMeans Data 2022 – 43 <sup>rd</sup> Edition

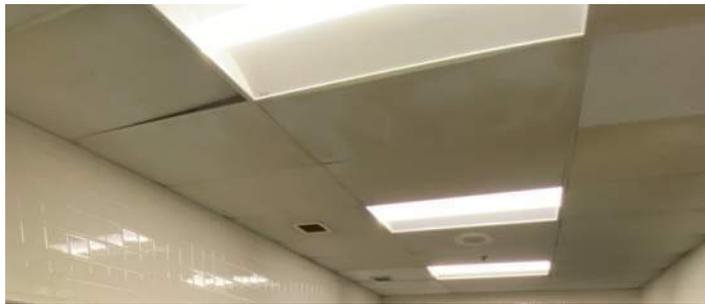
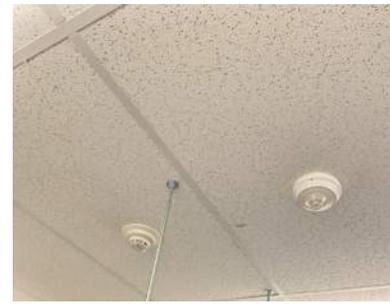
Water damage, missing tiles, corroded grids.

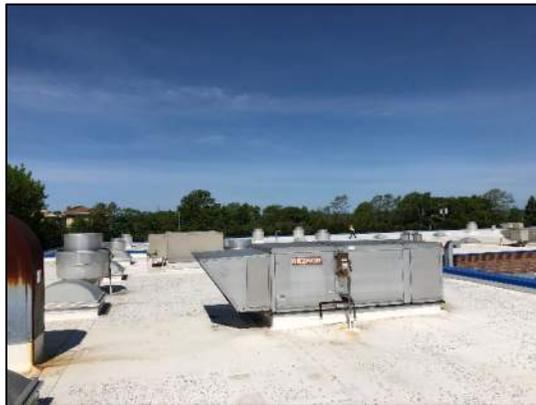
Figure 16: Makeup Air Unit

The maintenance bays are supplied with local rope-and-pully exhaust at each hydraulic lift and pit. Centrifugal upblast fans exhaust the maintenance areas. On the roof, existing make-up air units (MAUs) are original to the building (1993). The existing control system detecting CO and NO2 is not operational.

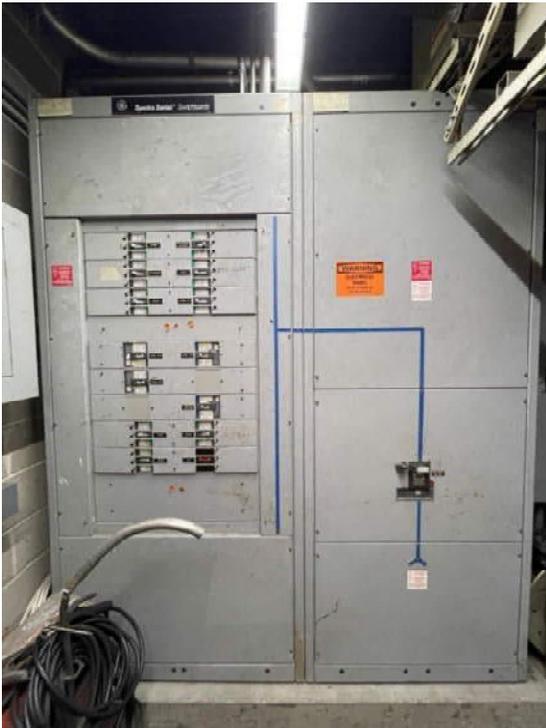
Figure 1: Switchboard (277/480V)

A 800A, 480V service installed approximately 30 years ago. The service is fed from the pad mounted transformer (Figure 2) (South side of the building) and enters the main switchboard (Figure 1) located in the Electrical Room. Building is served by a backup diesel generator (Figure 3). All distribution equipment appears to be in adequate condition, but it is approaching expected useful life based on industry standards.

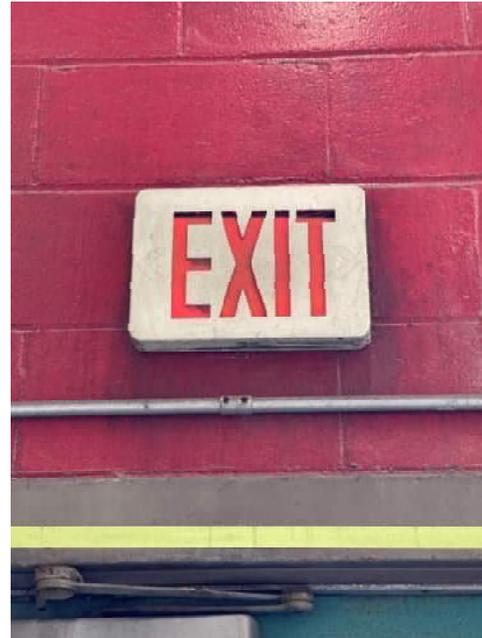
Figure 2: Exit Sign (Not Illuminated)

LED high-bay fixtures with integral occupancy sensors (*Figure 1*) are installed throughout the first-floor garage space and appear to be in good condition. Exit signs (*Figure 2*) throughout the space do not appear to be illuminated and are not operational.

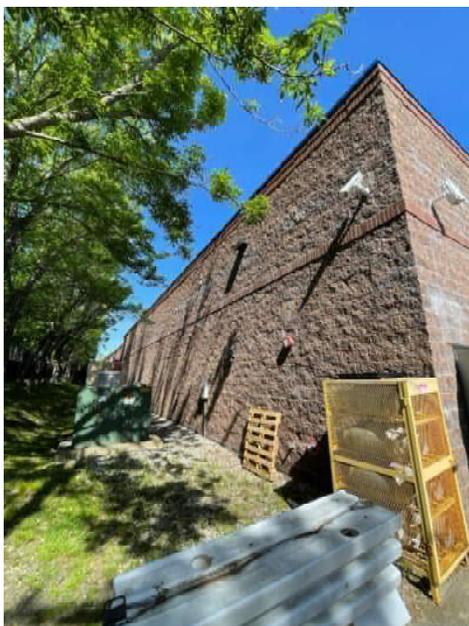
*Figure 9: Exterior Wall packs*

Wall packs (*Figure 9*) are installed along perimeter of building. Photocells on wall packs appear to have issues (lights staying on throughout the day). Emergency wall packs (*Figure 10*) are located above doors for emergency egress lighting.

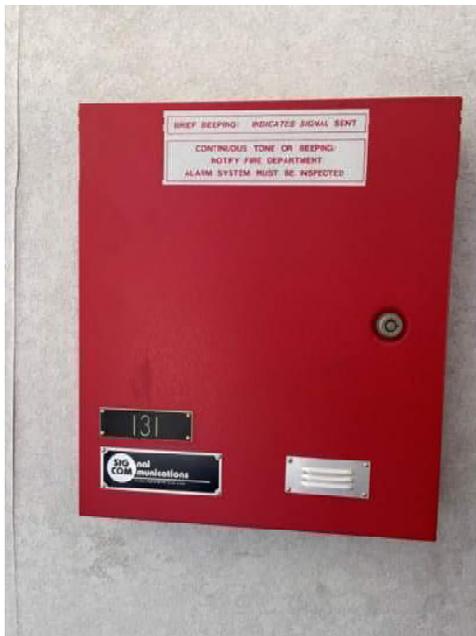
Figure 1: Gamewell Master Box

Fire alarm system consists of an addressable Fire Alarm Control Panel (Figure 2) (Simplex 4007) and associated devices manufactured by Simplex. Connection to local fire department is through a Radio Master Box (Figure 1). Pneumatic CO detection system installed throughout the garage space is no longer operational. One operational CO detection device was observed throughout the space (Figure 3). A fire suppression system is installed in the IT room (Figure 4). Fire Alarm system and associated devices and wiring appear to be in good condition.

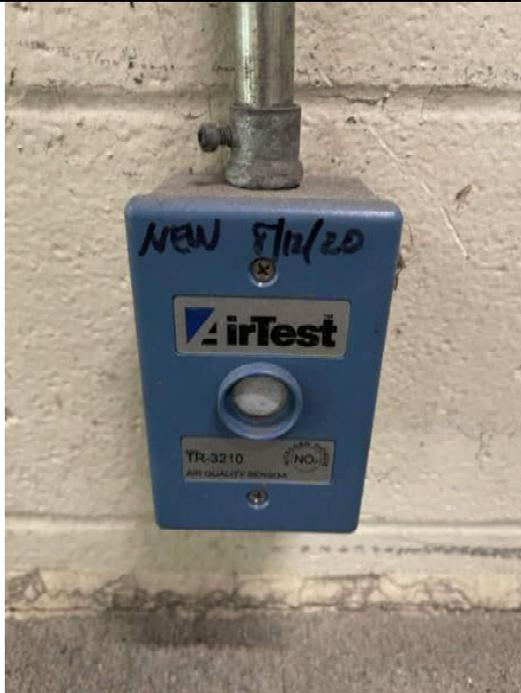
Figure 3: CO system

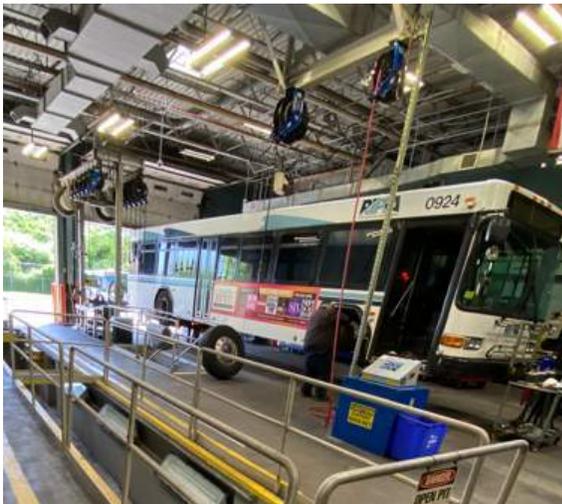
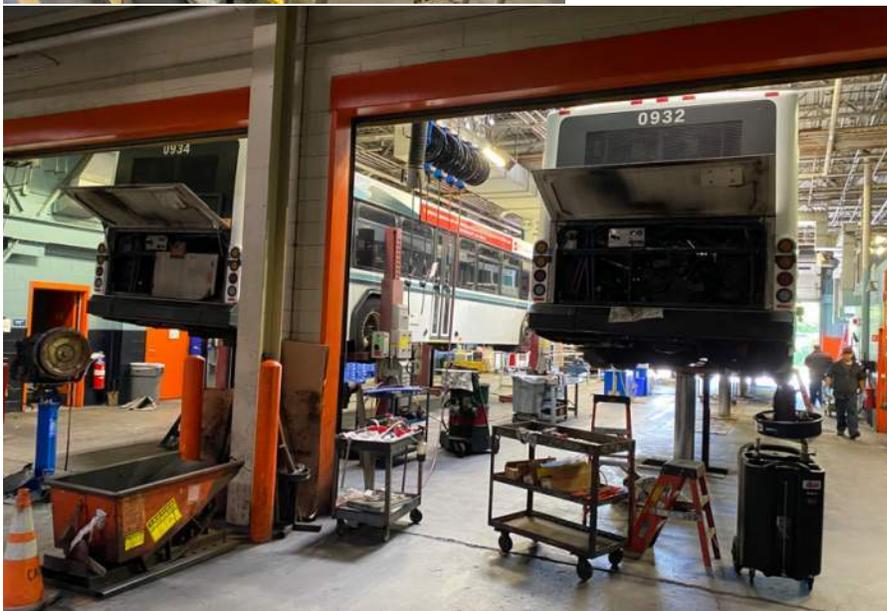
Coding / Field Name	Asset Description
System Name	Vehicle lifts
Condition	3
Quantity	3
Unit Cost	Total: \$105,000
Year in Service	29
Expected Useful Life	20 years
Remaining Useful Life	10 years, Estimated, Based on Date of Observation
Location	Building interior
Basis of Costing	Square Foot Costs with RSMMeans Data 2022 – 43 <sup>rd</sup> Edition

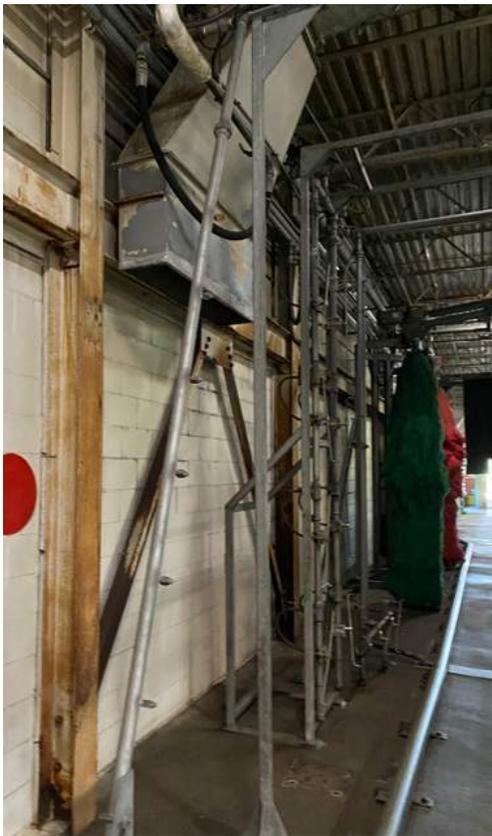
Coding / Field Name	Asset Description
System Name	Bus wash
Condition	2
Quantity	2
Unit Cost	Total: \$99,172
Year in Service	29
Expected Useful Life	25 years
Remaining Useful Life	5 years, Estimated, Based on Date of Observation
Location	Building interior
Basis of Costing	Square Foot Costs with RSMeans Data 2022 – 43 <sup>rd</sup> Edition

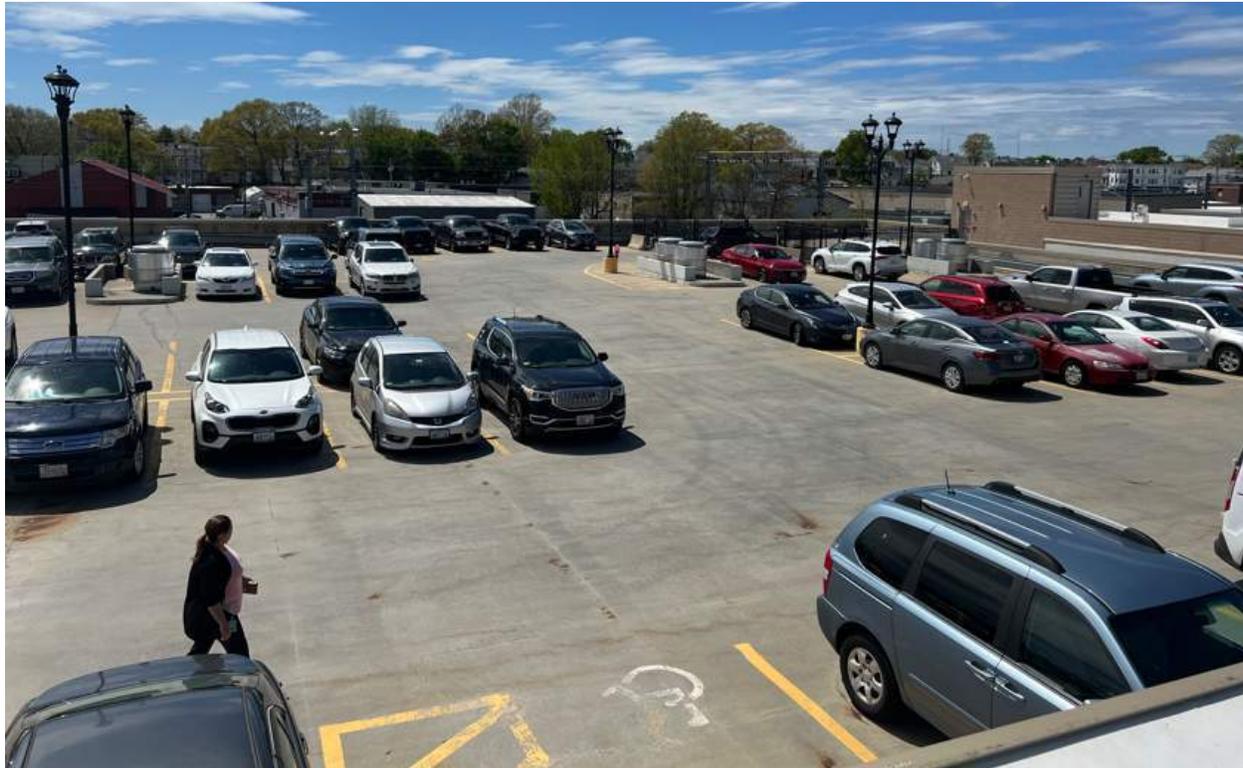
Coding / Field Name	Asset Description
System Name	Parking deck slab and structure
Condition	3
Quantity	~72,150 sq. ft.
Unit Cost	\$3,473,300
Year in Service	2009
Expected Useful Life	80 years
Remaining Useful Life	60 years
Location	Parking roof deck
Basis of Costing	Square Foot Costs with RSMeans Data 2022 – 43 <sup>rd</sup> Edition

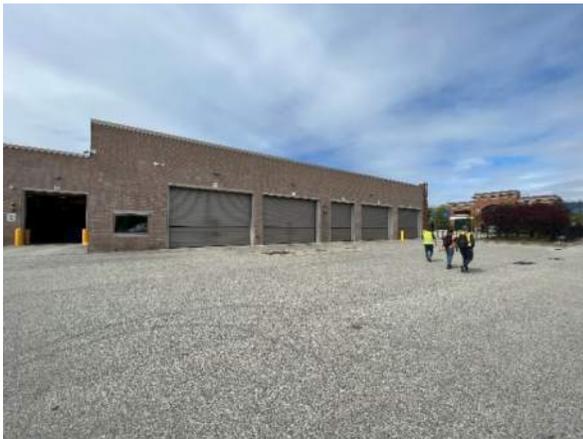
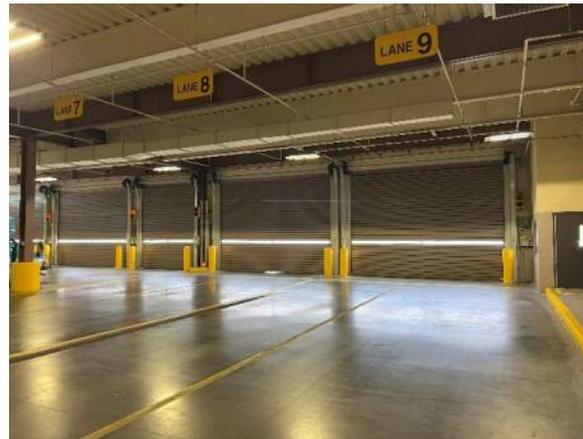
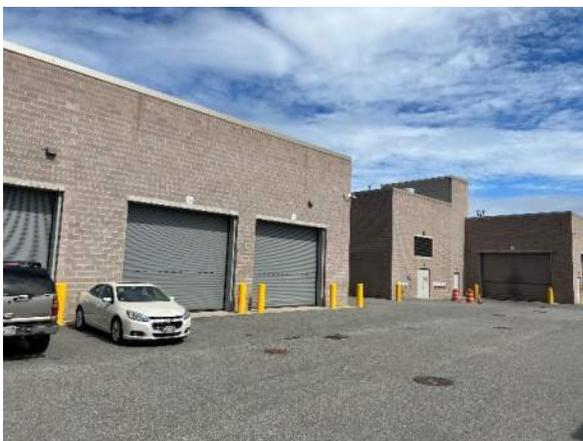
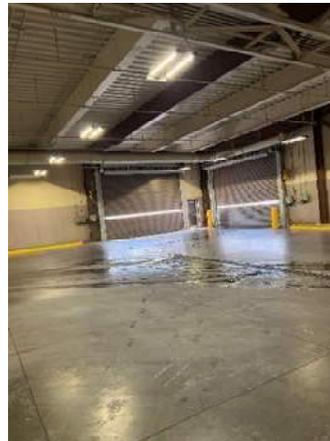
Coding / Field Name	Asset Description
System Name	Overhead coiling doors
Condition	3
Quantity	12
Unit Cost	\$93,490
Year in Service	2009
Expected Useful Life	30 years
Remaining Useful Life	20 years, Estimated, Based on Date of Observation
Location	Building exterior
Basis of Costing	Square Foot Costs with RSMeans Data 2022 – 43 <sup>rd</sup> Edition

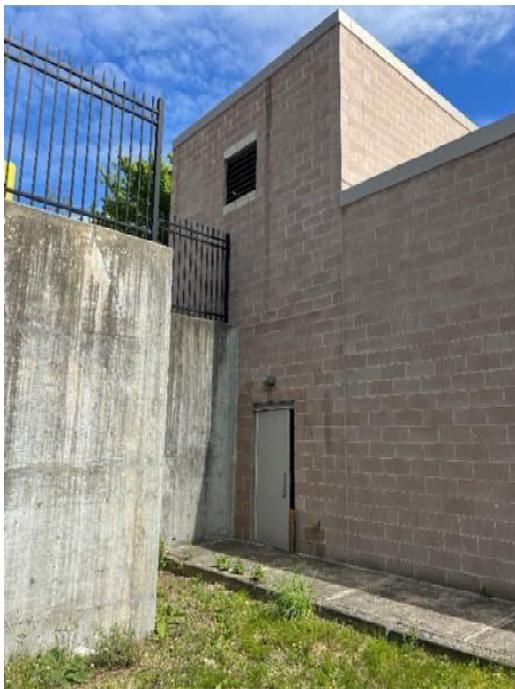
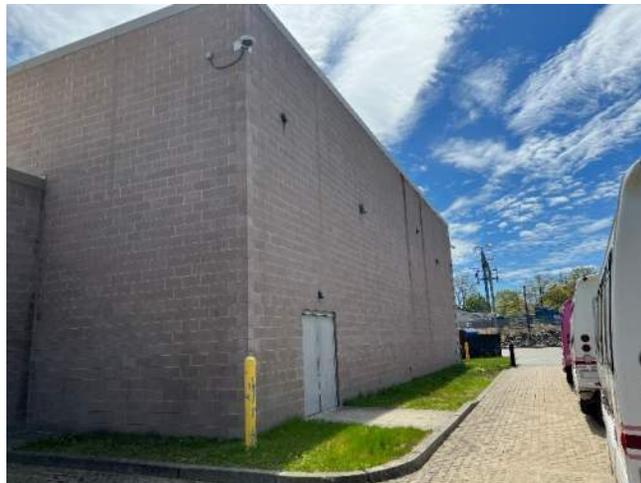
Coding / Field Name	Asset Description
System Name	Exterior metal doors & frames
Condition	3
Quantity	27
Unit Cost	Total: \$56,366
Year in Service	2009
Expected Useful Life	50 years
Remaining Useful Life	40 years, Estimated, Based on Date of Observation
Location	Building exterior
Basis of Costing	Square Foot Costs with RSMMeans Data 2022 – 43 <sup>rd</sup> Edition

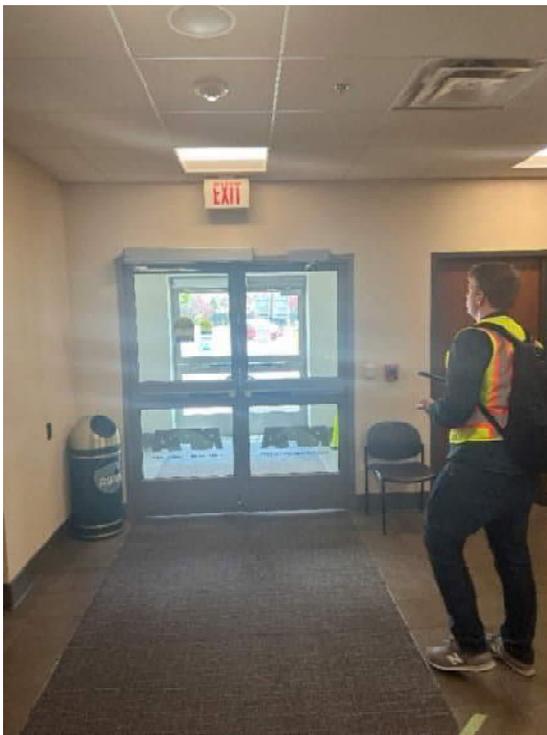
Coding / Field Name	Asset Description
System Name	Aluminum automatic entrances
Condition	3
Quantity	2
Unit Cost	\$29,650
Year in Service	2009
Expected Useful Life	25 years
Remaining Useful Life	15 years, Estimated, Based on Date of Observation
Location	Building exterior
Basis of Costing	Square Foot Costs with RSMeans Data 2022 – 43 <sup>rd</sup> Edition

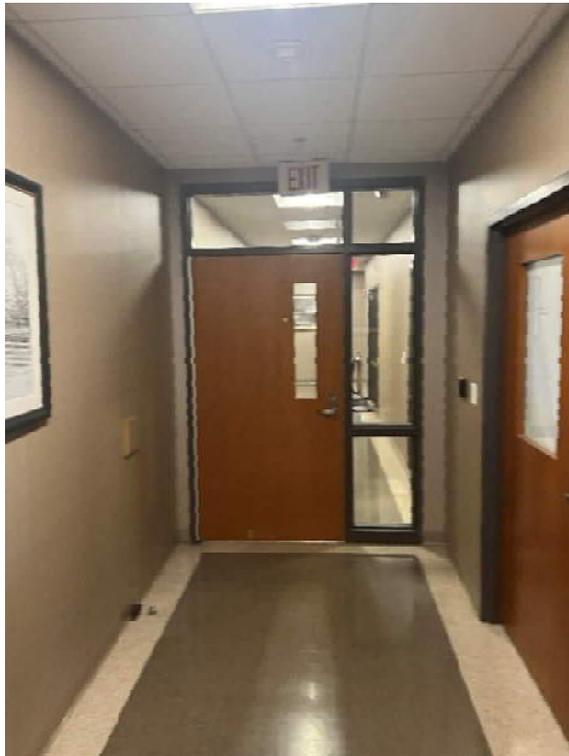
Coding / Field Name	Asset Description
System Name	Interior wood doors and frames
Condition	4
Quantity	81
Unit Cost	\$106,118.1
Year in Service	2009
Expected Useful Life	50 years
Remaining Useful Life	40 years, Estimated, Based on Date of Observation
Location	Building interior
Basis of Costing	Square Foot Costs with RSMeans Data 2022 – 43 <sup>rd</sup> Edition

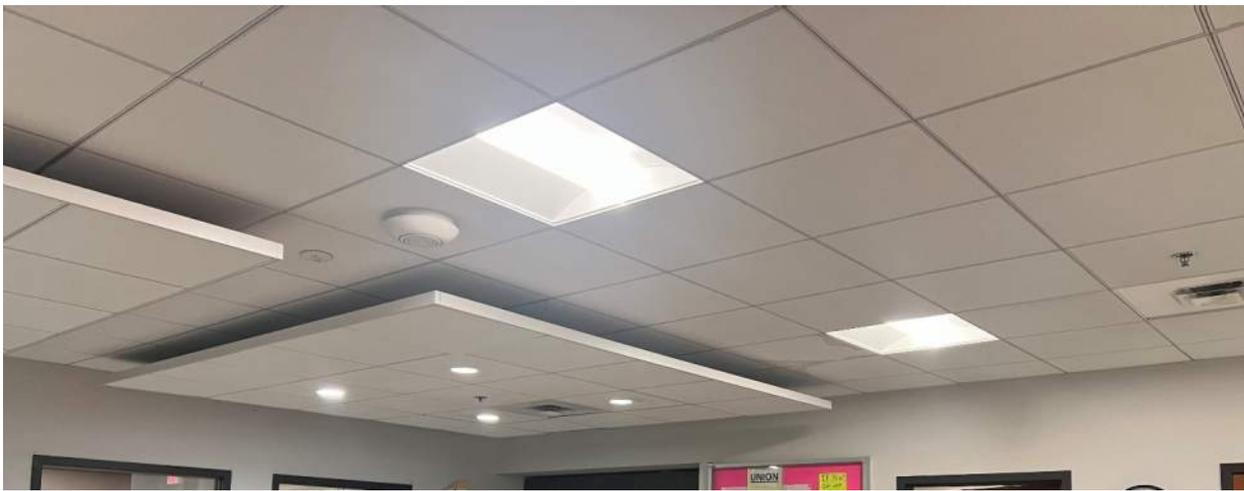
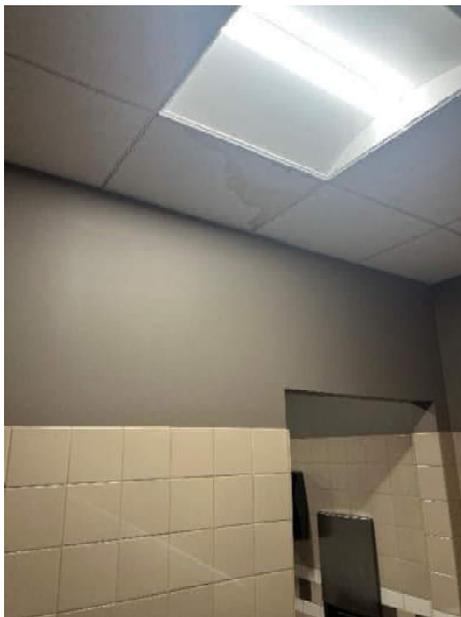
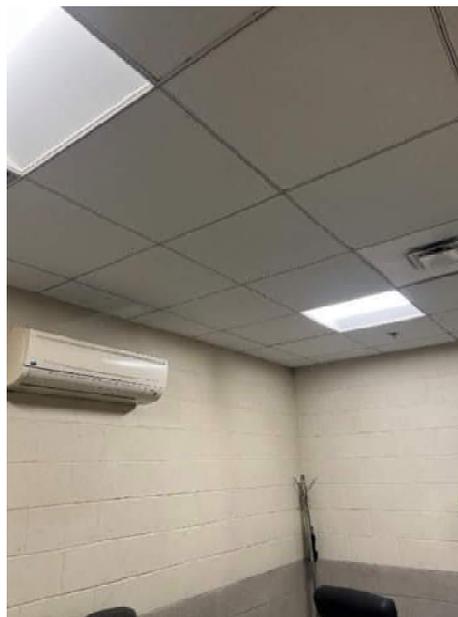
Coding / Field Name	Asset Description
System Name	Acoustic ceiling tiles and grids
Condition	4
Quantity	~26,040 sq. ft.
Unit Cost	\$280,711.23
Year in Service	2009
Expected Useful Life	40 years
Remaining Useful Life	30 years, Estimated, Based on Date of Observation
Location	Building interior
Basis of Costing	Square Foot Costs with RSMeans Data 2022 – 43 <sup>rd</sup> Edition

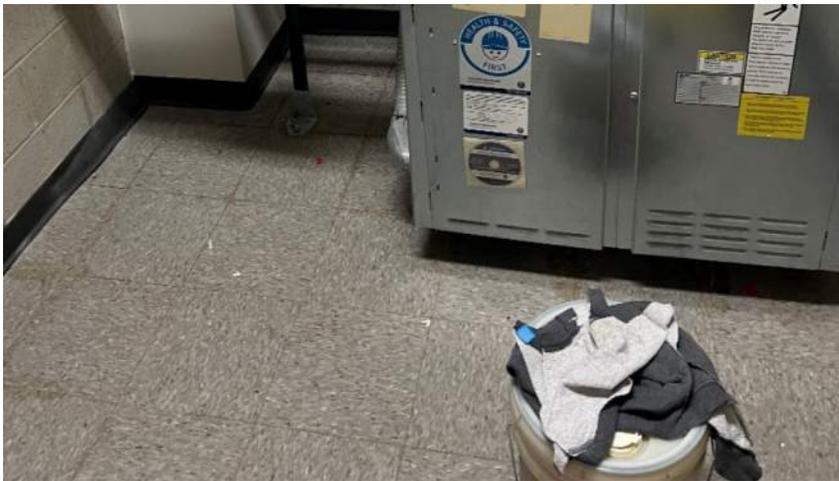
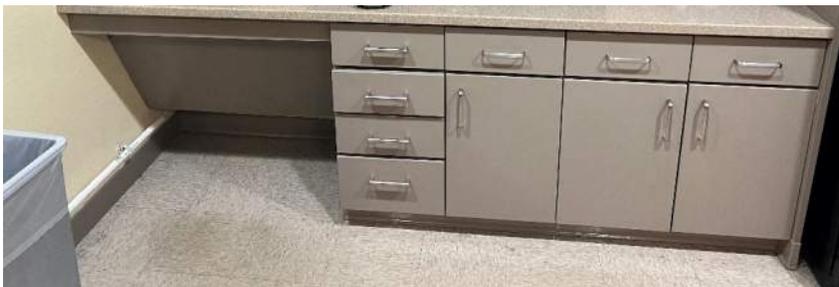
Coding / Field Name	Asset Description
System Name	Vinyl composition tile
Condition	3
Quantity	~26,040 sq. ft.
Unit Cost	\$175,770
Year in Service	2009
Expected Useful Life	50 years
Remaining Useful Life	25 years, Estimated, Based on Date of Observation
Location	Building interior
Basis of Costing	Square Foot Costs with RSMeans Data 2022 – 43 <sup>rd</sup> Edition

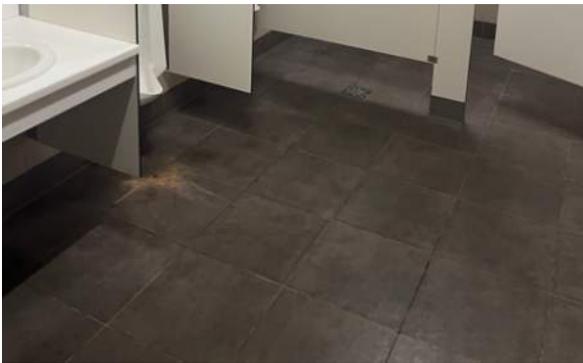
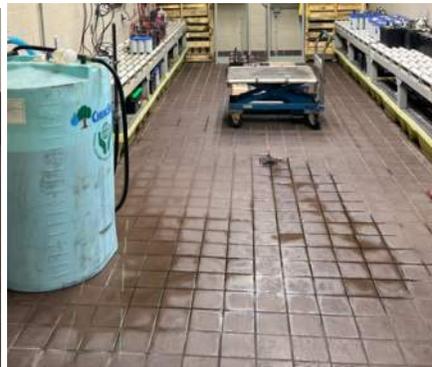
Coding / Field Name	Asset Description
System Name	Ceramic Tile Floor & base
Condition	3
Quantity	~1,200 sq. ft.
Unit Cost	\$16,335.84
Year in Service	2009
Expected Useful Life	75 years
Remaining Useful Life	60 years, Estimated, Based on Date of Observation
Location	Building interior
Basis of Costing	Square Foot Costs with RSMMeans Data 2022 – 43 <sup>rd</sup> Edition

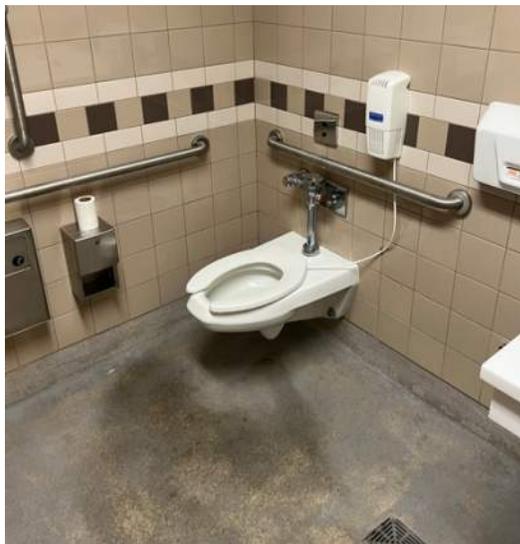
Coding / Field Name	Asset Description
System Name	Restroom fixtures and accessories
Condition	3
Quantity	4 restrooms
Unit Cost	Total: \$65,196
Year in Service	2009
Expected Useful Life	30 years
Remaining Useful Life	20 years, Estimated, Based on Date of Observation
Location	Building interior
Basis of Costing	Square Foot Costs with RSMeans Data 2022 – 43 <sup>rd</sup> Edition

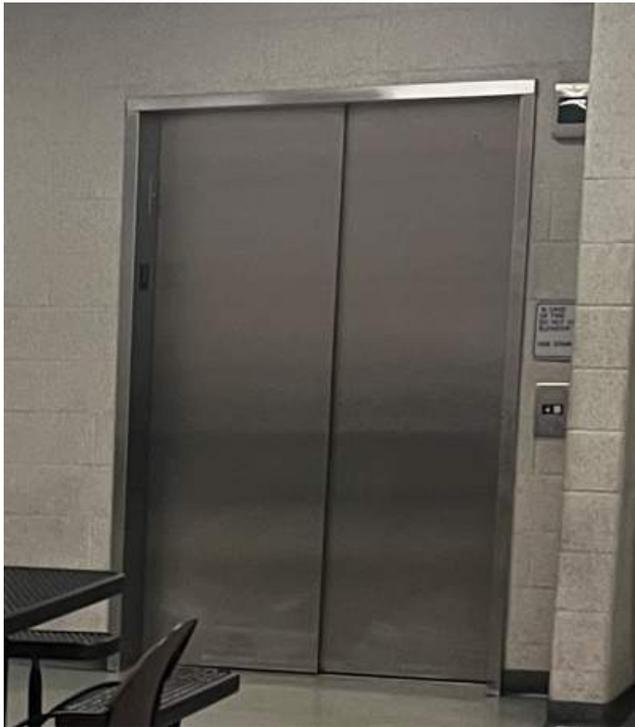
Coding / Field Name	Asset Description
System Name	Elevator
Condition	3
Quantity	1
Unit Cost	\$453,500
Year in Service	2009
Expected Useful Life	25 years
Remaining Useful Life	10 years, Estimated, Based on Date of Observation
Location	Building interior
Basis of Costing	Square Foot Costs with RSMeans Data 2022 – 43 <sup>rd</sup> Edition

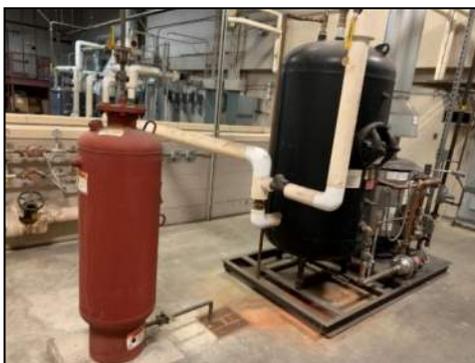
Figure 2: Domestic Water Boiler and Storage Tank

On the mechanical mezzanine, a gas-fired boiler with an accompanying 200-gallon tank provides the facility domestic hot water. Recirculation pumps provide recirculation through the facility.

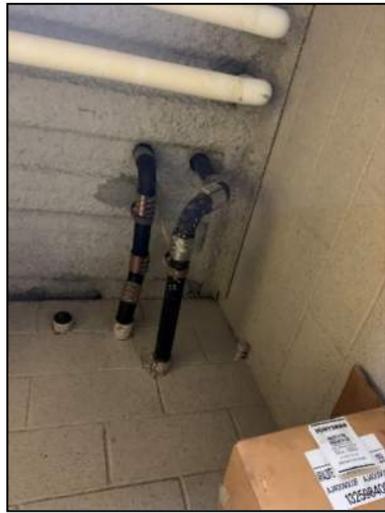
Figure 9: Sanitary Drainage Piping

The sanitary piping is no-hub cast iron. The piping appears in good, working order. A water-oil separator is present in the garage. This separator handles the runoff from the parts cleaning room, the bus bays, and other areas that have drains that could be contaminated with oil.

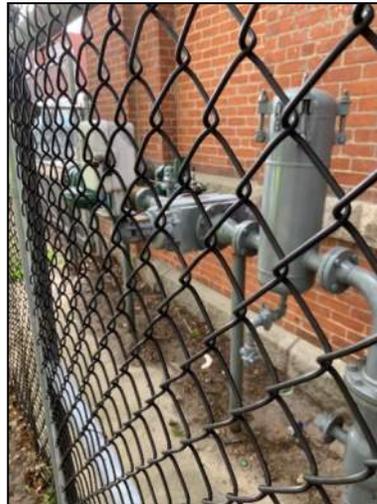
Figure 13: Gas Service Meter and Regulator

The building is served by a natural-gas system on the North side of the facility. The incoming service is ~2” and increases to ~3” after the compressors. A few items requiring gas are the boilers for the hydronic and domestic water and the boilers in the water treatment room.

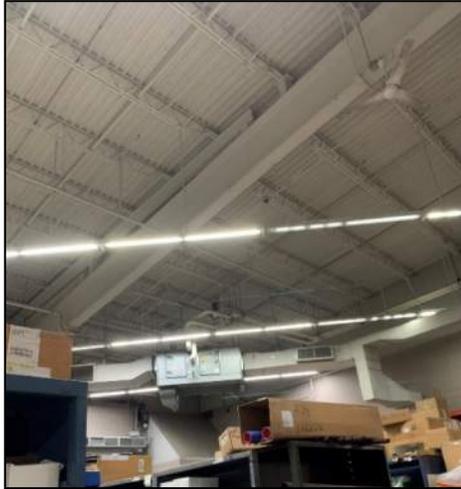
Figure 20: Fan Coil Unit in Parts Storage

The MAUs provide tempered air to replace the air exhausted from the various exhaust systems. Some MAUs are hung from the ceiling at locations on the perimeter of the garage area. These units are ducted across the garage and to various rooms along the perimeter. MAUs are also mounted on the flat roof and provide MAU to the exterior spaces, outside of the garage area. An additional Fan Coil Unit is in the parts storage area.

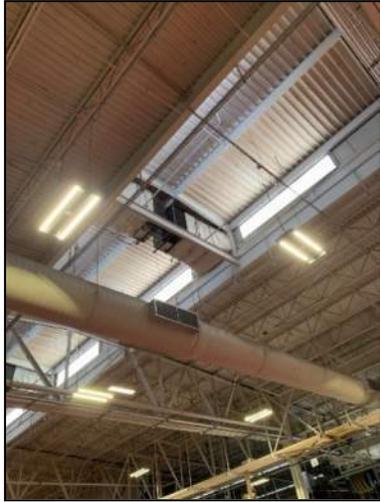
Figure 30: Exhaust Fans at Ceiling Peak

The main floor of the garage has exhaust fans mounted on both sides of the peak of the ceiling. These exhaust fans face one another and exhaust directly to the exterior. On the walls of the garage, there are control sensors that measure CO and NO<sub>2</sub> and control the fans.

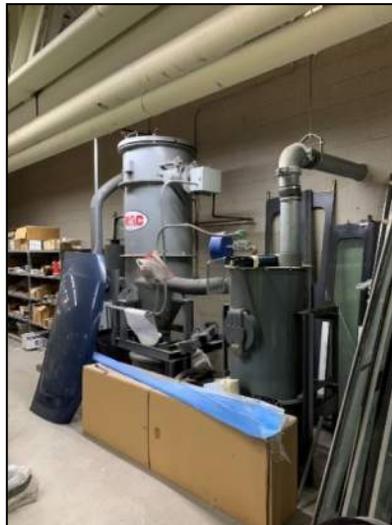
Figure 32: Smoke Exhaust System

The Body Shop is equipped with a localized smoke exhaust. The machine appears in working order.

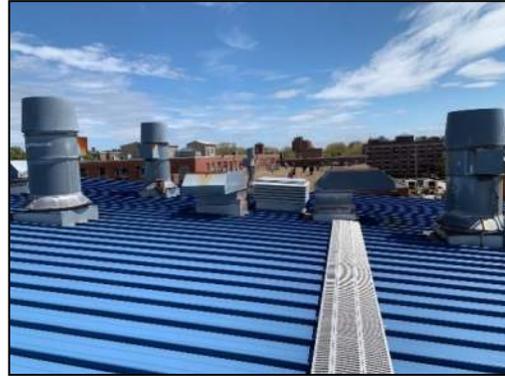
Figure 35: Paint Booth Exhaust Roof Terminations

The facility has a paint booth that has an integral exhaust system. The interior of the paint booth has rows of filters. The exhaust terminates on the roof through exhaust stacks.

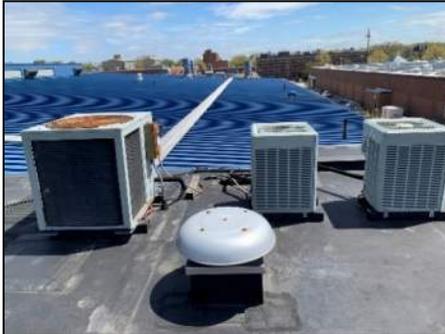
Figure 37: Air Conditioning Condensers on Flat Roof

comfort cooling systems are in place around the facility. The office area is equipped with a standard split, direct expansion system. The condensers are located on the flat roof on the South Side of the building, above the office area. The indoor units are hung from the ceiling in a mechanical space adjacent to the office area.

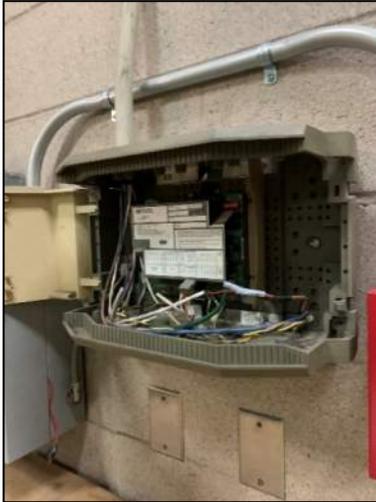
Figure 44: Abandoned BMS Control Panel

An abandoned in-place BMS controls system panel is in the parts storage room. The abandoned system is JCI MetaSys system. The working controls system panel is in the boiler room. The working BMS controls system is JCI Facility Explorer.

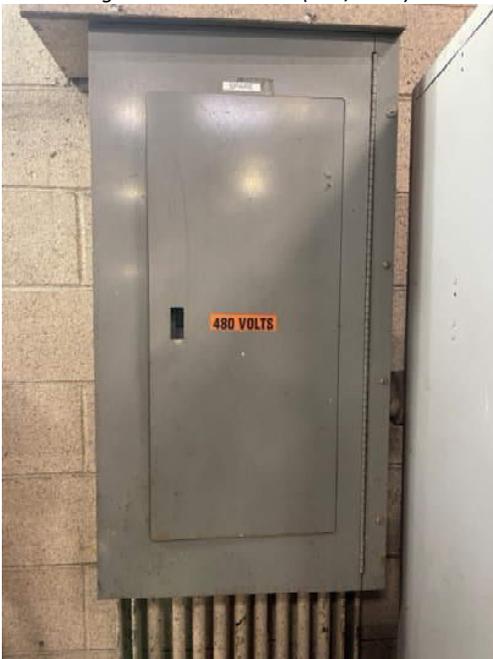
Figure 2: Transformer

A 1,600A, 480V service installed approximately 20 years ago. The service is fed from the pad mounted transformer (South side of the building) (*Figure 2*) and enters the main switchboard (*Figure 1*) located in the Electrical Room. Building is served by a 265KW backup diesel generator (*Figure 4*). Many older panelboards are deteriorating and/or are damaged or abandoned in place (*Figure 3*).

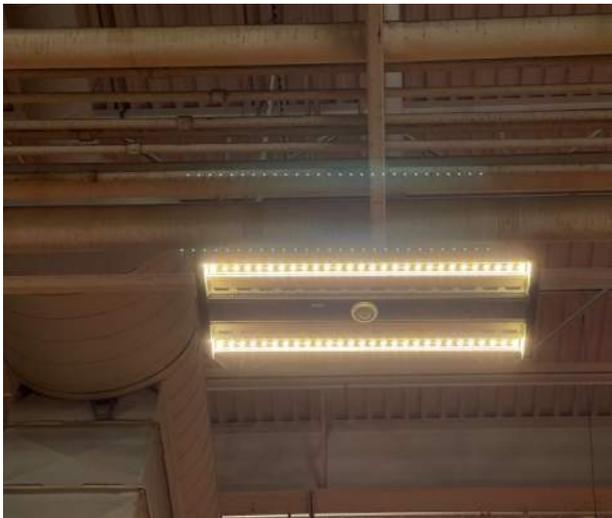
LED high-bay fixtures with integral occupancy sensors (*Figure 1*) are installed throughout the first-floor garage space. Older fluorescent fixtures were left in place (*Figure 2*). All exit signs throughout the space are illuminated and appear to be completely operational.

*Figure 1: LED High-bay fixtures with integral occupancy sensor*

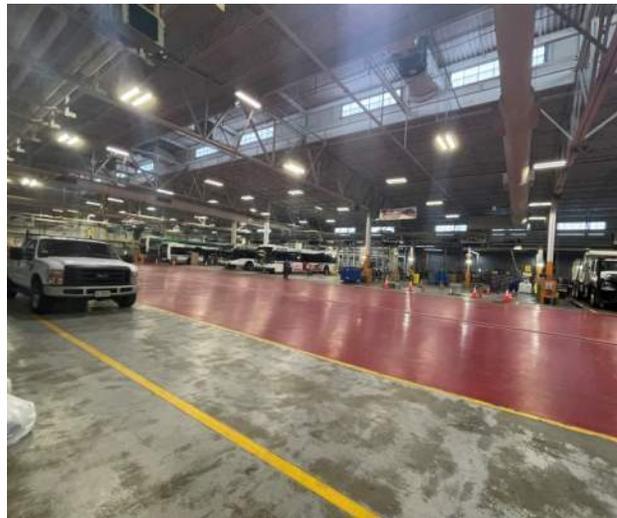
*Figure 2: LED High-bay and fluorescent fixtures*
