# Transit Asset Management Plan

October 1, 2022 – September 30, 2026

**RHODE ISLAND PUBLIC TRANSIT AUTHORITY**

# RITPA Transit Asset Management Facility Condition Assessment

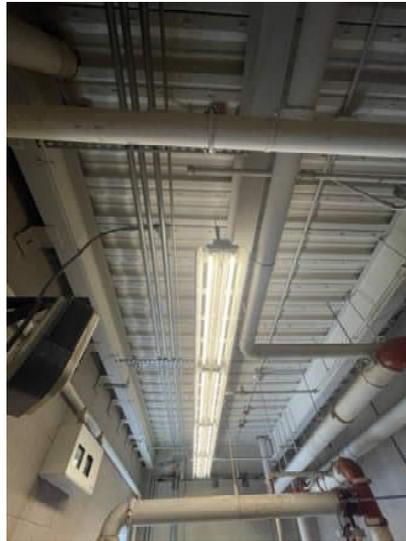
Figure 6: Fluorescent Fixtures

Storage/office spaces consist of LED 2’X2’ and 2’X4’ troffer fixtures (Figure 3) and linear LED fixtures controlled by a combination of toggle switches (Figure 7), ceiling mounted occupancy sensors (Figure 4), and wall switch occupancy sensors (Figure 8). Exit signs were observed throughout the space and appear to be fully operational (Figure 5). Emergency battery units were observed in some storage/mechanical/electrical rooms. In addition to emergency battery units, lighting fixtures throughout the office space are on generator backup. Fluorescent fixtures (Figure 6) are still operational throughout the office space and storage areas.

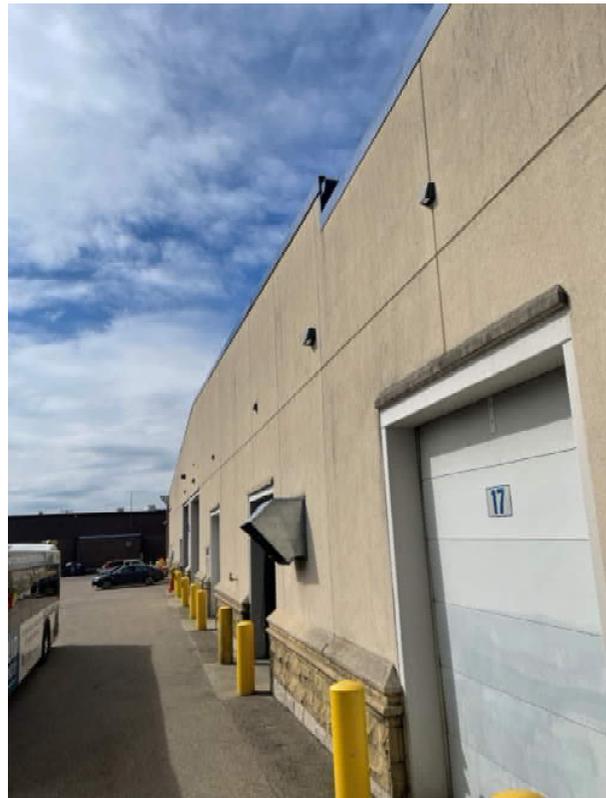
Figure 10: Emergency Wall packs

Coding / Field Name	Asset Description
Exterior Lighting System	Exterior wall pack fixtures, emergency remote heads
Condition	3 – Adequate
Quantity	Exterior Lighting System
Unit Cost	~ \$7,500
Year in Service	Lighting, Branch Wiring, and Associated controls ~ 20 years
Expected Useful Life (EUL)	Lighting, Branch Wiring, and Associated controls ~ 20 years
Remaining Useful Life (RUL)	Lighting, Branch Wiring, and Associated controls ~ 0-5 years; Estimation contingent on equipment meeting the American National Standards Institute/International Electrical Testing Association (ANSI/NETA) Standard for Maintenance Testing Specifications.
Location	Building Exterior
Basis of Costing	RMS Means Data with Contingencies Added

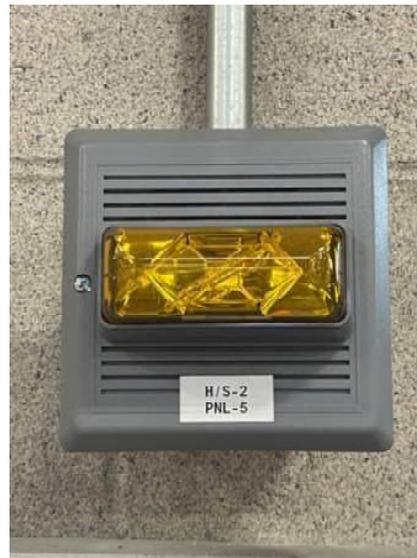
Figure 2: Amber Strobe for CO detection system

Fire alarm system (*Figure 1*) consists of an addressable Fire Alarm Control Panel (Edwards EST-3) and associated devices manufactured by Edwards. Connection to local fire department is through a Gamewell Master Box. CO detection system is installed throughout the garage space (*Figure 2*). Fire Alarm system and associated devices and wiring appear to be in working condition, however some devices are approaching their expected useful life based on industry standards.

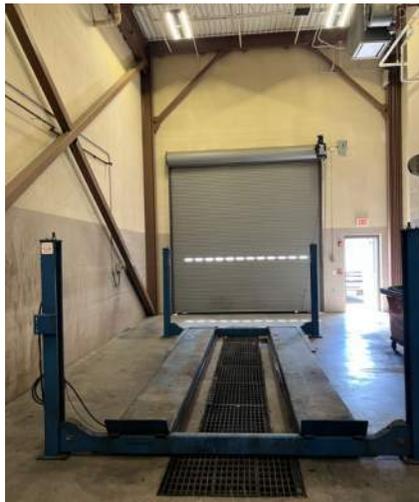
Coding / Field Name	Asset Description
System Name	Vehicle lifts
Condition	3
Quantity	5
Unit Cost	\$175,000
Year in Service	2009
Expected Useful Life	20 years
Remaining Useful Life	10 years, Estimated, Based on Date of Observation
Location	Building interior
Basis of Costing	Square Foot Costs with RSMMeans Data 2022 – 43 <sup>rd</sup> Edition

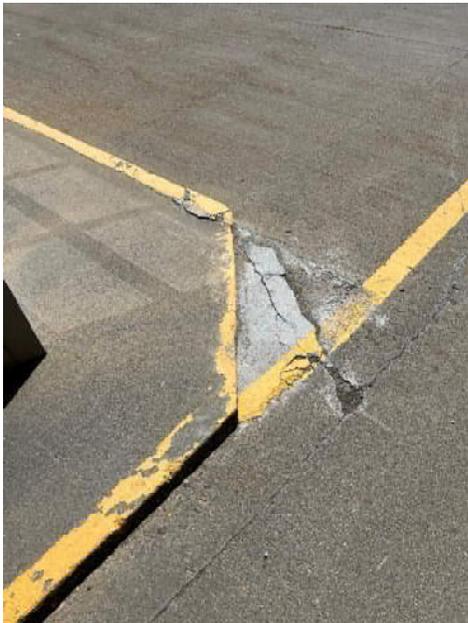
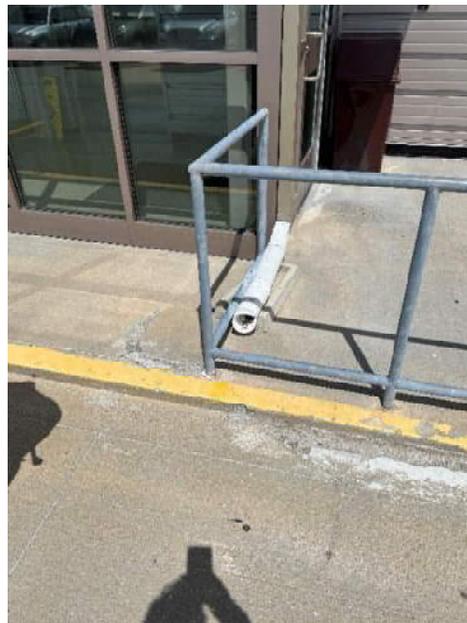
Coding / Field Name	Asset Description
System Name	Site work and parking lot
Condition	3
Quantity	~ 90,857.75 sq. ft.
Unit Cost	\$478,809.60
Year in Service	2009
Expected Useful Life	25 years
Remaining Useful Life	5 years, Estimated, Based on Date of Observation
Location	Building Exterior
Basis of Costing	Square Foot Costs with RSMeans Data 2022 – 43 <sup>rd</sup> Edition
